Stage 1 Road Safety Audit

Proposed Re-development and Enhancement of Public Realm Market Square,
Letterkenny

Client:	Donegal County Council
Document No:	220316-ORS-XX-XX-RP-TR-7d-001
Date:	18/05/2022

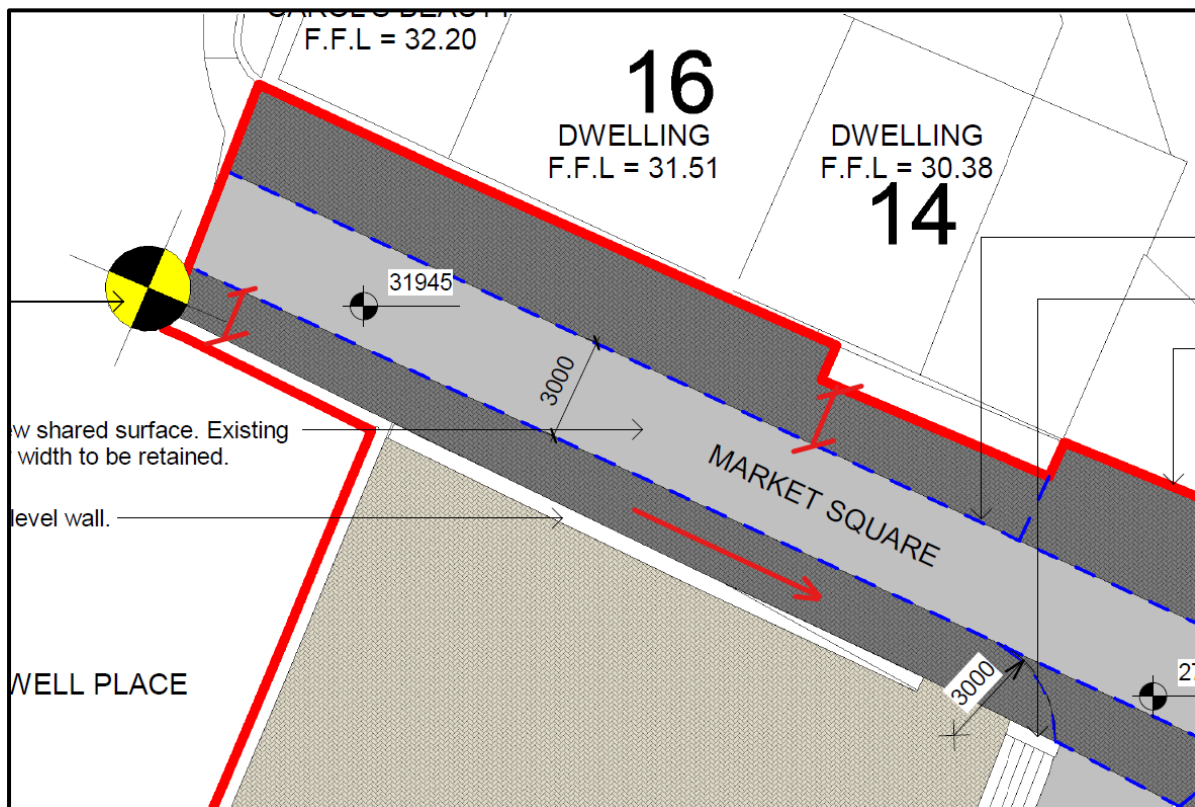
Location: Market Square Road

Problem No.01: Footpath Widths & Gradients

The audit team note that there is a lack of information for the proposed footpaths including widths and gradients. The audit team are concerned that the footpaths narrow down to inappropriate widths and include steep gradients at various locations throughout the scheme which creates an increased risk of potential conflicts both for footpath users and vehicles. Disabled road users may veer into the road at narrow sections and steep gradients which may result in wheelchair users for example losing control resulting in injury.

The design team should ensure that appropriate footpath and roads widths are provided for throughout the scheme and steep gradients be reduced within acceptable guidelines with intermittent level sections in accordance with DMURS guidelines and national Disabled Authority guidelines.

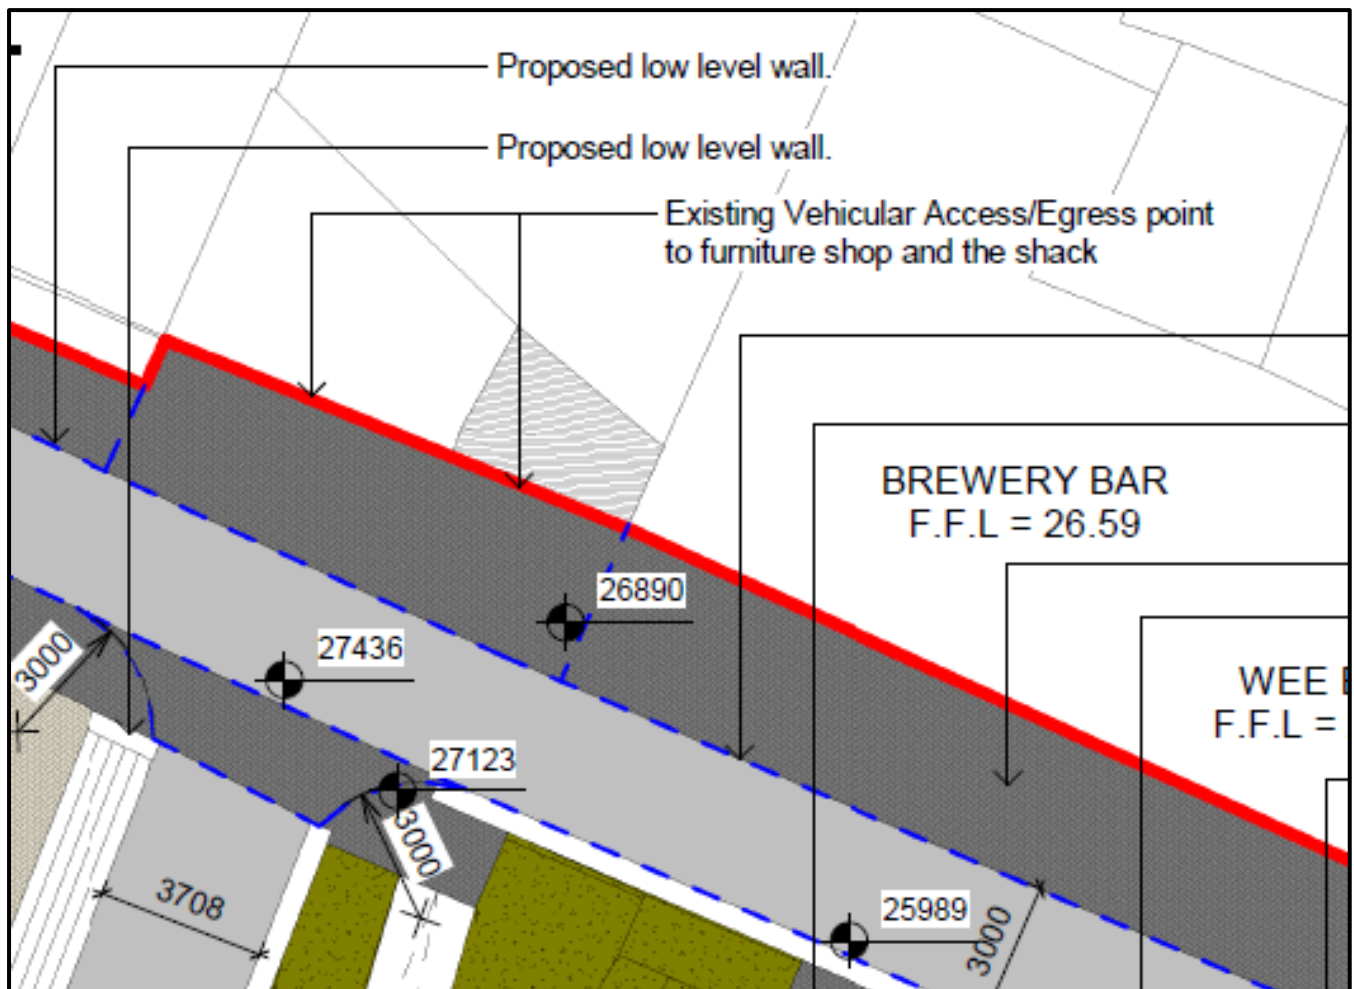
Location: Vehicle Access /Egress point

Problem No.02: Pedestrian Disabled Access

The audit team note that paving differentiation is not specified throughout the scheme and at existing vehicle access/egress points to differentiate clearly between pedestrian and vehicle surfaces. Shared surfaces can cause problems for disabled users with cognitive difficulties who may find the environment difficult to interpret and the absence of conventional kerbing poses problems for blind or partially sighted people to find their way around. The omission may result in vulnerable road users travelling in the roadway putting them at risk of conflict with vehicles.

The design team should ensure that shared surfaces and roadways are clearly distinguishable throughout the scheme. The design team should also ensure that details and locations of 'drop kerbs' and tactile paving is provided throughout the scheme at proposed crossing points

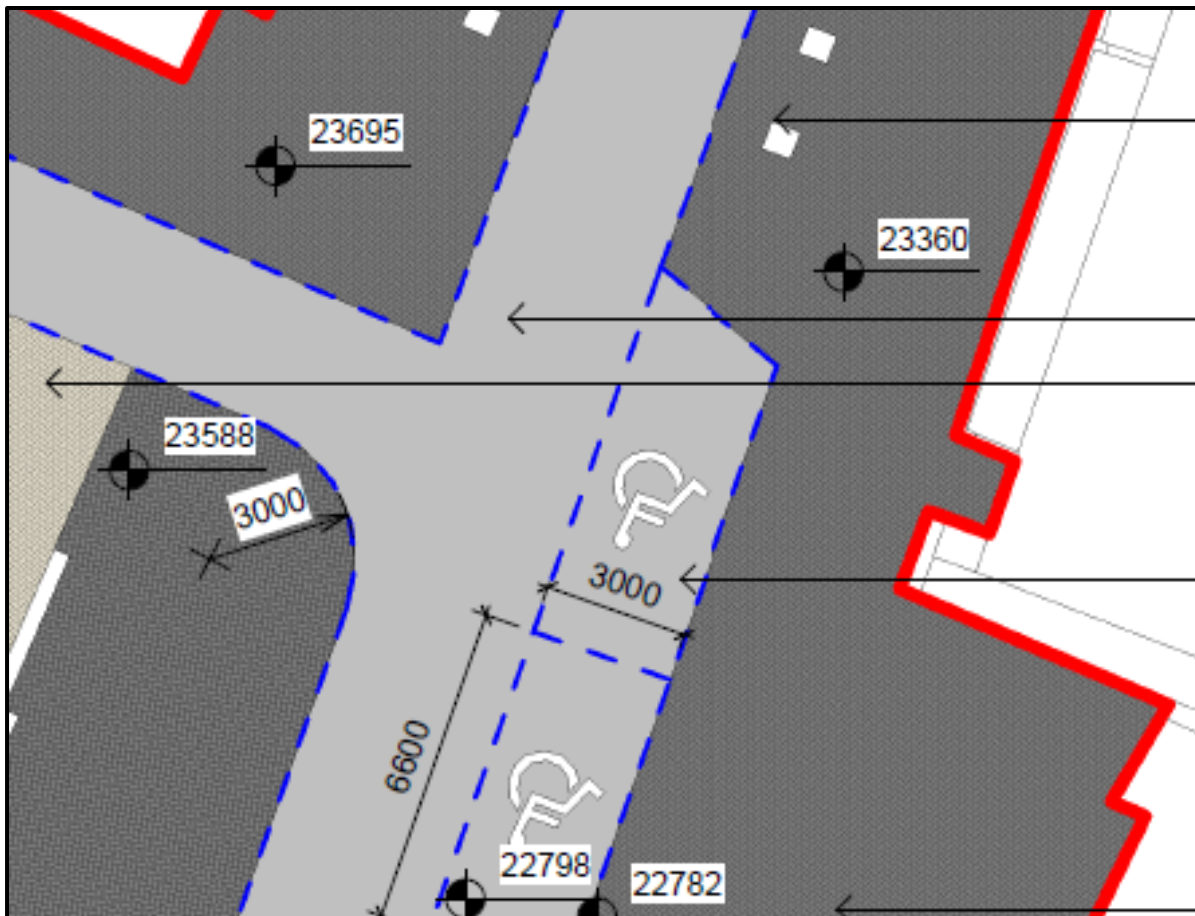
Location: Site entrance and internal roads

Problem No. 03: Signage & Road Markings

The audit team note that there is a lack of signage and markings for the site access junction and internal roadways on the drawings provided. Signage and markings aid in informing road users of the direction of travel and presence of vulnerable road users and ramps. Inadequate signage and road markings may lead road users not being alerted to the shared space which may result in vehicle-vehicle or vehicle-cycle conflicts causing injury.

The design team should include signage and marking on the shared roadways in line with the applicable Traffic Signs Manual.

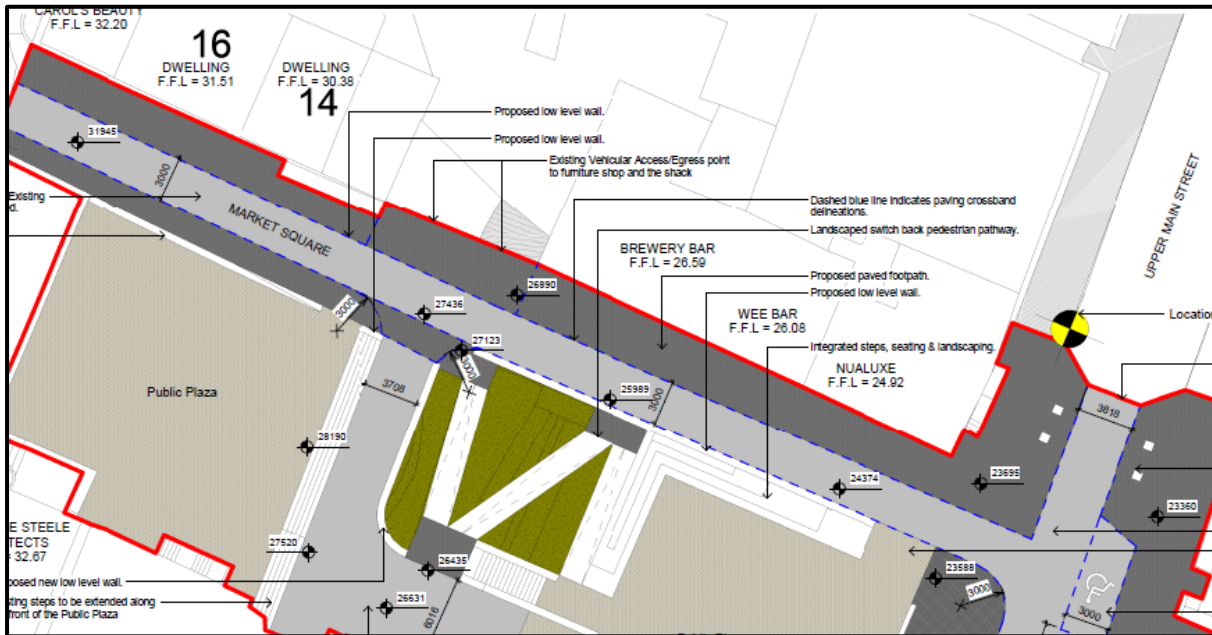
Location: Market Square Street

Problem No.04: Speed Control Measures

The audit team note from the drawings provided that there are limited speed control measures proposed within the site. The audit team are concerned that the long sections of straight road with steep downhill gradient could result in higher speeds which could put vulnerable users within the shared surface at risk.

The design team should ensure that appropriate speed control measures are incorporated within the schemes to reduce vehicular speeds.

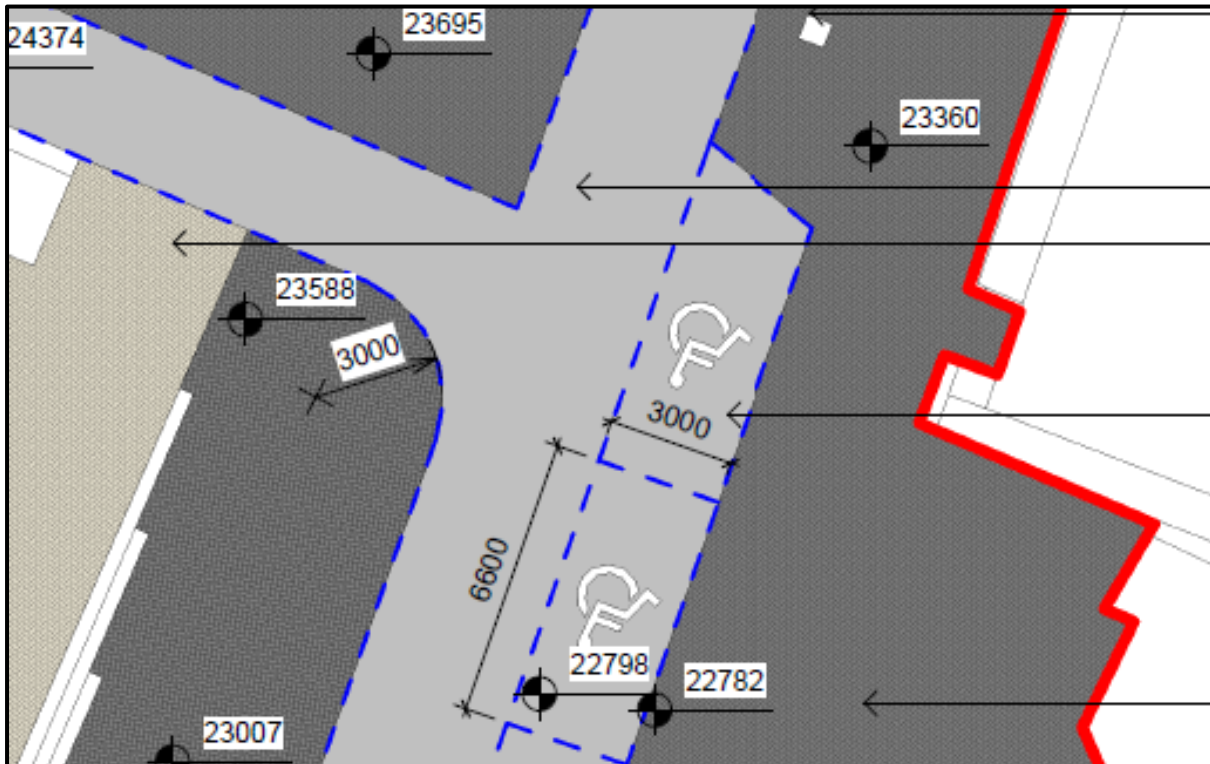
Location: Market Square / Lower Main Street Junction

Problem No. 05: Pedestrian Vehicle Separation

The audit team note from the drawings provided that the proposed shared space does not include protection for pedestrians at locations where vehicles conduct turning movements which may result in pedestrian vehicle conflicts and injury.

The design team should consider measures for physical separation at locations where vehicles may enter pedestrian zones including junctions and parking bays.

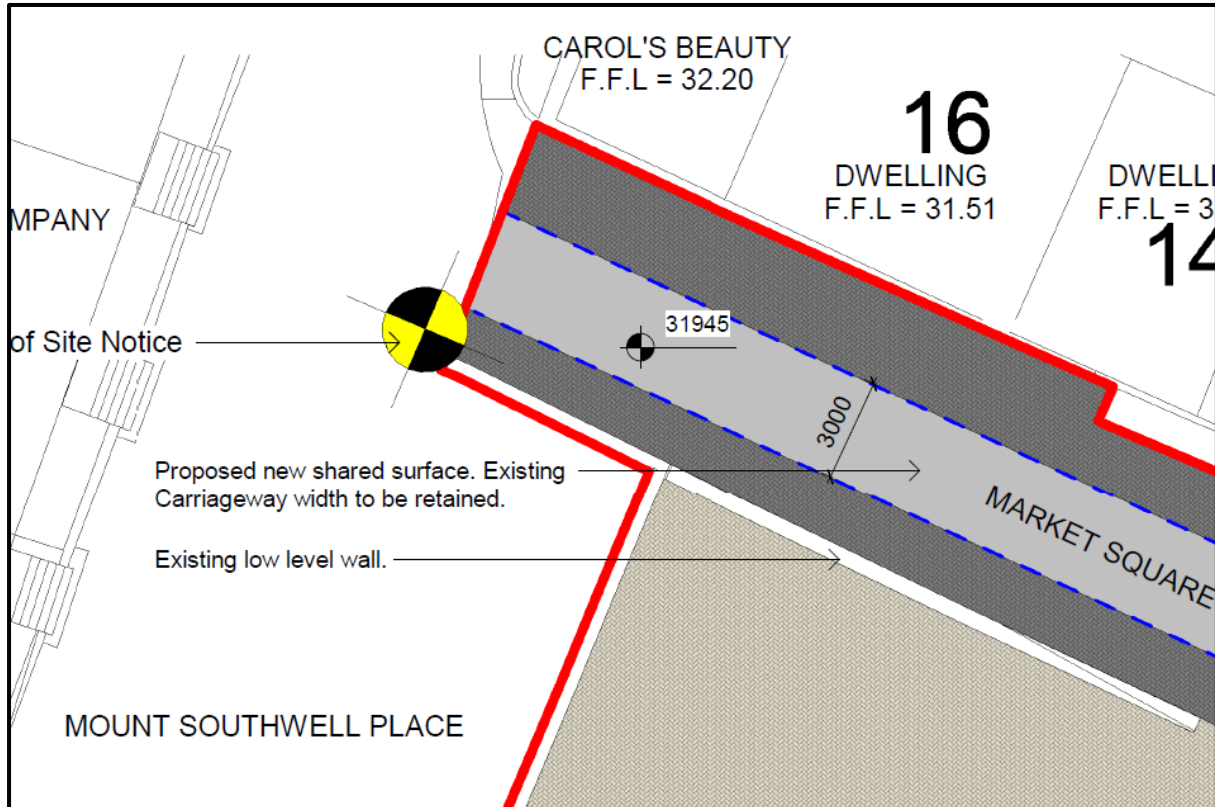
Location: North-West Tie-In Point

Problem No. 06: Connections to Existing Infrastructure

The audit team note from the drawings provided and site visit that the proposed new footpath to the north-west does not tie into existing footpath infrastructure. It appears the footpath terminates abruptly and leads pedestrians into the roadway in this area on both sides of the road. This could put users at serious risk of conflict with vehicles which could result in injury.

The design team should ensure that appropriate infrastructure is proposed at this location to ensure that appropriate footpath provisions are provided for to mitigate the risk of conflict with vehicles.
