Port Pier Inver

Condition Assessment Report

Donegal County Council

Report No. CM1379-STR-R001

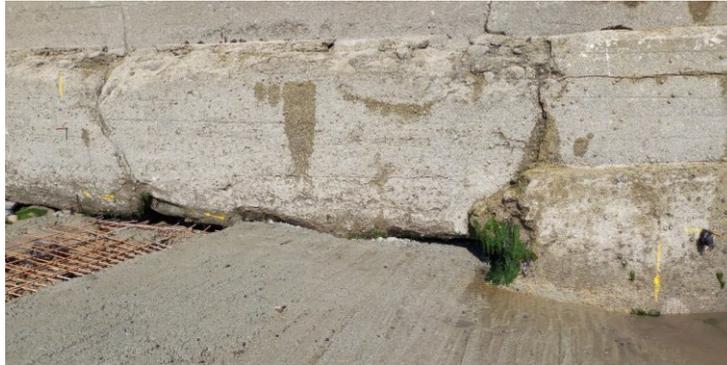
There are however some locations which would require attention to prevent further deterioration such as the undermining of the pier wall near both slipways and the steps.

Figure 2: Undermining of the pier wall near both slipways

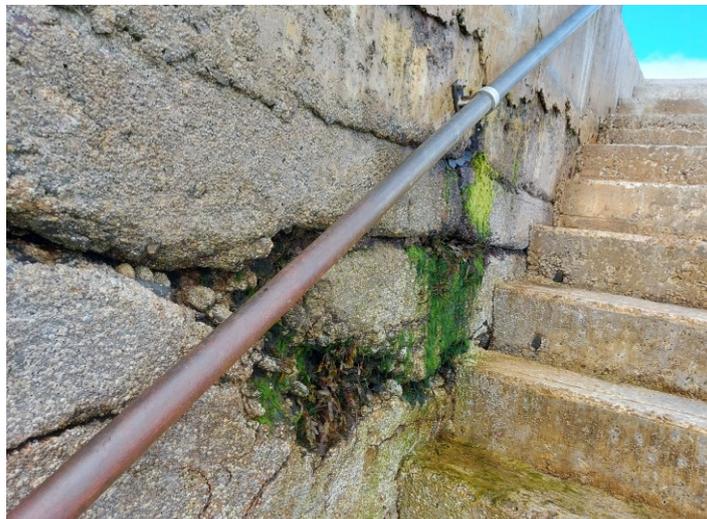
Figure 3: Grout loss/Undermining of the pier wall near the concrete steps

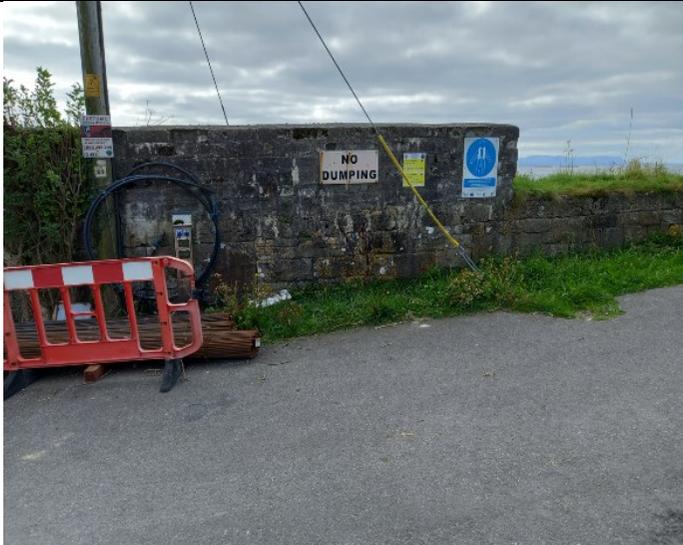
Ref:001 Caption: General condition of masonry sea wall – north elevation

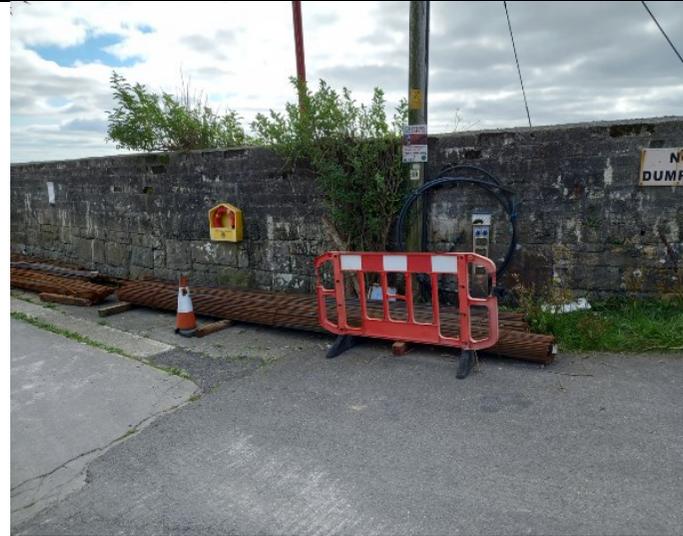
Ref:002 Caption: General condition of masonry sea wall– north elevation

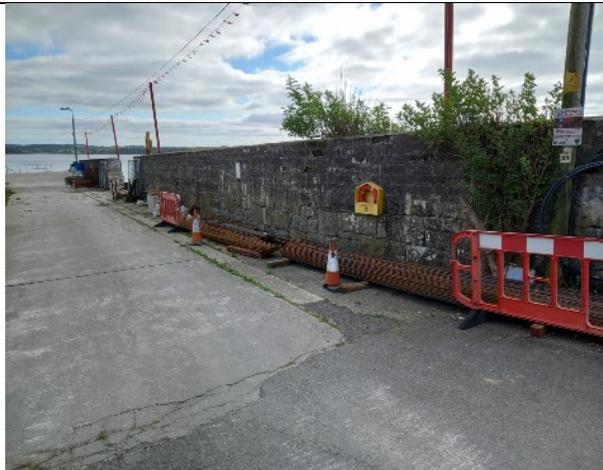
Ref:003 Caption: General condition of masonry sea wall

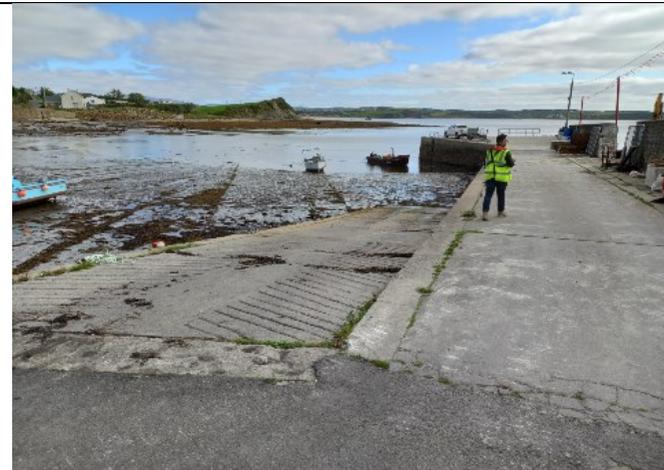
Ref:004 Caption: General condition of concrete deck and slipway

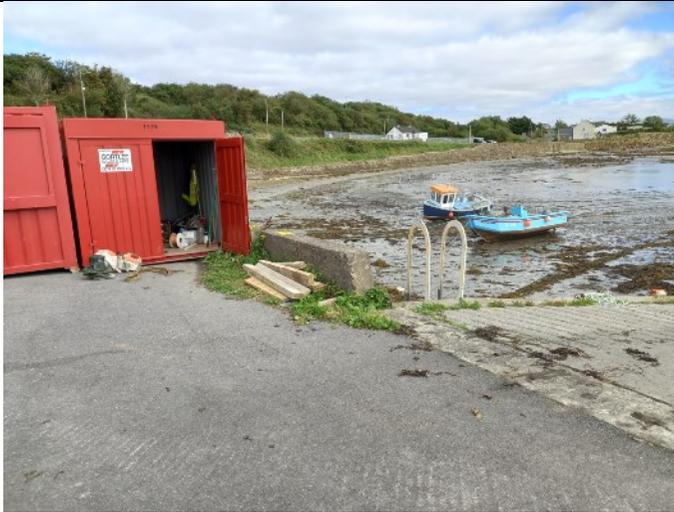
Ref:005 Caption: General condition of slipway

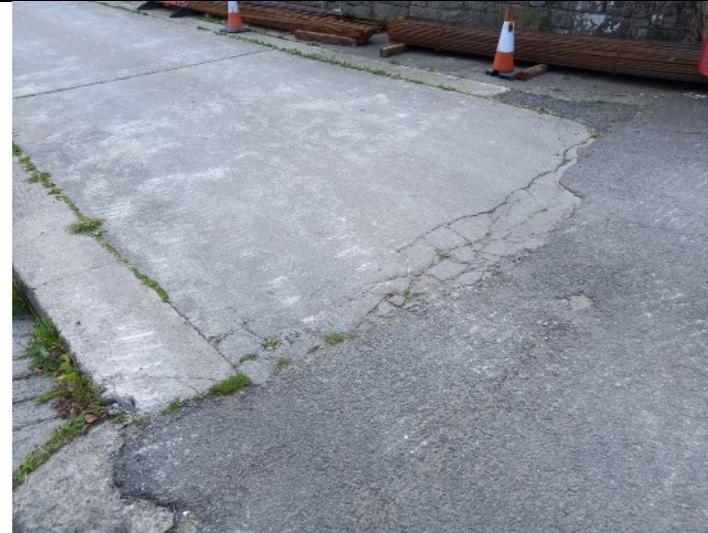
- There are signs of wear and tear to the concrete surface particularly near the of start of the pier which shows localised failure, likely to be between the transition between approach slab and concrete pavement. Vegetation is present between concrete joints at various locations throughout which would require removal and repairing. Various sizes of cracking is also present.

Ref:006 Caption: General condition of concrete deck – localised failure & cracking of concrete surface at interchange zone

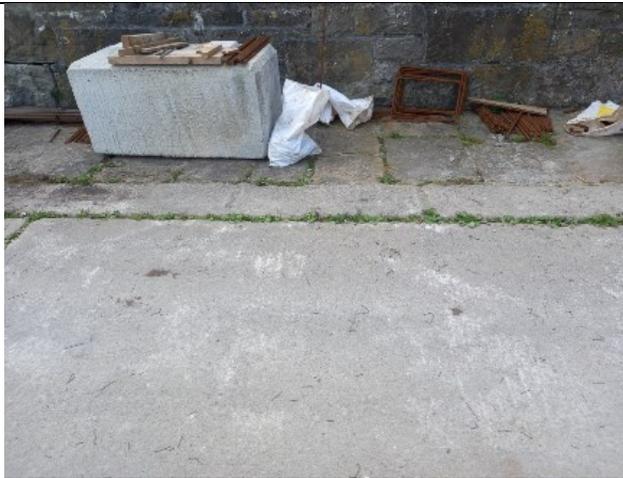
Ref:007 Caption: General condition of concrete deck – localised cracking of concrete surface & vegetation present in joint

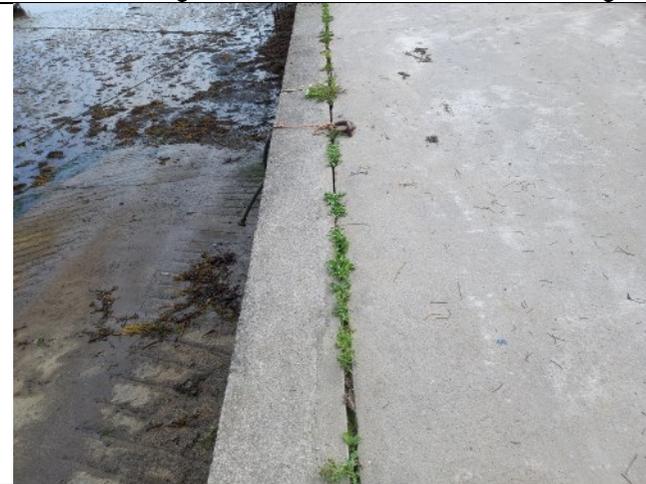
- The cope beam that is closest to the existing slipway has shown signs of wear, evident by the localised spalling of the edge of the concrete. The joint between the cope and pavement is largely filled with vegetation which would require removal and repairing. The alignment of the cope appears okay considering the age of the structure. There are some cracks present and it is our opinion that the cracks observed are generally hairline to fine cracks (ranging between Category 0 and Category 1 – Table 1). The new cope beam that was constructed in 2017 appears in good condition.

Ref:008 Caption: General condition of concrete deck & cope beam – vegetation present in joint

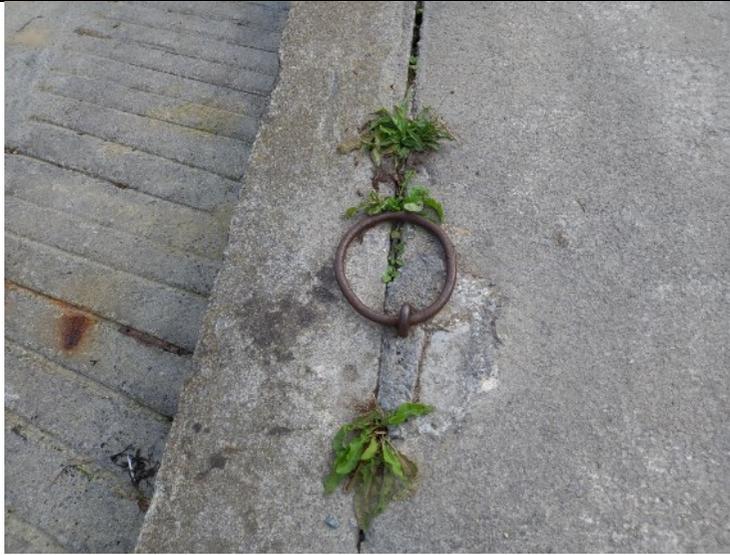
Ref:009 Caption: General condition of concrete deck & cope beam – localised spalling & exposed rebar

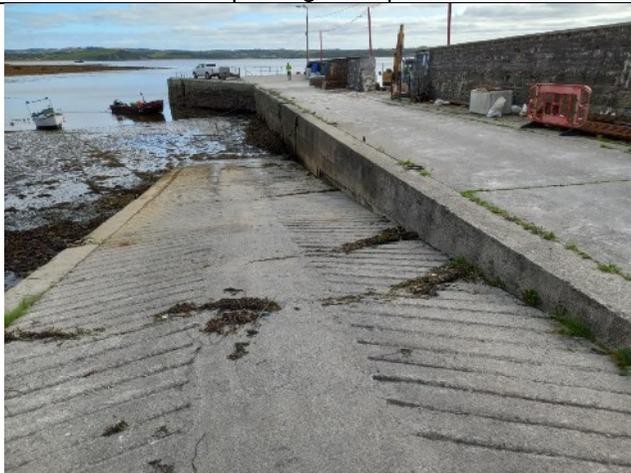
Ref:011 Caption: General condition of slipway

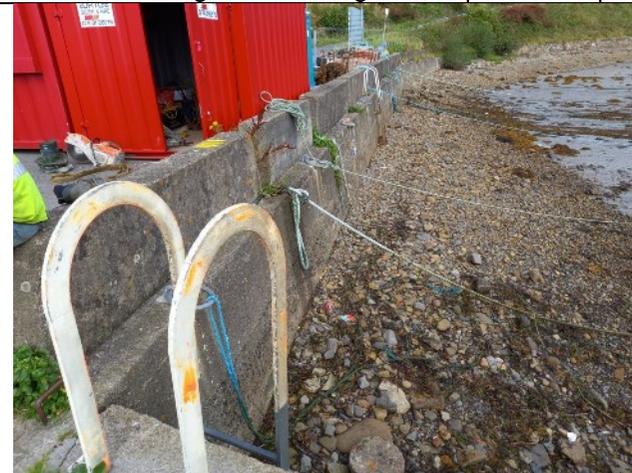
Ref:012 Caption: General condition of slipway

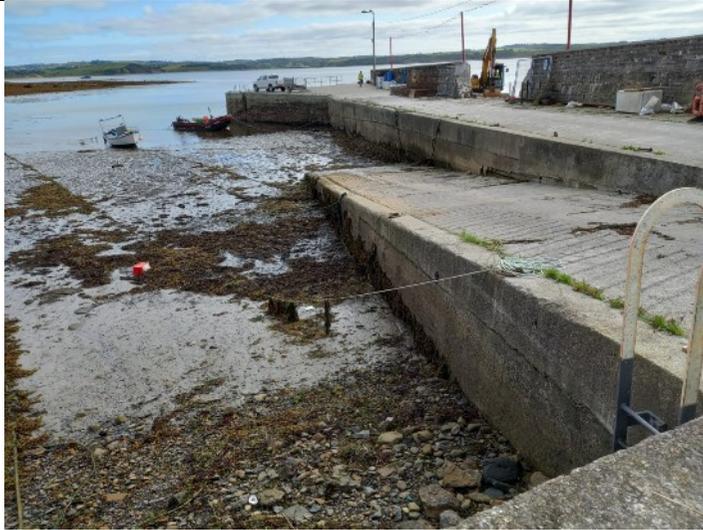
Ref:013 Caption: General condition of slipway & cope

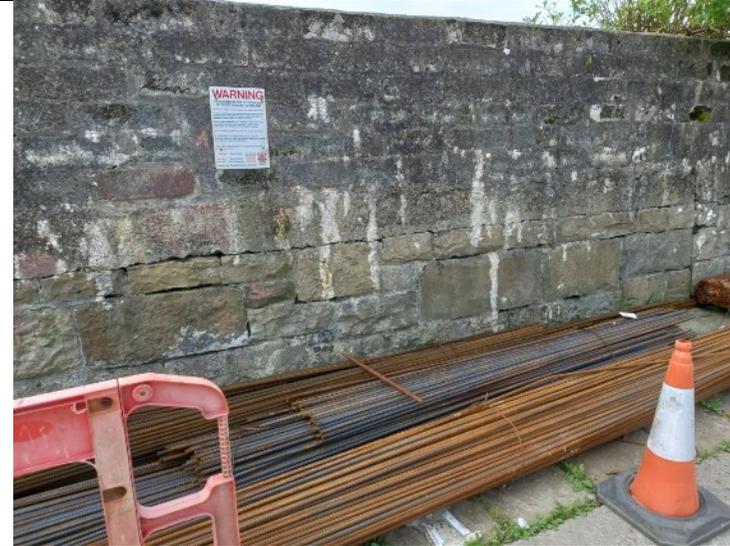
- The existing seawall is constructed from a variety of materials. It appears it was originally built from large stone blocks circa 1m wide. It has been extended using a nominally reinforced concrete core with a concrete block facing capped with a layer of mortar. Cracking to the existing masonry/concrete block seawalls was evident. It is our opinion that the cracks observed are generally hairline to fine cracks (ranging between Category 0 and Category 1 – Table 1). There is also a loss of mortar between joints which would require repointing.

Ref:014 Caption: General condition of masonry sea wall- north elevation - mortar missing from joints

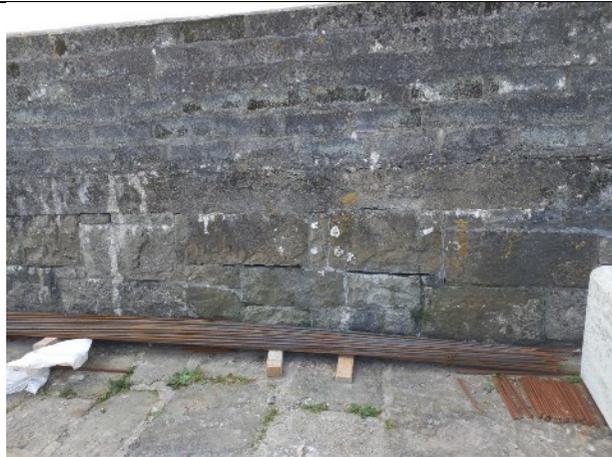
Ref:015 Caption: General condition of masonry sea wall - north elevation

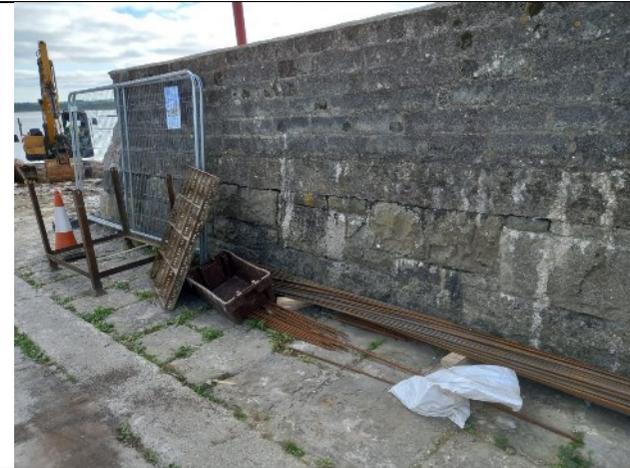
Ref:016 Caption: General condition of masonry sea wall- north elevation

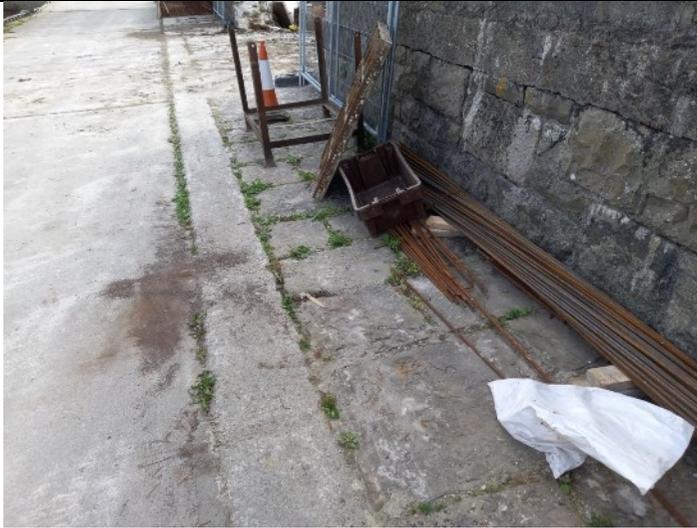
Ref:017 Caption: General condition of masonry sea wall & deck – vegetation present

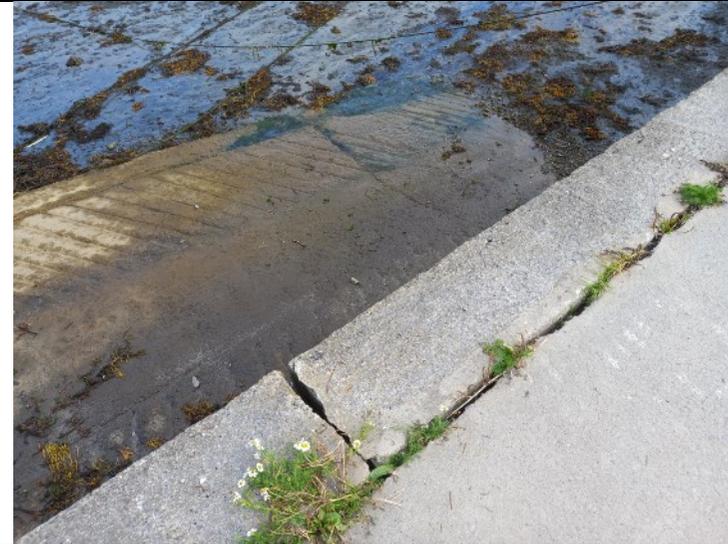
Ref:018 Caption: General condition of cope beam and slipway – vegetation present in joint

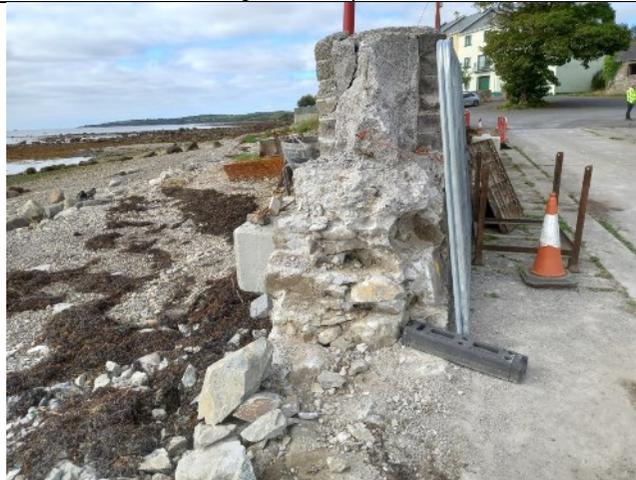
Ref:019 Caption: General condition of masonry sea wall at opening

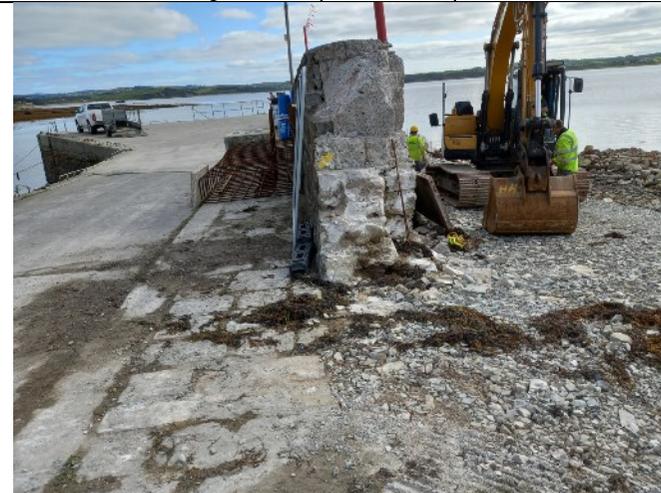
Ref:020 Caption: General condition of masonry sea wall at opening

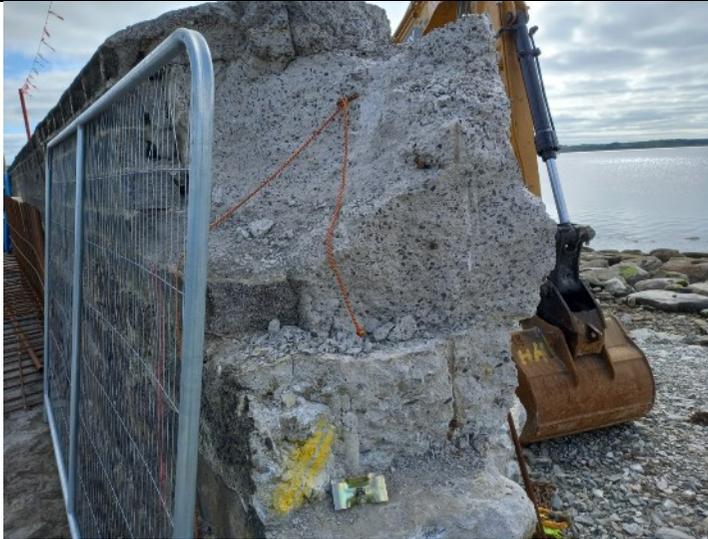
Ref:021 Caption: General condition of masonry sea wall at opening – build up of wall

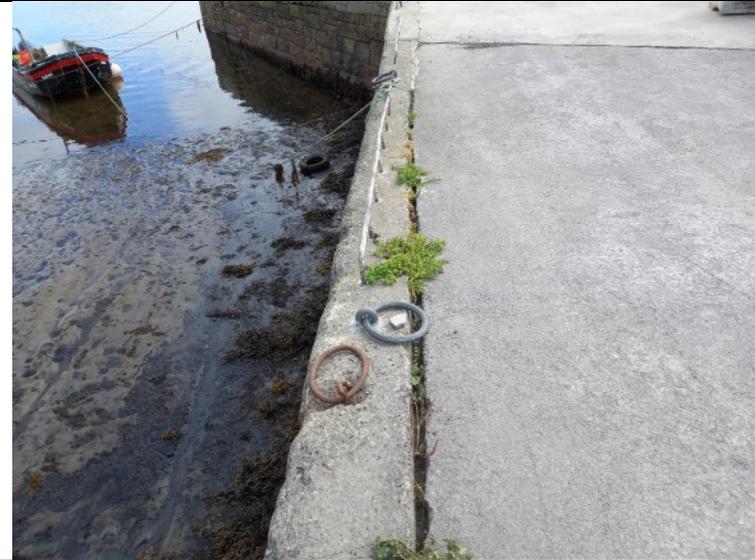
Ref:022 Caption: General condition of cope beam & concrete deck

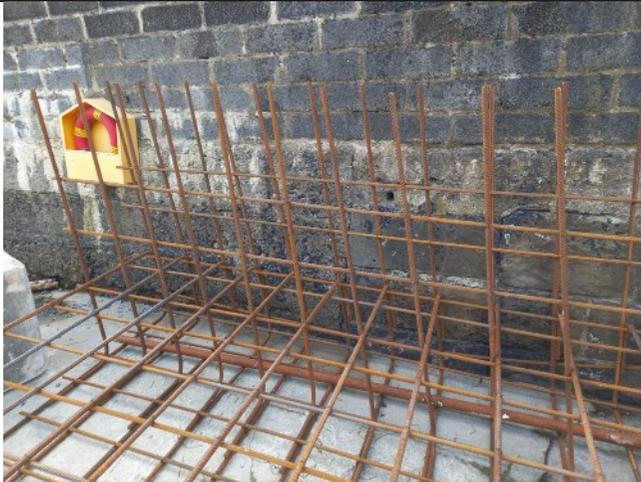
Ref:023 Caption: General condition of masonry sea wall

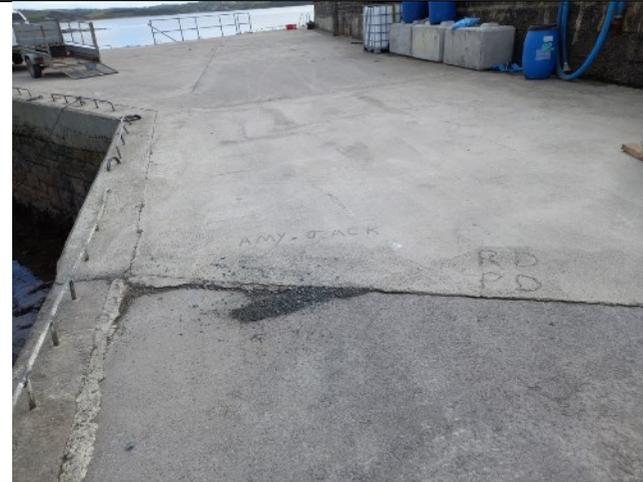
Ref:024 Caption: General condition of concrete deck

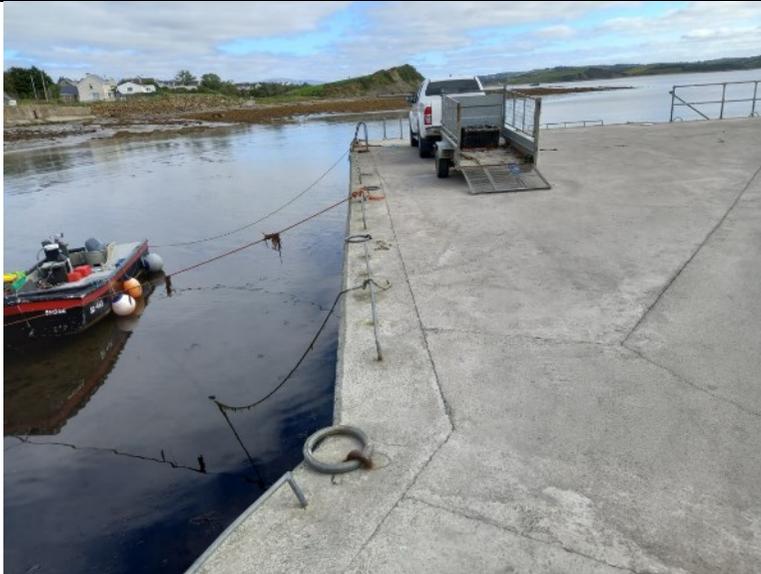
Ref:025 Caption: General condition of concrete deck

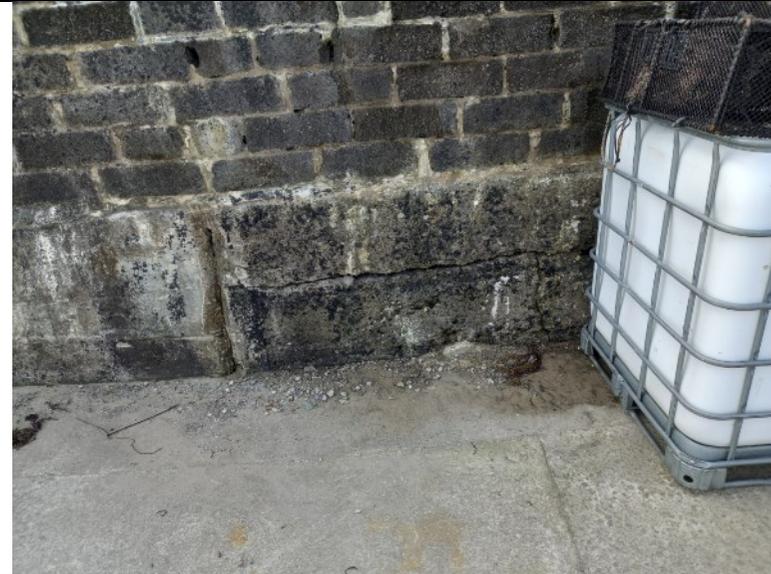
Ref:026 Caption: General condition of masonry sea wall - north elevation – cracking present

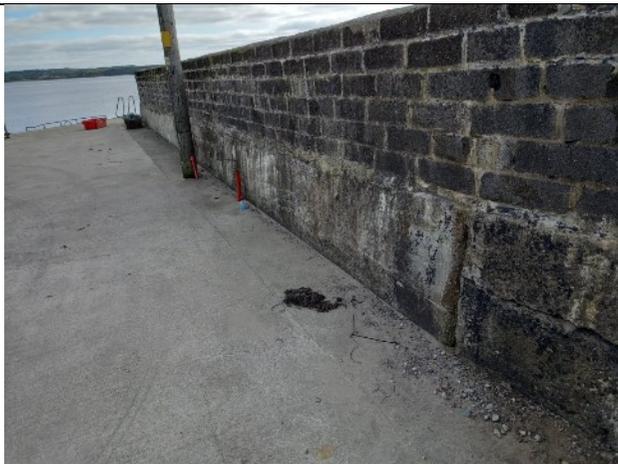
Ref:027 Caption: General condition of masonry sea wall– north elevation

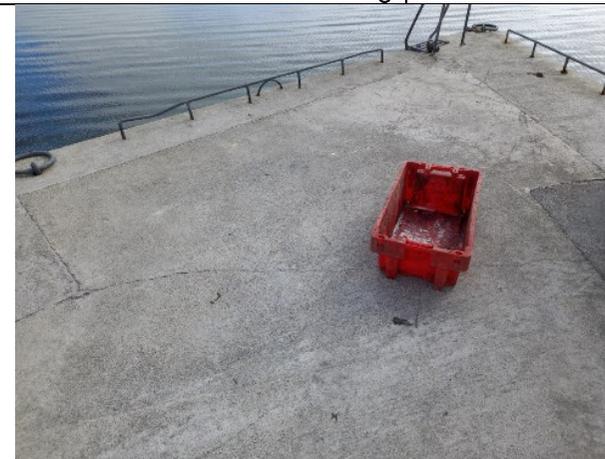
- Cracking to the top surface of the concrete pavement was evident with cracks generally emanating from corners of concrete joints. It is our opinion that the cracks observed are generally hairline to fine cracks (ranging between Category 0 and Category 1 – Table 1). While the existing pavement does not show any significant signs of failure, we do not know why the deck was raised, or what the condition of the old slab was (i.e. had the old slab reached its end of design life and in need of repair, or showing signs of failure / cracking around the head of the pier)

Ref:028 Caption: General condition of concrete deck – cracking on top surface

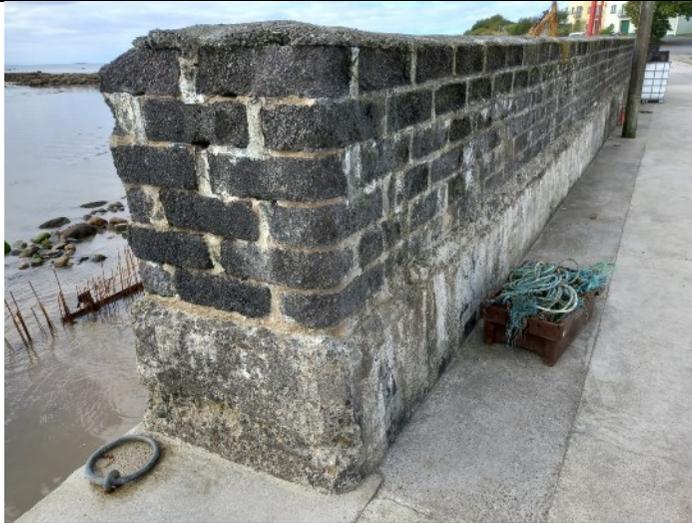
Ref:029 Caption: General condition of masonry sea wall

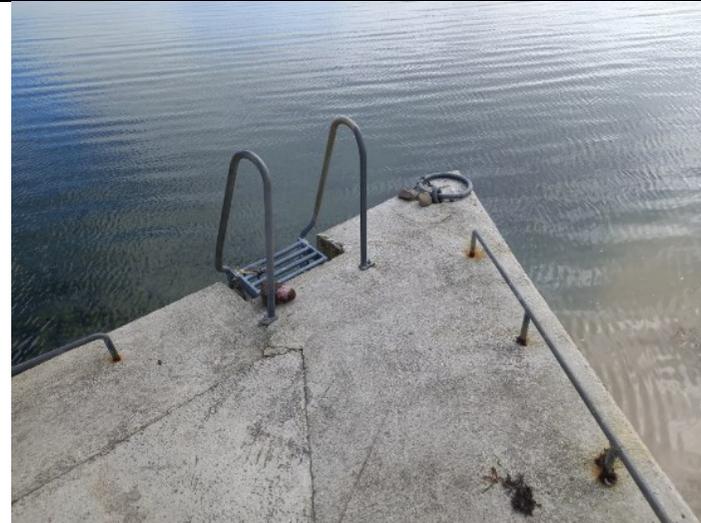
Ref:030 Caption: General condition of concrete deck

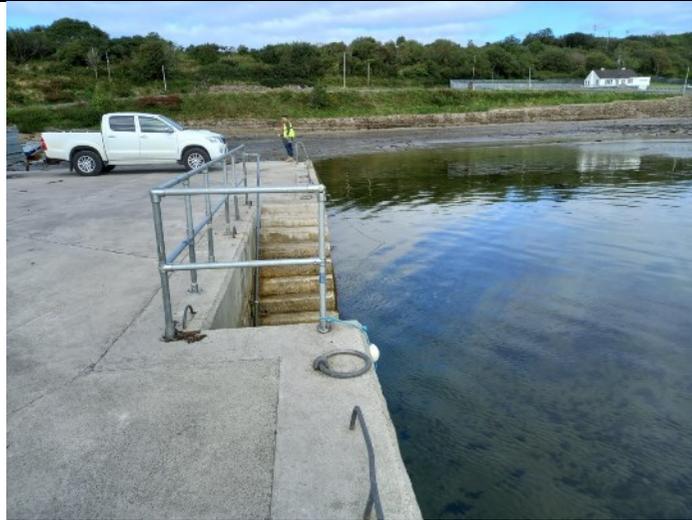
Ref:031 Caption: General condition of concrete deck & stairs

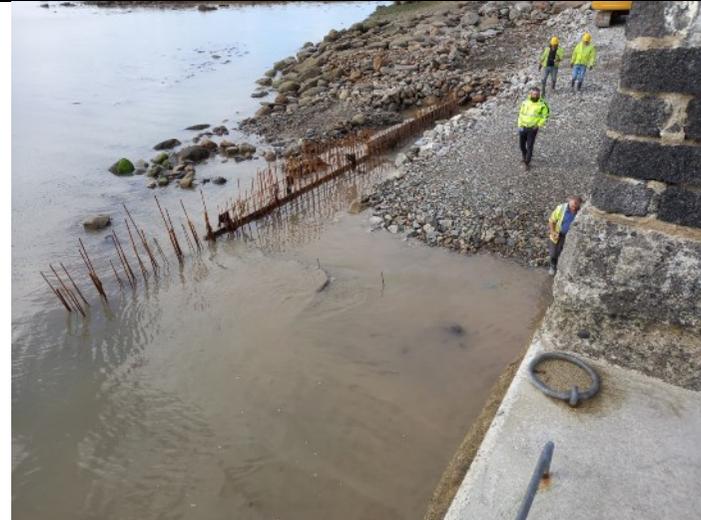
Ref:032 Caption: New slipway adjacent the pier– south elevation

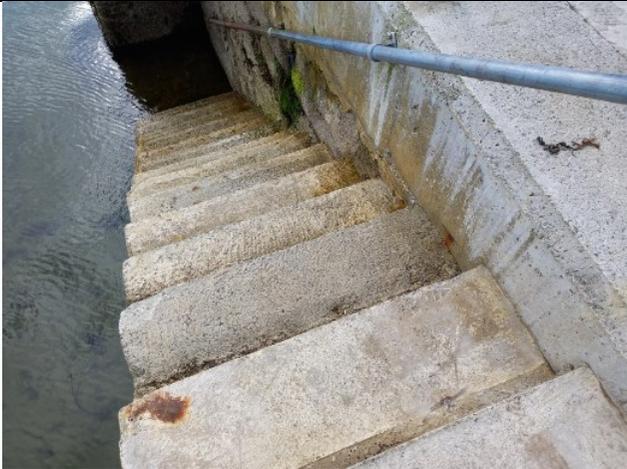
Ref:033 Caption: General condition of concrete steps – east elevation – undermining/grout loss present between junction of concrete pavement and old pier wall

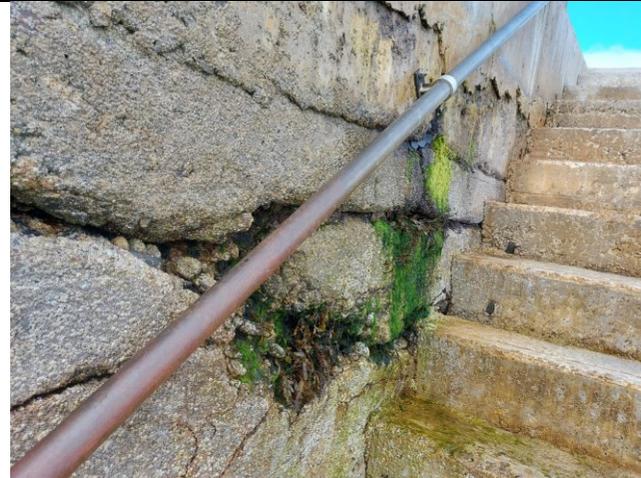
Ref:034 Caption: General condition of concrete steps – east elevation – undermining/grout loss present between junction of concrete pavement and old pier wall

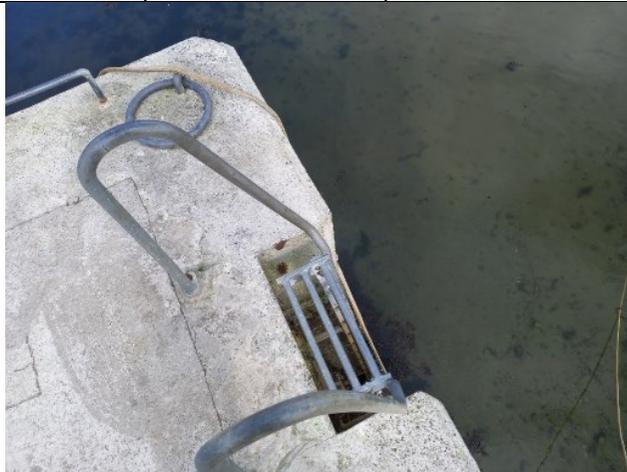
Ref:035 Caption: General condition of ladders

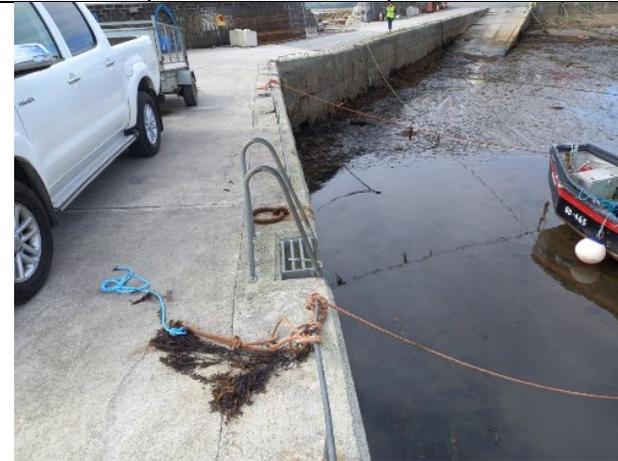
Ref:036 Caption: General condition of cope beam and concrete deck

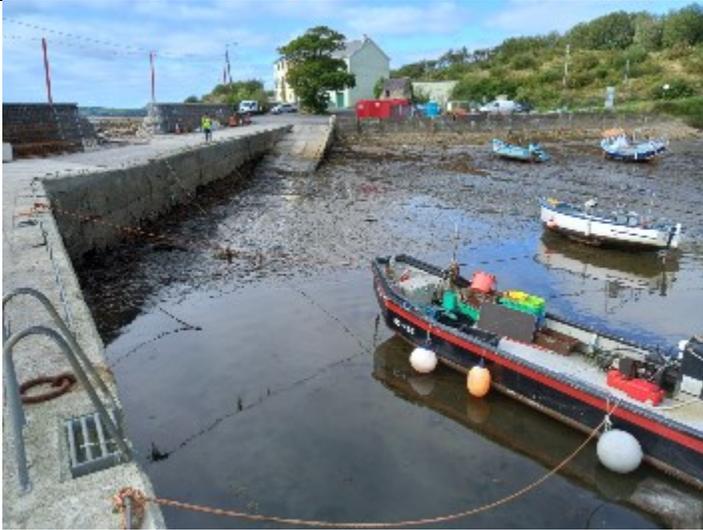
Ref:037 Caption: General condition of pier wall

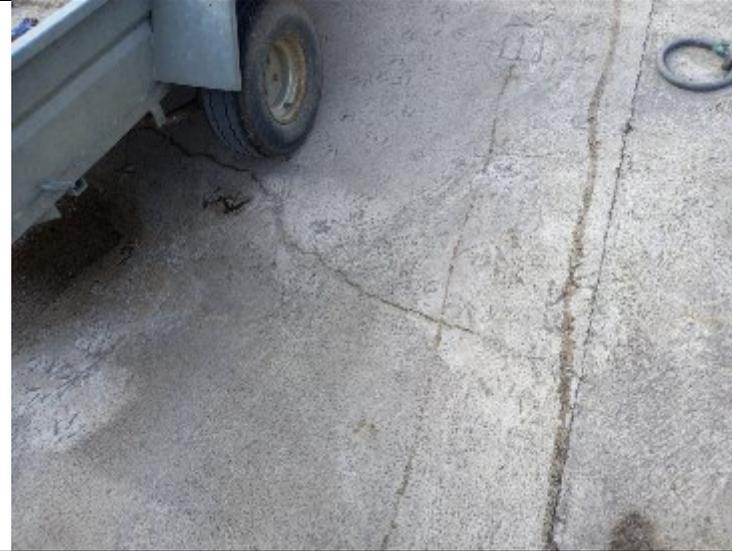
Ref:038 Caption: General condition of concrete deck – cracking evident on surface

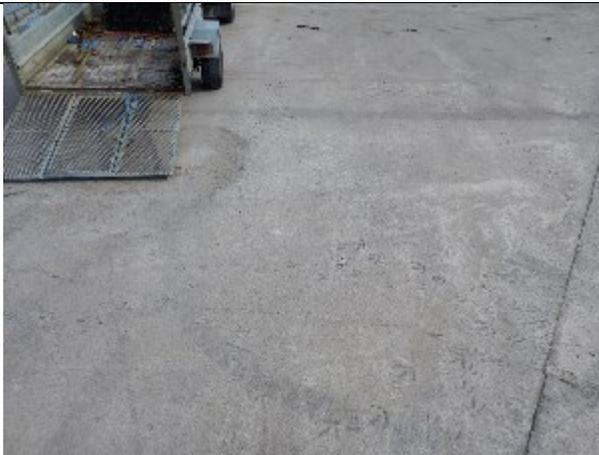
Ref:039 Caption: General condition of concrete deck – cracking evident on surface

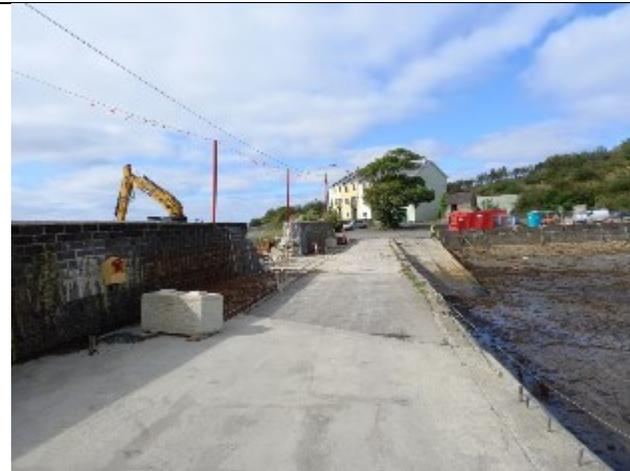
Ref:040 Caption: General condition of concrete deck – cracking evident on surface

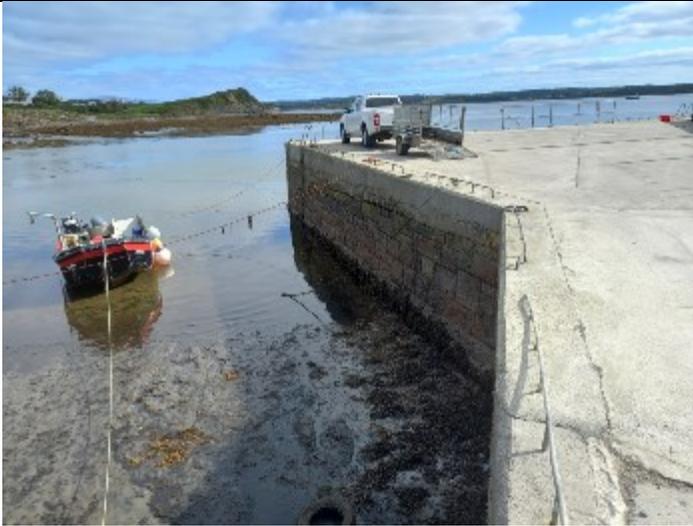
Ref:041 Caption: General condition of pier

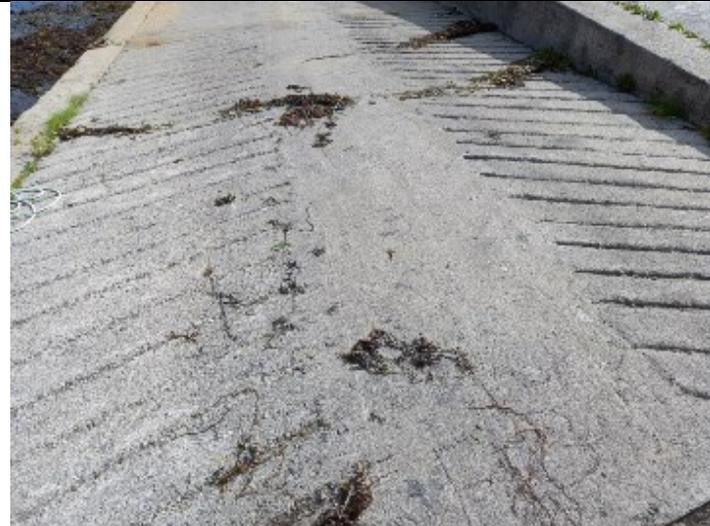
Ref:042 Caption: General condition of slipway surface

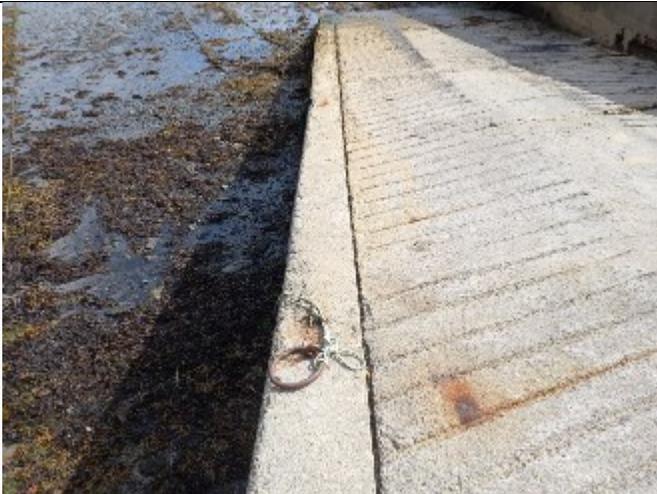
- The surface of the concrete slipway is in reasonable structural condition. There are signs of wear to the surface and localised cracking. Corrosion is present at localised locations near embedded steel at the surface. The joint between cope and slipway requires repair. The cope at the slipway has similar defects as per the main pier cope beam.

Ref:043 Caption: General condition of slipway surface – corrosion emanating from mooring ring & embedded steel on surface

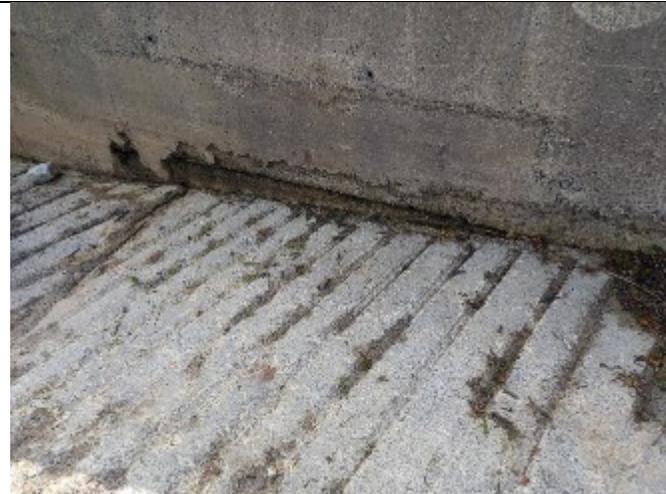
Ref:044 Caption: General condition of slipway surface – localised undermining/washout

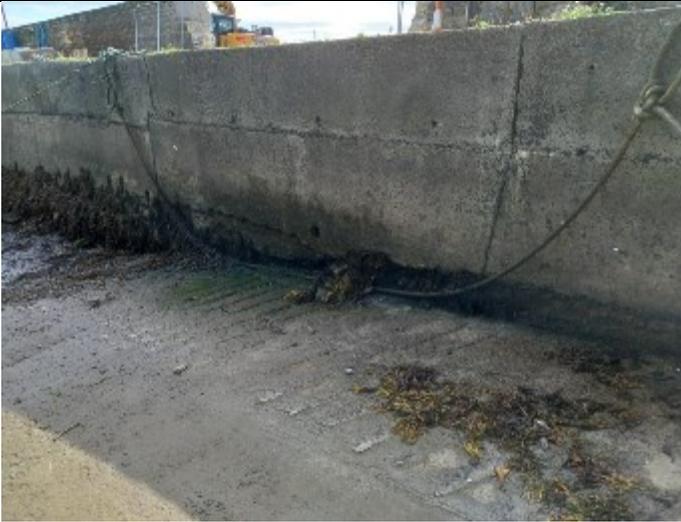
Ref:045 Caption: General condition of slipway surface – localised undermining

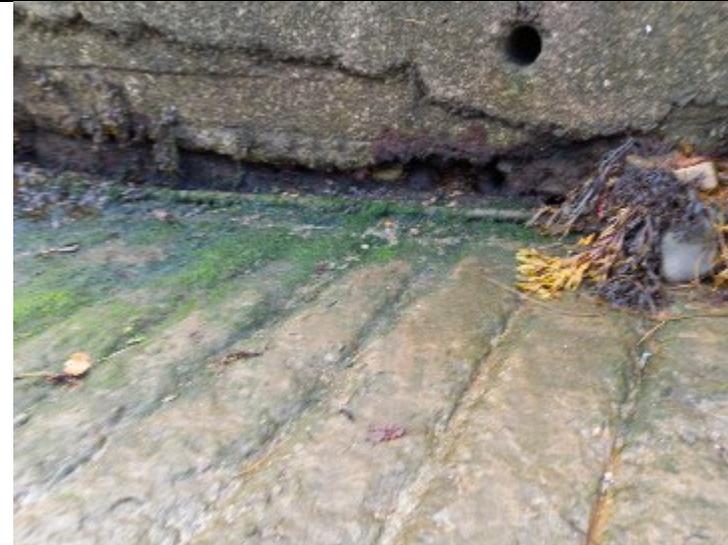
Ref:046 Caption: General condition of slipway surface – localised undermining

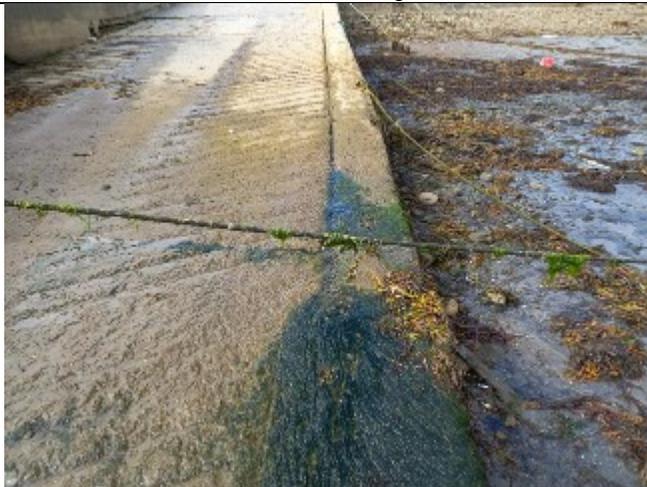
Ref:047 Caption: General condition of slipway

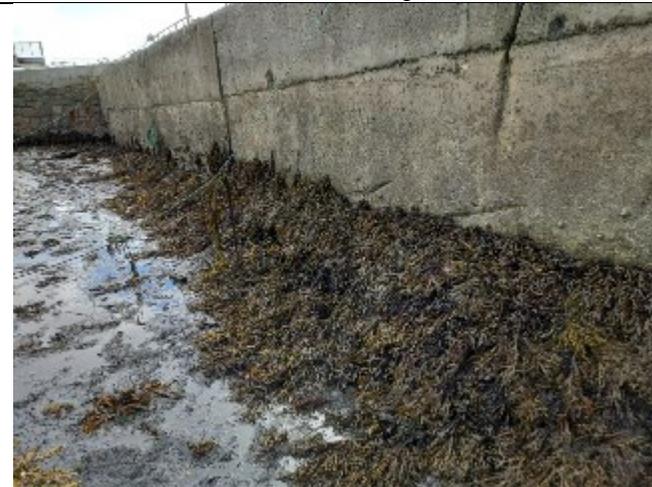
Ref:048 Caption: General condition of pier– north elevation – marine growth covering the base

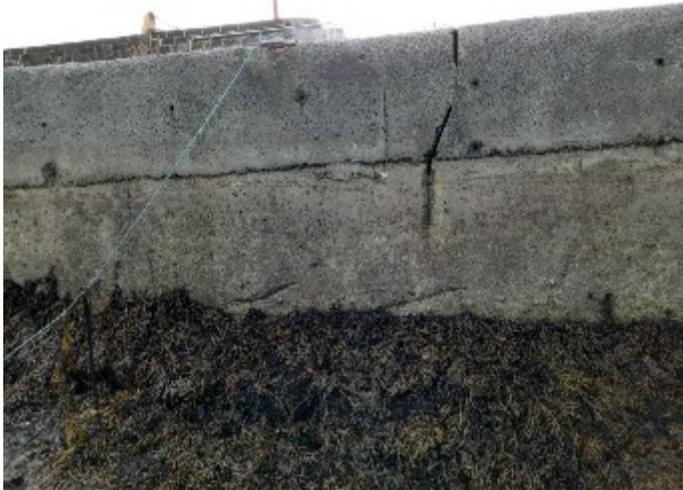
Ref:049 Caption: General condition of pier– north elevation

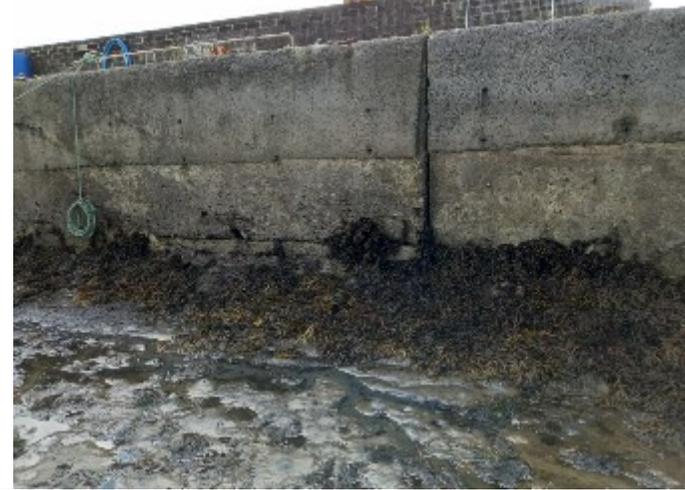
Ref:050 Caption: General condition of pier– north elevation

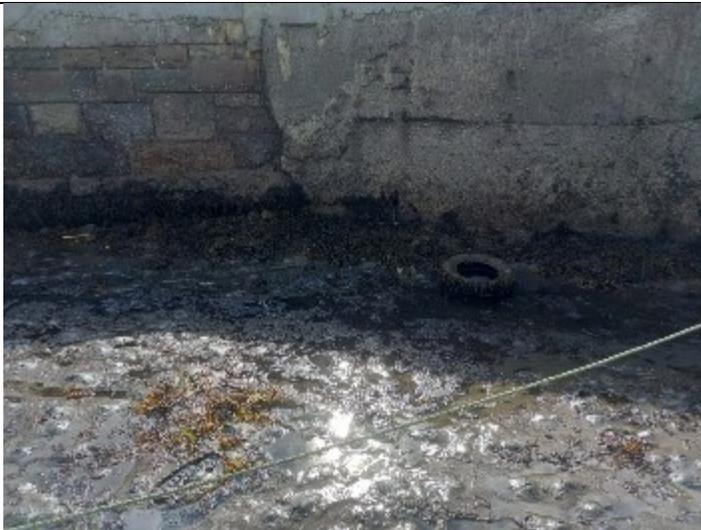
Ref:051 Caption: General condition of pier– north elevation

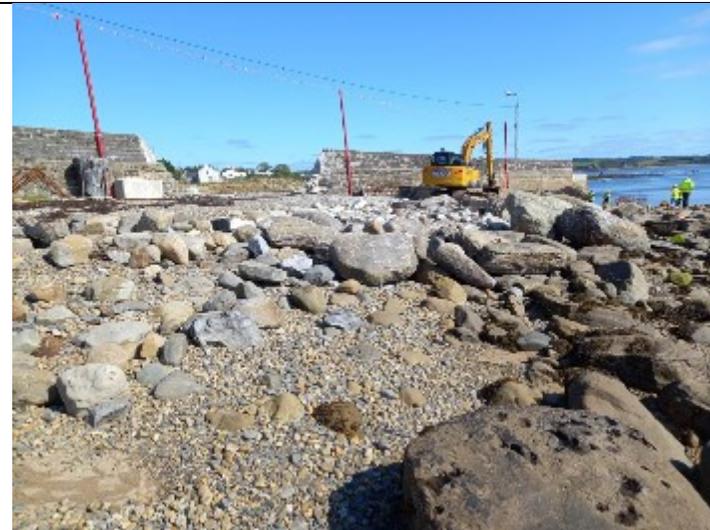
Ref:052 Caption: General overview of masonry sea wall– south elevation

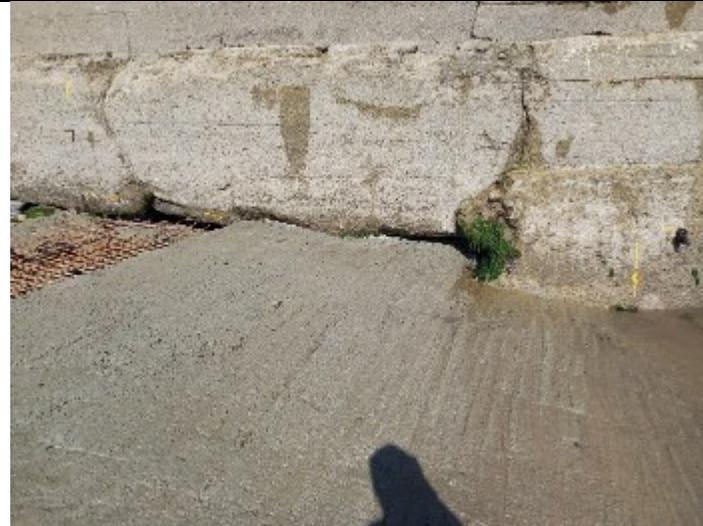
- The pier wall is in reasonable structural condition, given the age of the structure. In areas where there is a concrete surface, honeycombing and spalling is present. The junction between the existing slipway and wall shows localised undermining and would require addressing to prevent further deterioration. Furthermore, this undermining is also evident at the location between the new slipway and pier wall. Generally, the base of the wall is covered with marine growth which obscures the wall and therefore could not be inspected in detail. The head of the pier wall is faced with large stone blocks of varying size. The mortar between some joints in the old stone wall has been removed and would require replacing to prevent further deterioration. The east facing elevation is largely covered with marine growth and could not be fully inspected. Overall, the vertically of the pier is reasonable given the age of the structure and the wall shows no signs of significance stress.

Ref:054 Caption: General condition of pier – local undermining adjacent new slipway– south elevation

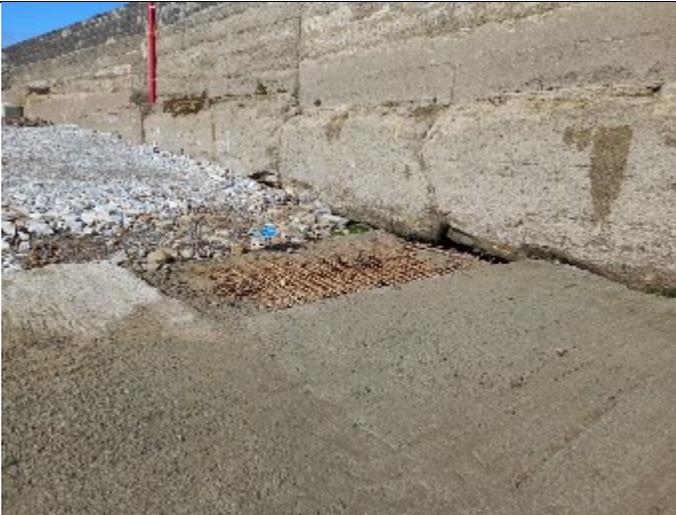
Ref:055 Caption: General condition of pier – local undermining adjacent new slipway – south elevation

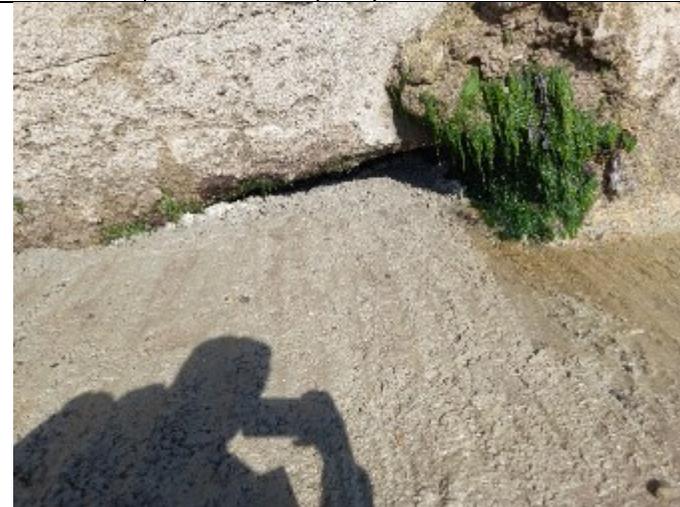
Ref:056 Caption: General condition of pier – local undermining adjacent new slipway- south elevation

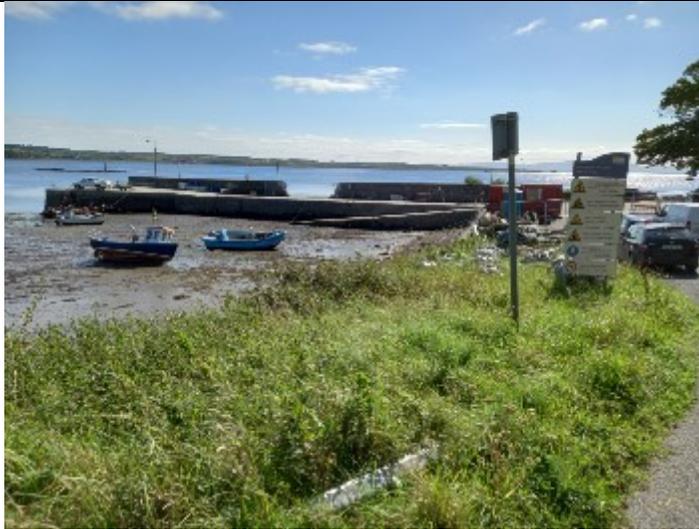
Ref:057 Caption: General overview of Pier- north elevation

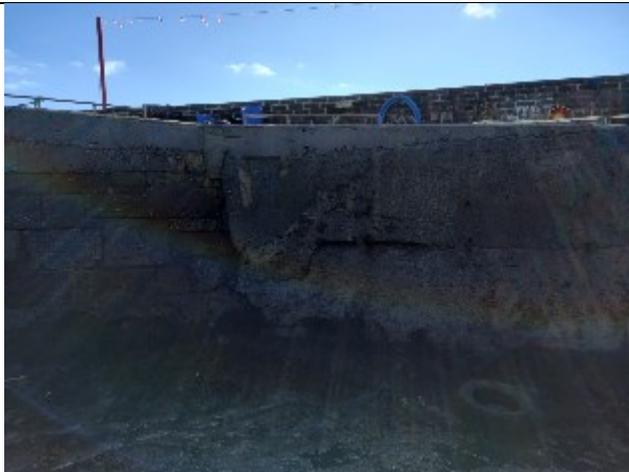
Ref:059 Caption: General condition of pier - north elevation – void present between mass concrete and old stone pier

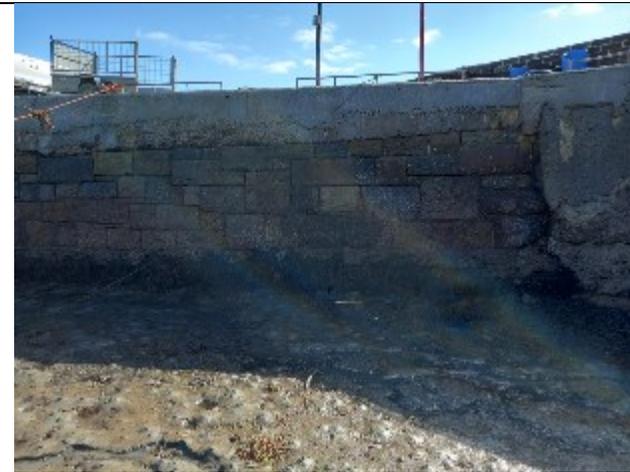
Ref:060 Caption: General condition of pier- north elevation - present between mass concrete and old stone pier

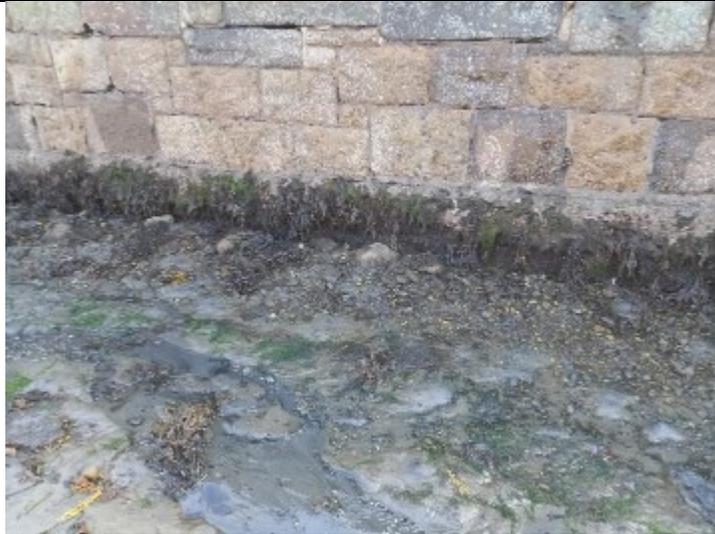
Ref:061 Caption: General condition of pier- north elevation – grout loss present
