Port Pier Inver

Condition Assessment Report

Donegal County Council

Report No. CM1379-STR-R001

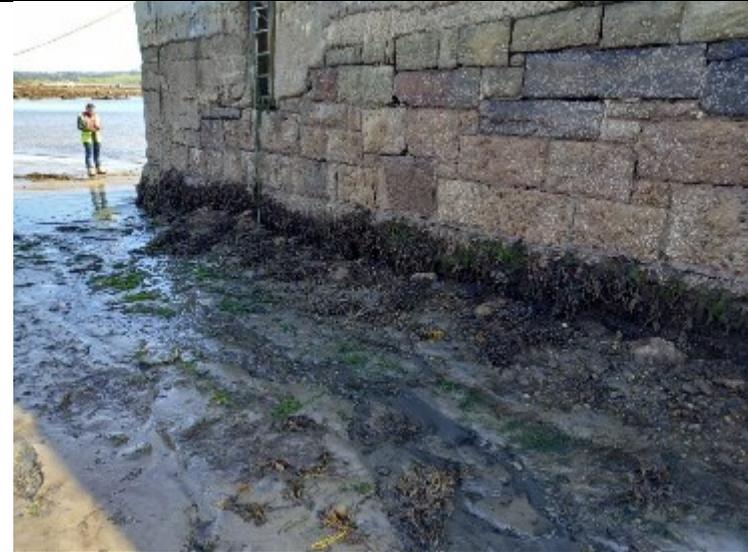
Ref:062 Caption: General condition of pier- north elevation – grout loss present

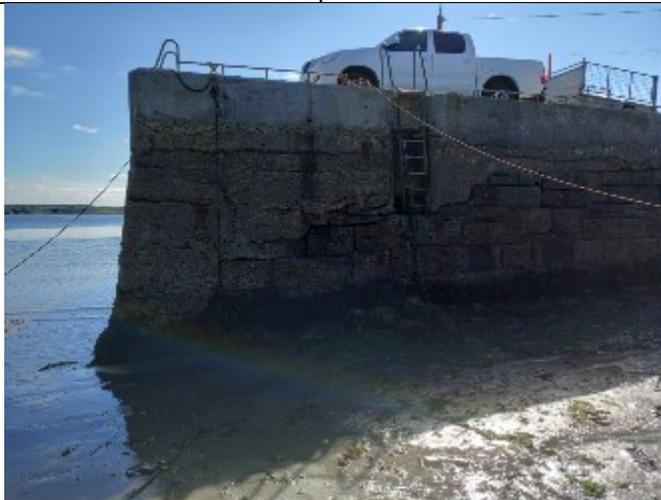
Ref:063 Caption: General condition of pier - north elevation – grout loss present

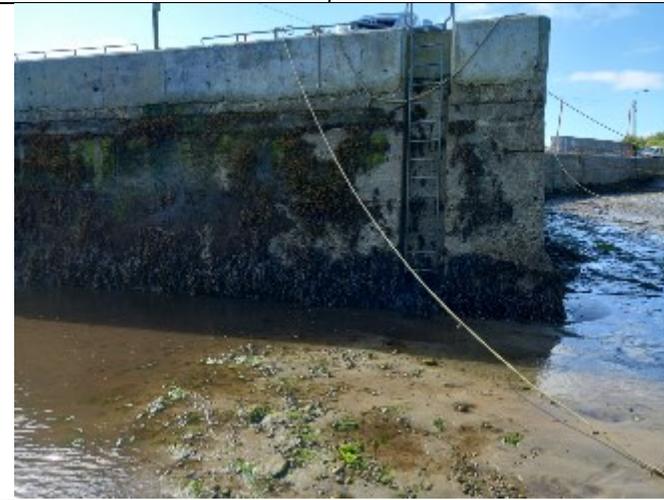
Ref:064 Caption: General condition of pier – east elevation – grout loss present

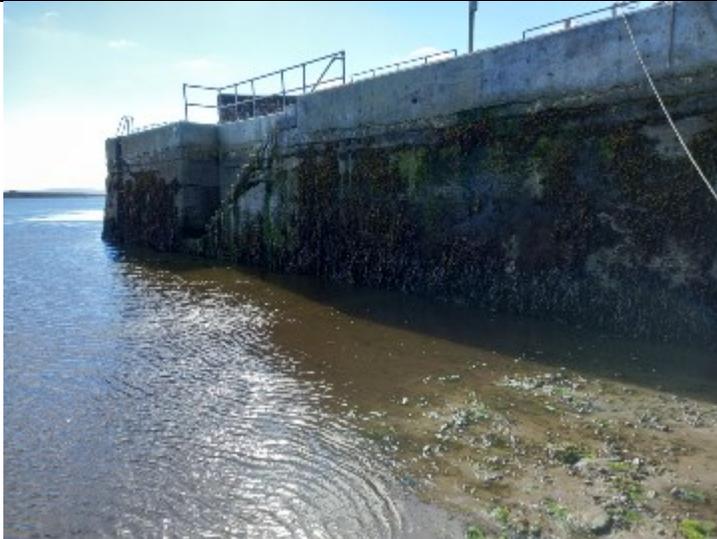
Ref:065 Caption: General condition of pier – east elevation

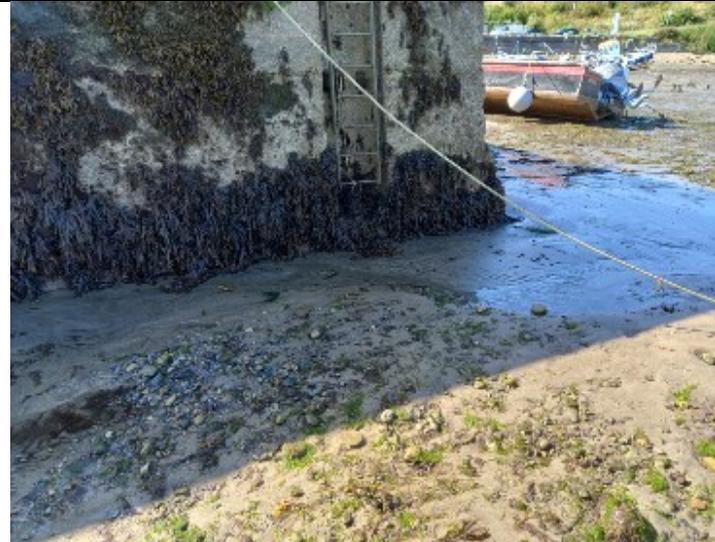
Ref:066 Caption: General condition of pier – east elevation

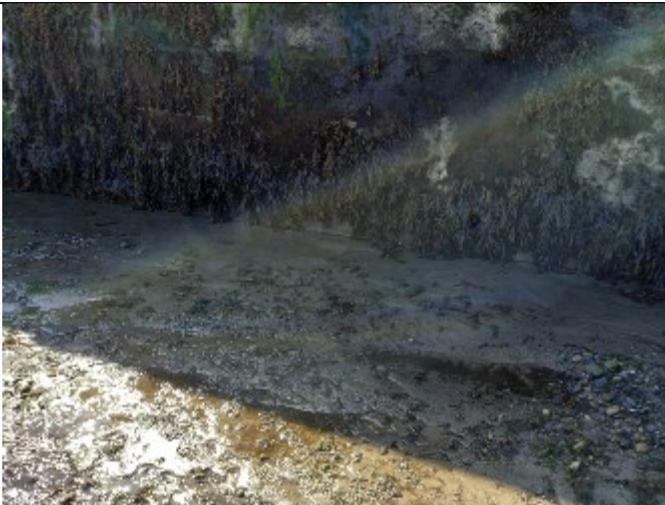
Ref:067 Caption: General condition of pier – east elevation

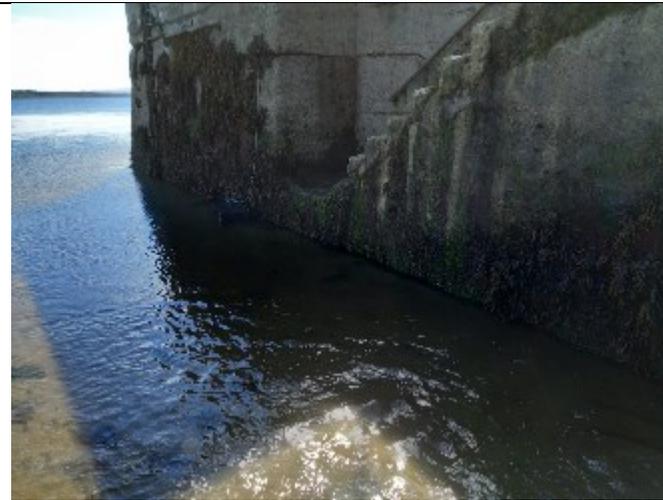
Ref:068 Caption: General condition of pier – east elevation

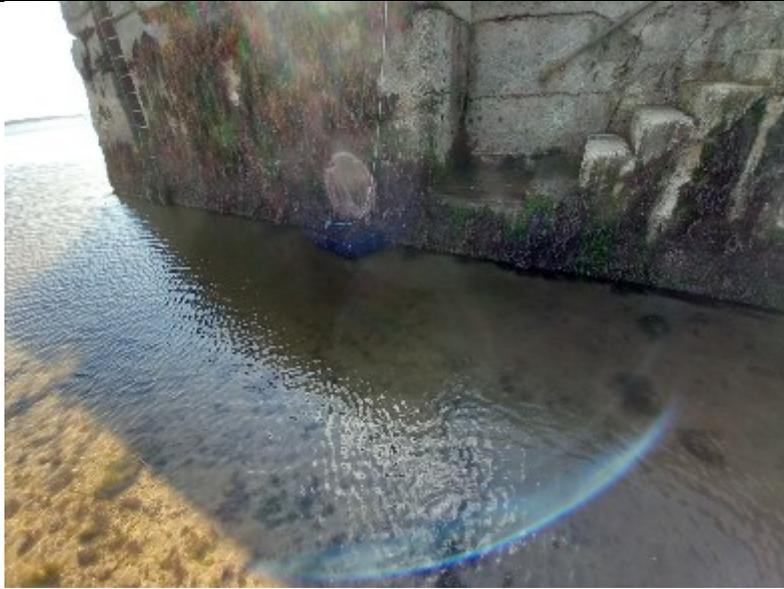
Ref:069 Caption: General condition of pier – east elevation

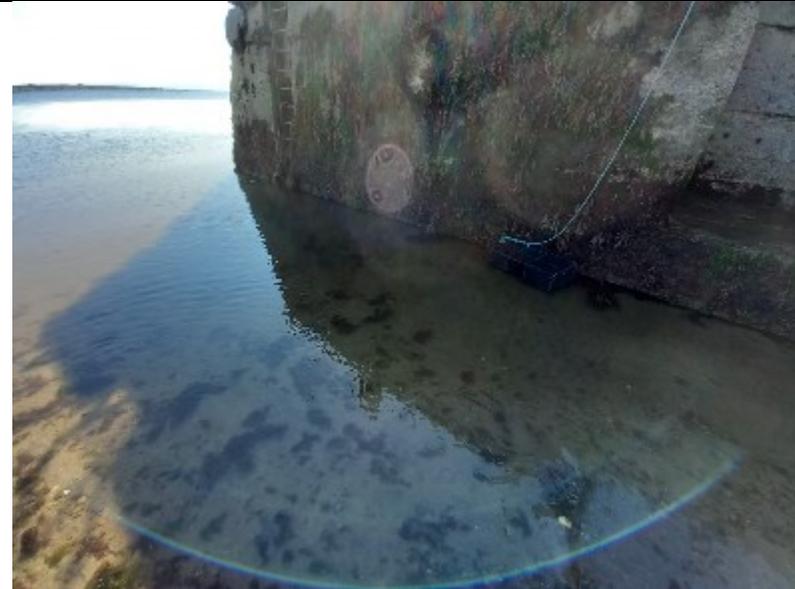
Ref:070 Caption: General condition of pier – east elevation
