Preliminary Ecological Appraisal :

**NORTH-WEST GREENWAY -
Derry to Buncrana and
Newtowncunningham**

Preliminary Ecological Appraisal : NORTH-WEST GREENWAY – Pennyburn to Buncrana and Newtowncunningham

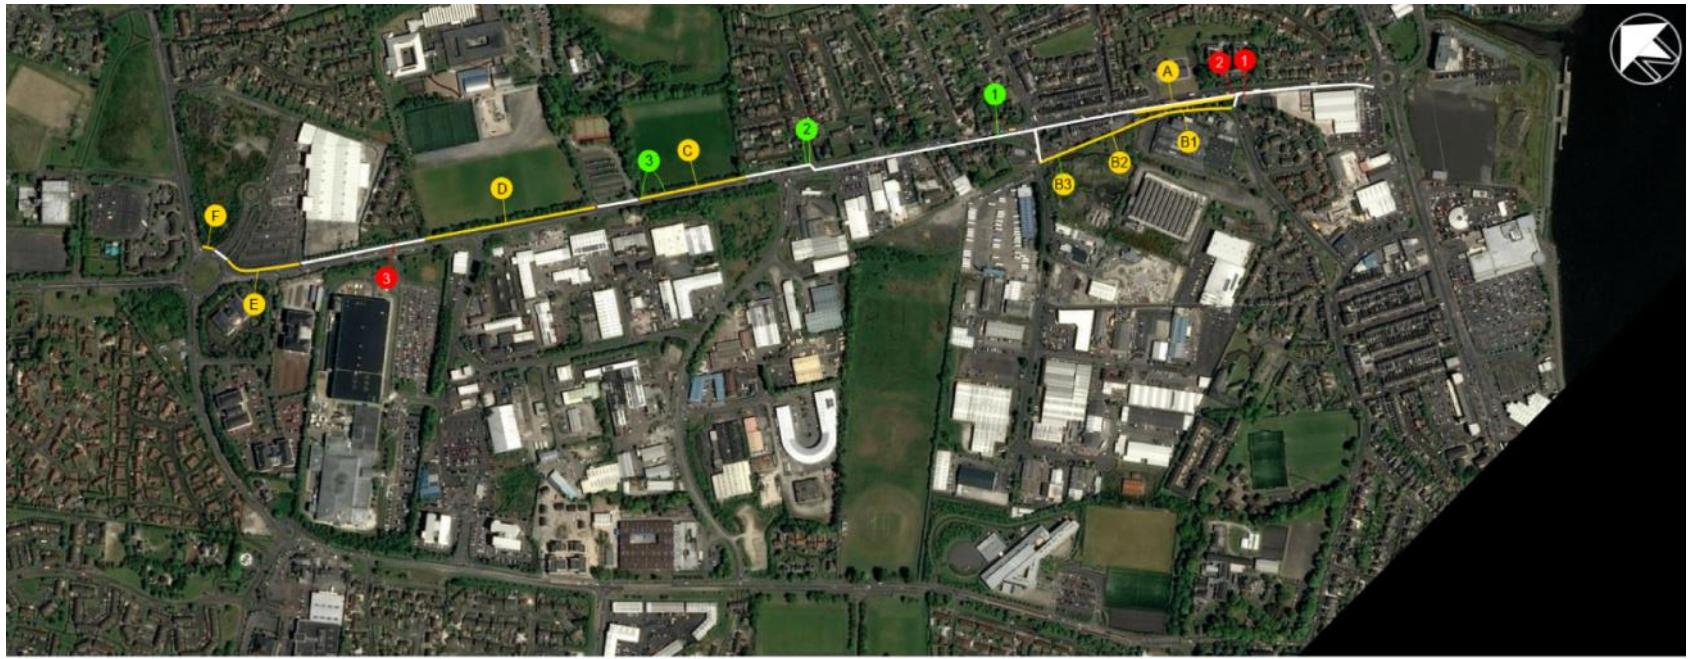
Map 1.2 covers the area between the Pennyburn and Branch Roundabouts along the existing A2.

TN2 – The section A route includes a short length of planted woodland in which a few canes of Japanese Knotweed were noted.

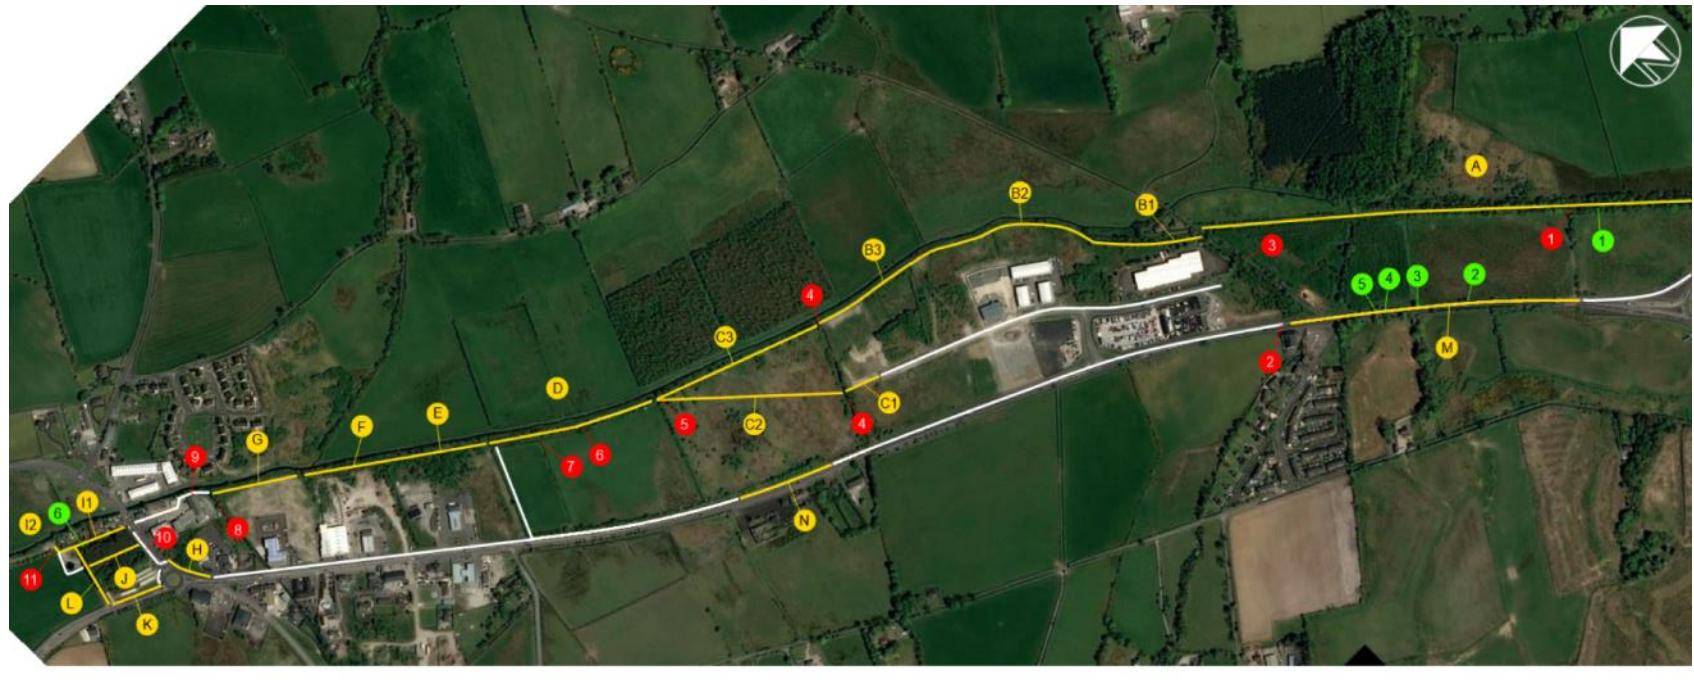
Map 1.4 covers the area between the Skeoge roundabout and the roundabout at the western side of Bridgend, crossing the border and passing Elagh and Bridgend business parks.

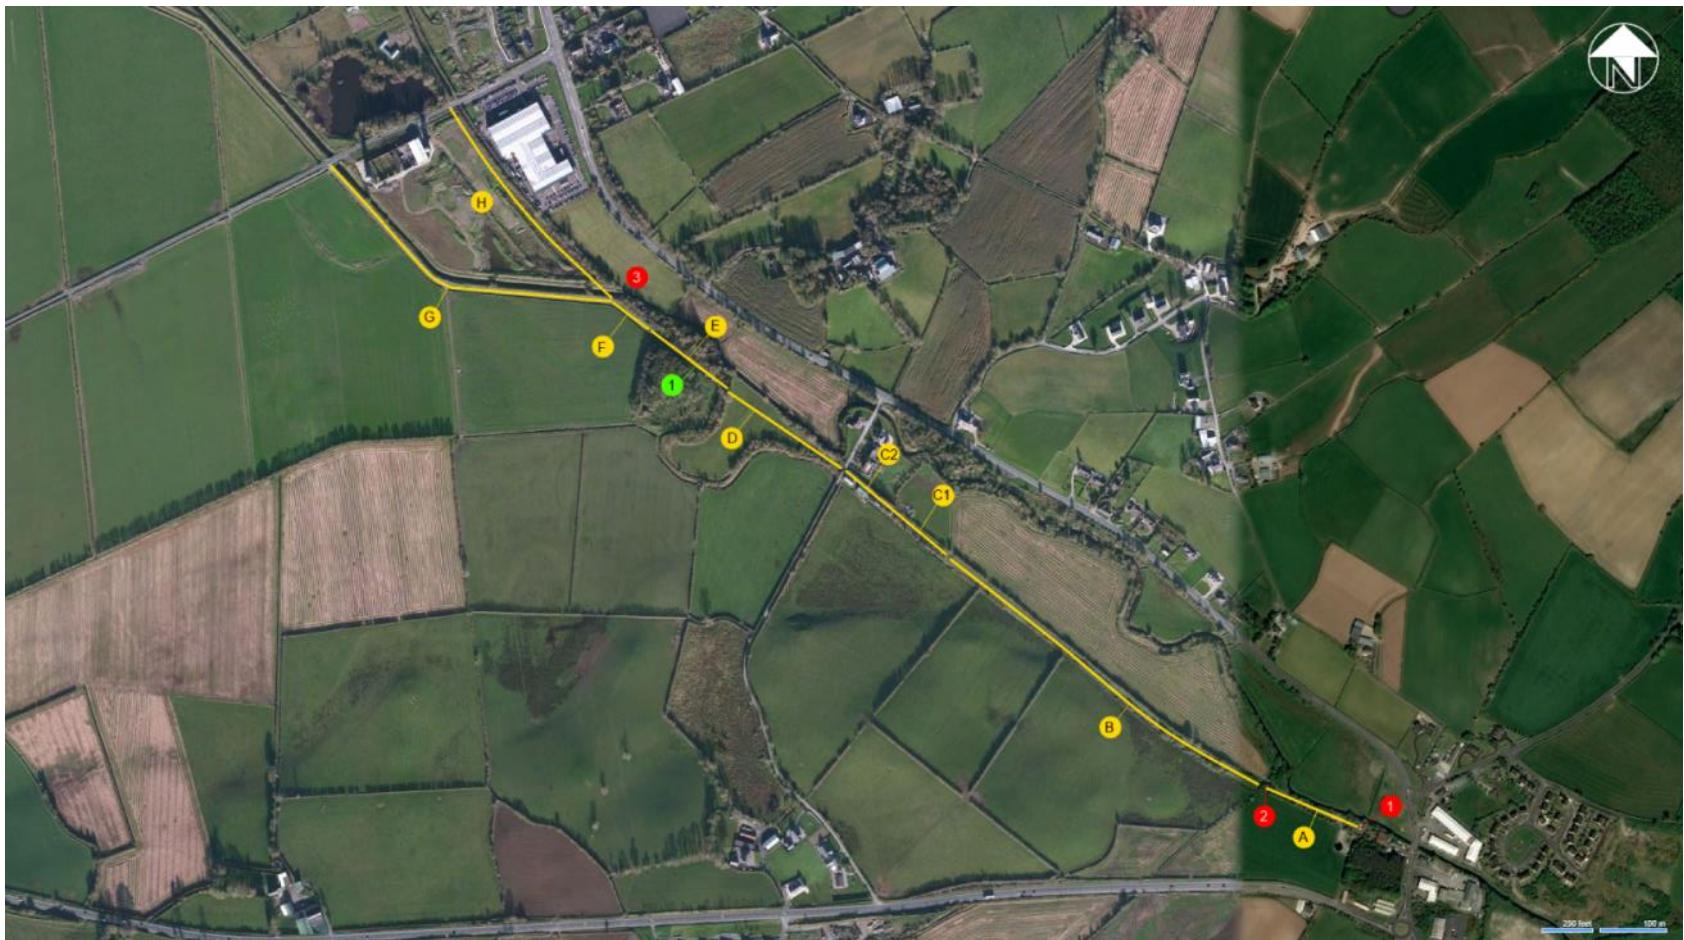
Map 2.2 Red and Blue Route

Map 2.2 covers the Blue and Red Corridors from the R238 to R239 (Slab Road)

Section A – The former railway line here is a semi-improved GS:2 dominated by Yorkshire-fog (*Holcus lanatus*) and with dense Hawthorn (*Crataegus monogyna*) and occasional semi-mature Rusty Willow (*Salix cinerea* subsp *oleifolia*) and Common Alder (*Alnus glutinosa*) on both banks. It carries a track that leads into the biomass field to the RHS of section B.

TN 2 – The existing track crosses a stream on a wide culvert here, a small piped culvert would be required to regain the railway line. Slender Rush (*Juncus tenuis*) noted here.

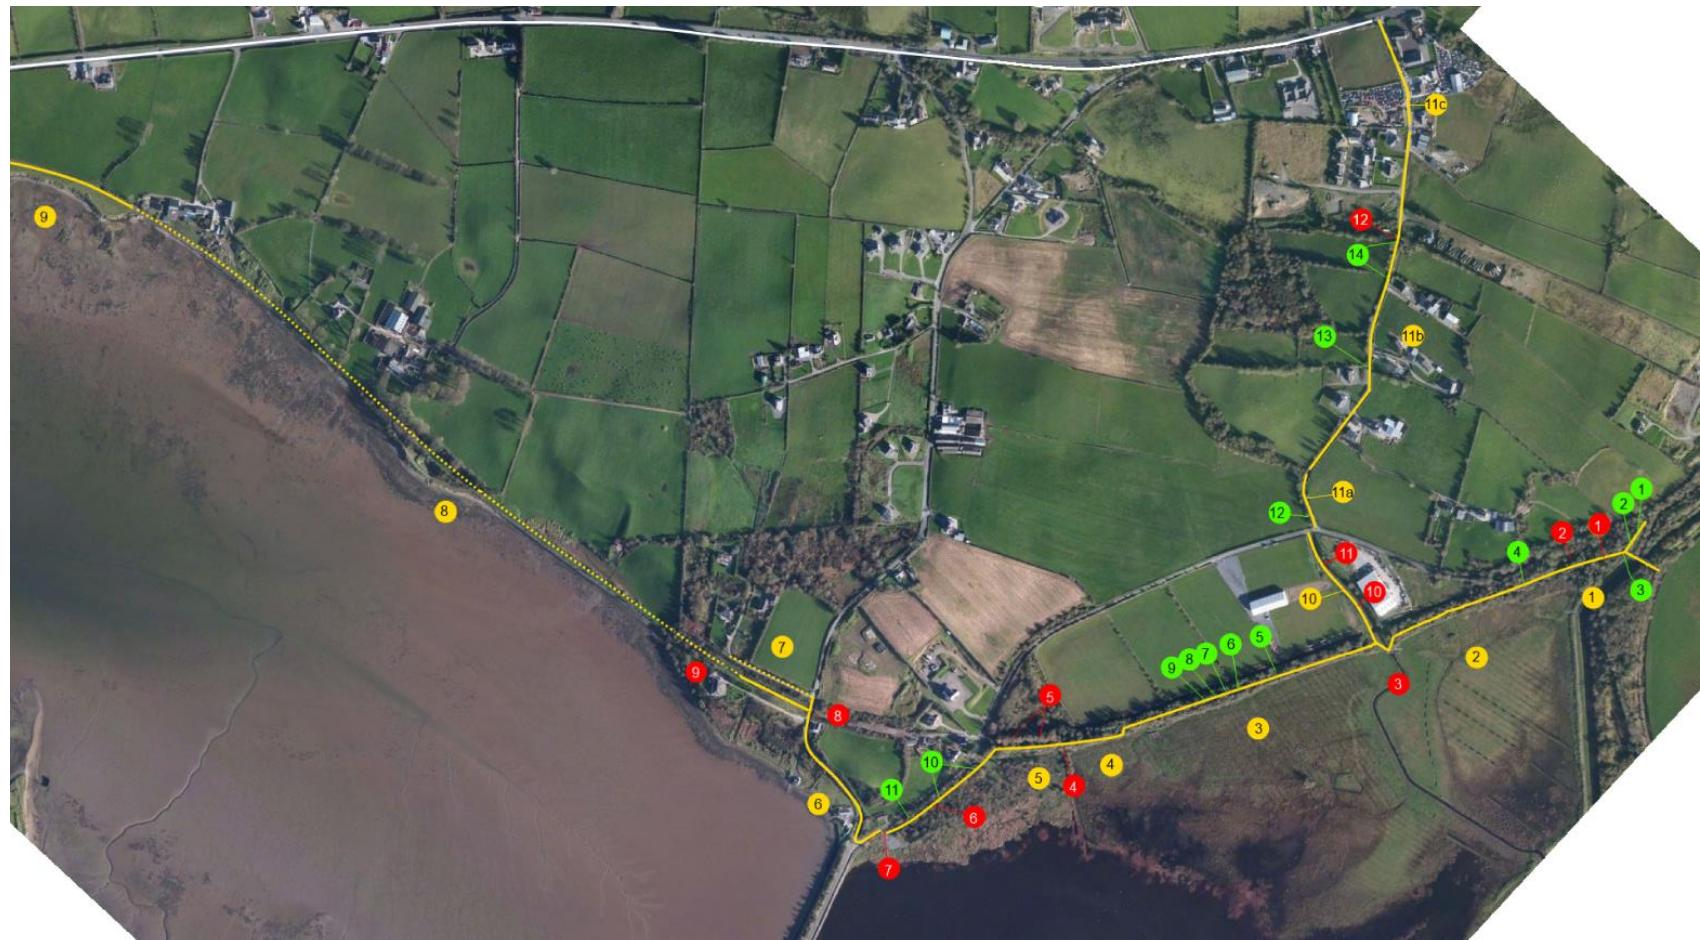
Map 3.2 shows the Blue and Purple Corridors, excluding the purple section along the R238, to a point just before the routes re-join. The rest of the Route Corridors are shown in Map 4.2

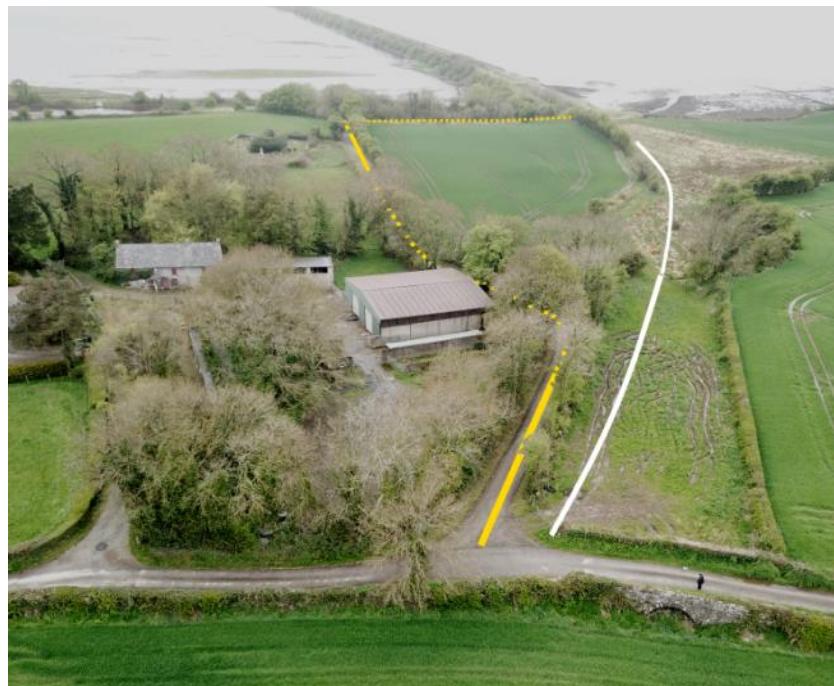
Section B – A 3.0 m wide unsurfaced track, embanked both sides, initially (B1) with unflailed overgrown Hawthorn (*Crataegus monogyna*) hedges and hedgerow trees, and subsequently (B2) with a flailed hedge to the RHS. A more direct alternative (but requiring land acquisition) was not investigated.

The proposal here is limited to re-surfacing, so the only issue is potential root damage to the adjacent trees

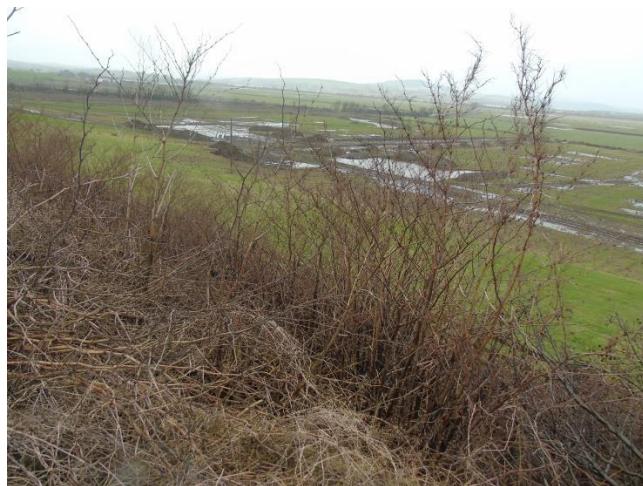
Japanese Knotweed @ Section D

Section D – beyond the farm both the verge and the reservation are narrow. Adjacent hedge is species-poor Hawthorn (*Crataegus monogyna*) in good ecological condition and represents the SPA boundary. The verge remains weedy False Oat-grass (*Arrhenatherum elatius*), Yorkshire-fog (*Holcus lanatus*), Cow Parsley (*Anthriscus sylvestris*), Hogweed (*Heracleum sphondylium*) and Broad-leaved Dock (*Rumex obtusifolius*). Sometimes with Bramble (*Rubus fruticosus* agg.). This continues down the steep bank to the Inch Levels. This is steep and with significantly large stands of Japanese Knotweed. The SPA boundary is drawn along the roadside here.
