Ramelton Public Realm Project

Inventory of Built Heritage & Impact Assessment

Issue: PLANNING APPLICATION STAGE: January 2022

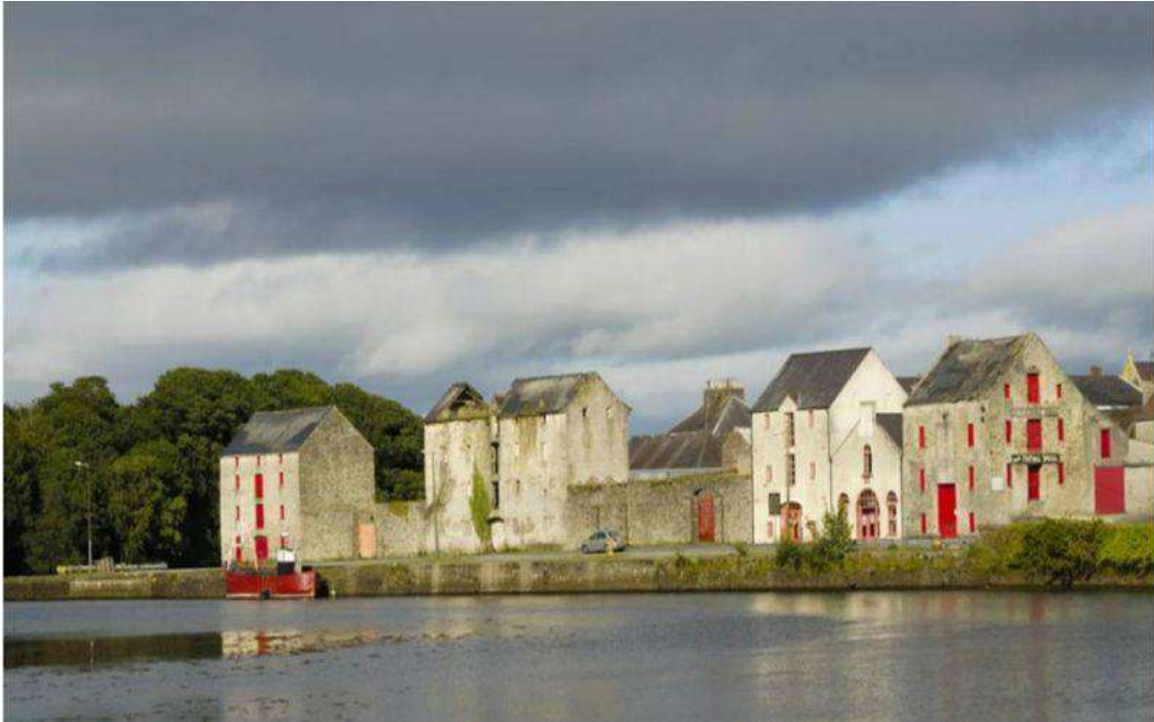
Figure 58 – Ramelton Warehouses, image from An Taisce Buildings at Risk Register

The important Georgian buildings in the Mall and warehouse buildings on the Quayside, all Protected Structures, are at risk. The Quayside warehouses were included on the national An Taisce Buildings at Risk list, although one of these appears may have a more promising future. Other industrial heritage buildings such as Kelly's mill and builder's merchants are in danger of future collapse. These, along with other buildings and their settings have been affected by ill-conceived development undertaken in the first decade of the 20th century which have subsequently failed and, because of their scale have blighted the immediate area of influence.
