Fort Dunree Project

Design Statement

August 2023

By
Keys and Monaghan Archiect
and
Taylor McCarney Architects

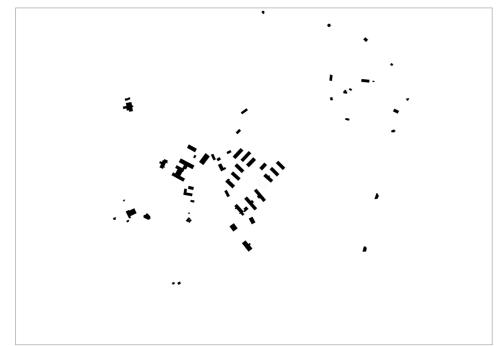
Existing Visible Structures (63 Not including foundations, underground stores, collapsed buildings) Principle: Retention of as much of the existing fabric as possible.

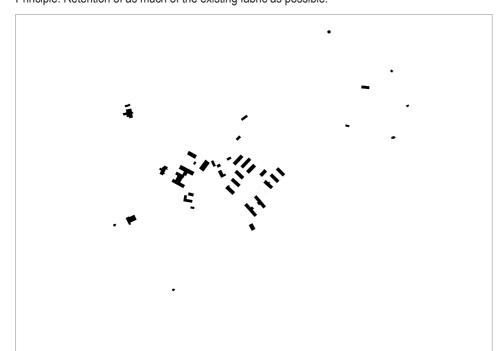
Proposed Visible Structures included within the Planning Application (Not including foundations underground stores, collapsed buildings))
34 existing structures are included in this application, this is over 53% of the existing structures; ensuring retention of as much of the existing fabric as possible.

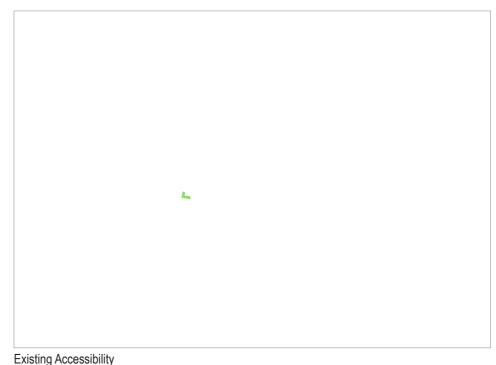
The existing accessibility on-site is extremely poor due to the natural topography and nature of the buildings. As shown only Cafeteria is accessible as a car park space is adjacent.

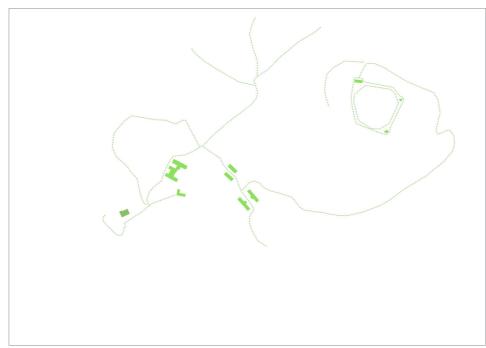
Proposed Accessibility
Through proposed path upgrades, the provision of an EV mobility bus and the usage of mobility scooters are the optimum solutions for a site of this nature to improve accessibility

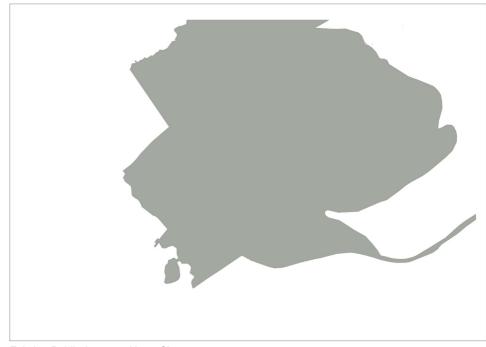
Existing Public Access without Charge
Only the Lower Fort is currently paid access, the remainder of the site is free to use.

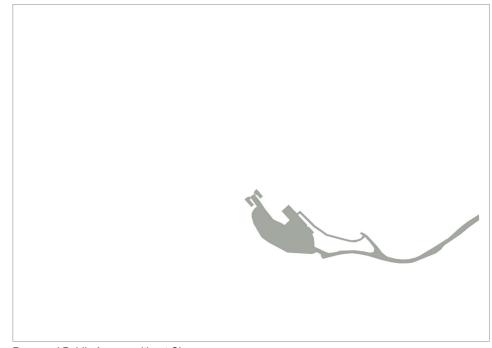
Proposed Public Access without Charge

To operate a paid site the public are restricted to the car park and both welcome buildings until a ticket is purchased. The Client is formulating an access strategy with the locals who regularly use the site.

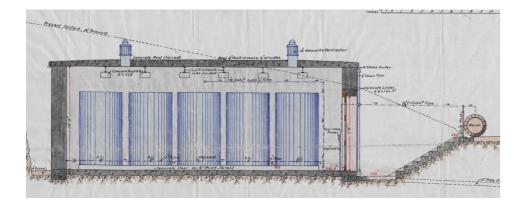
Kew drawing of the Oil Reserve Store at the High Fort

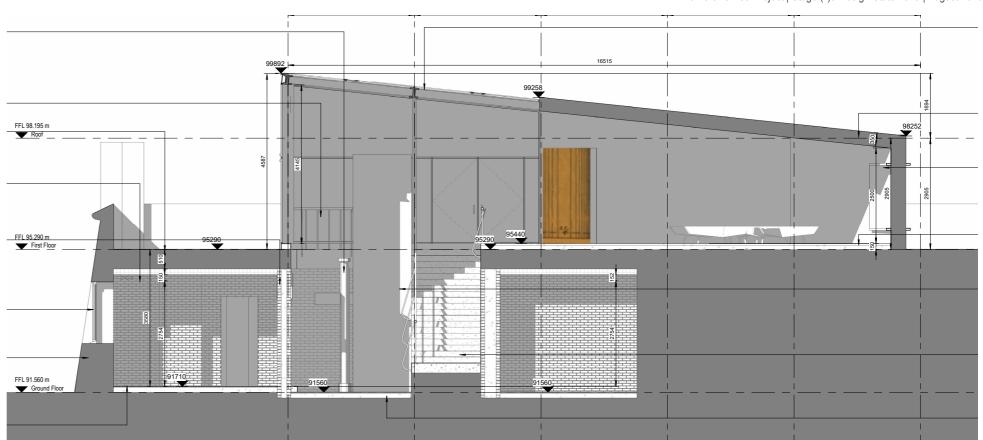
Section illustration of the oil tanks and suspended interpretative displays

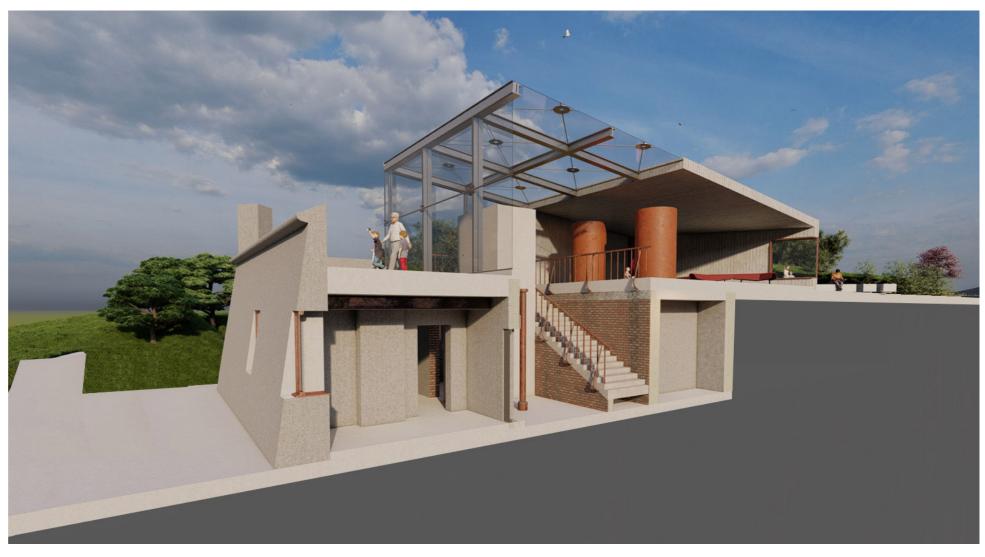
Illustration of the oil tanks and suspended interpretative displays

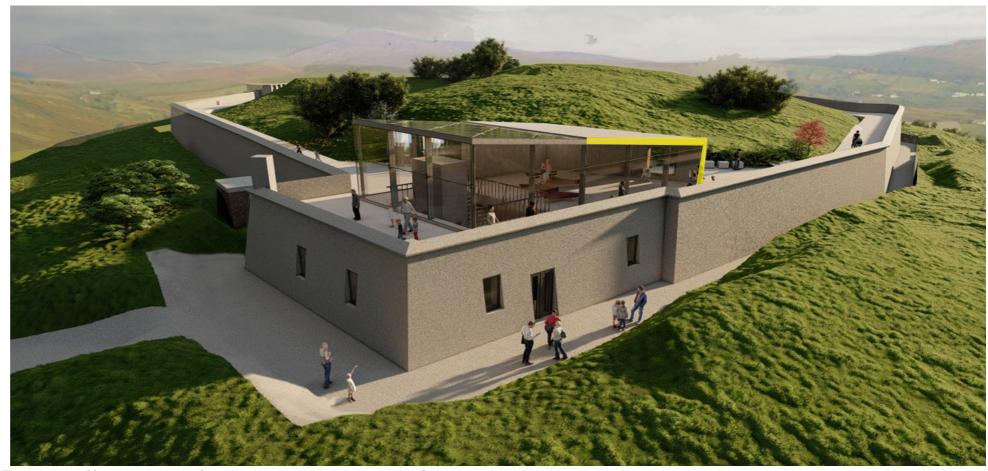
Thr proposed roof form takes inspiration from the existing concrete shelter at the High Guns.

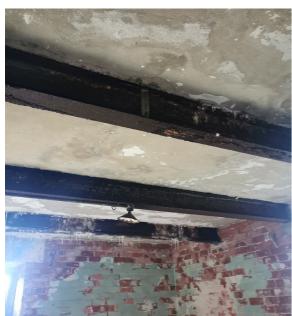
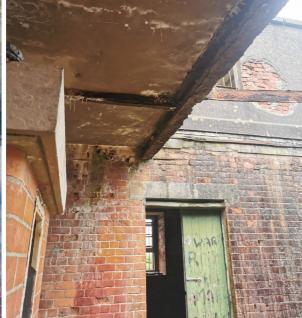
Existing Photographs - Ground Floor Structure

In principle and where feasible, all existing elements are to be repaired and restored.

Existing steel beams to be retained and paired with new to provide support

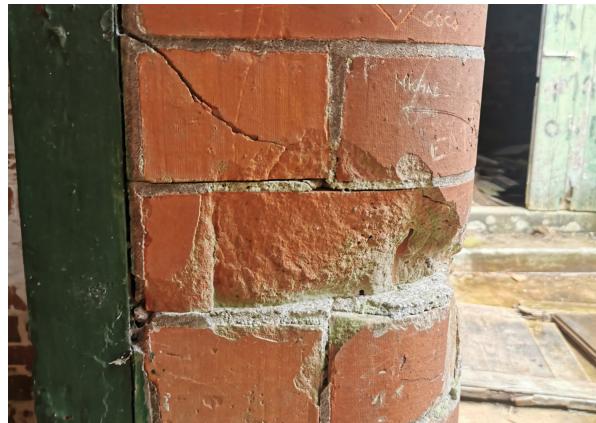
Existing brickwork to be repaired - to be colour matched

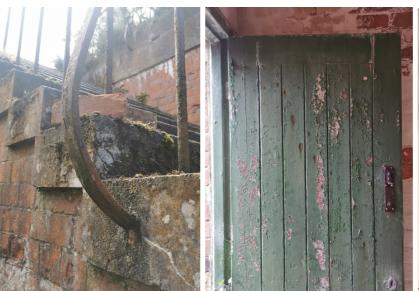
Existing metalwork to be surveyed throughout and repaired appropriately.

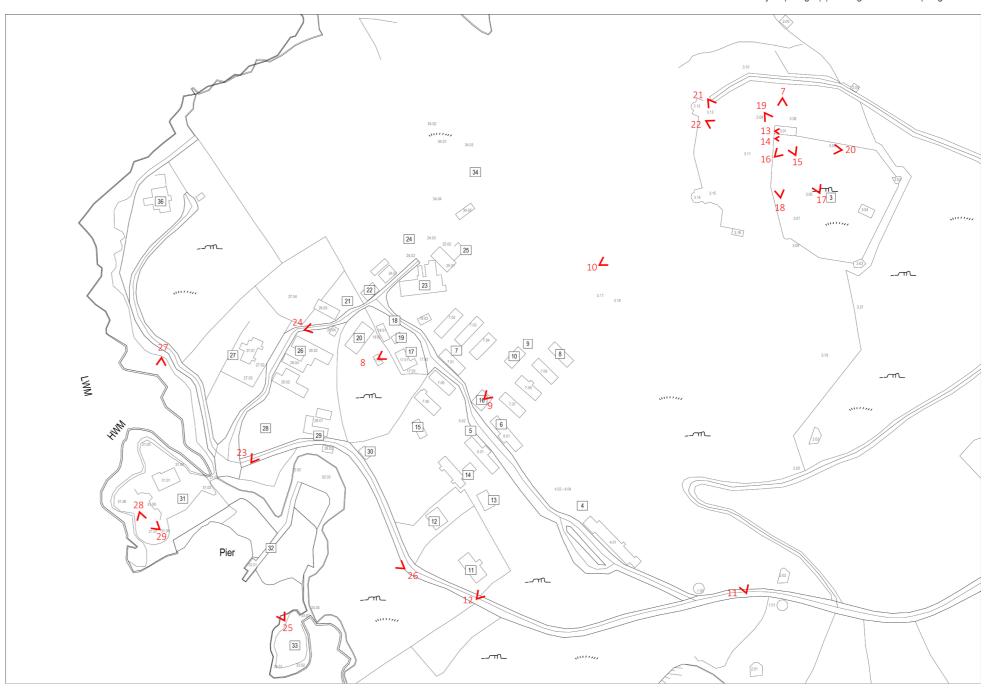
To determine if the proposal will result in a visual impact, the design team developed a series of comparative images between the existing and proposed.

It is important to note, that due to its location and topography of the site the proposal including the existing, is and will be sky-lining. Nonetheless from the majority of points we viewed, the Guard House is not viewable either due to the contours or vegetation. From this exercise, where the High Fort is visible it is our view that the proposal demonstrates a minimal / if any visual impact.

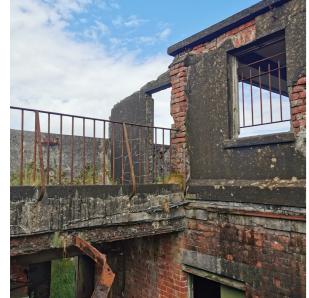
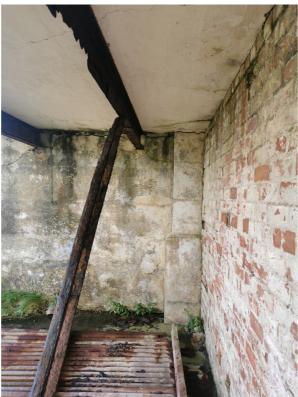
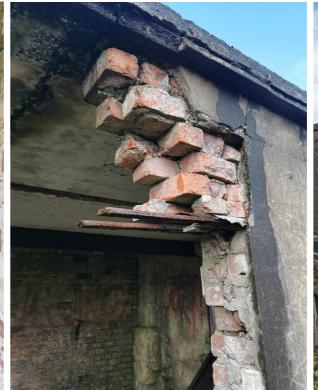
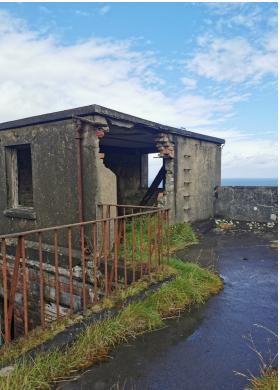
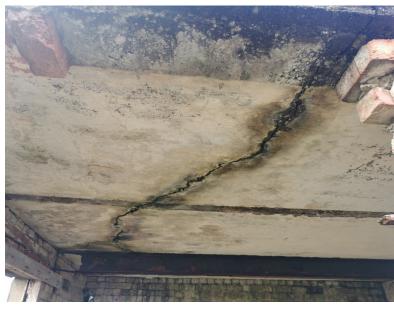
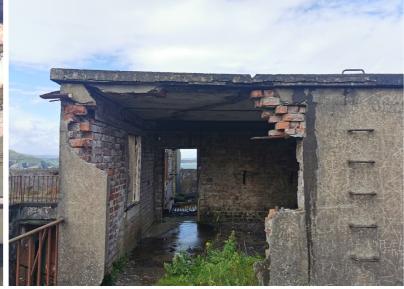
Existing Photographs - First Floor Structure

Due to the condition, the first floor non original structure is to be carefully removed.

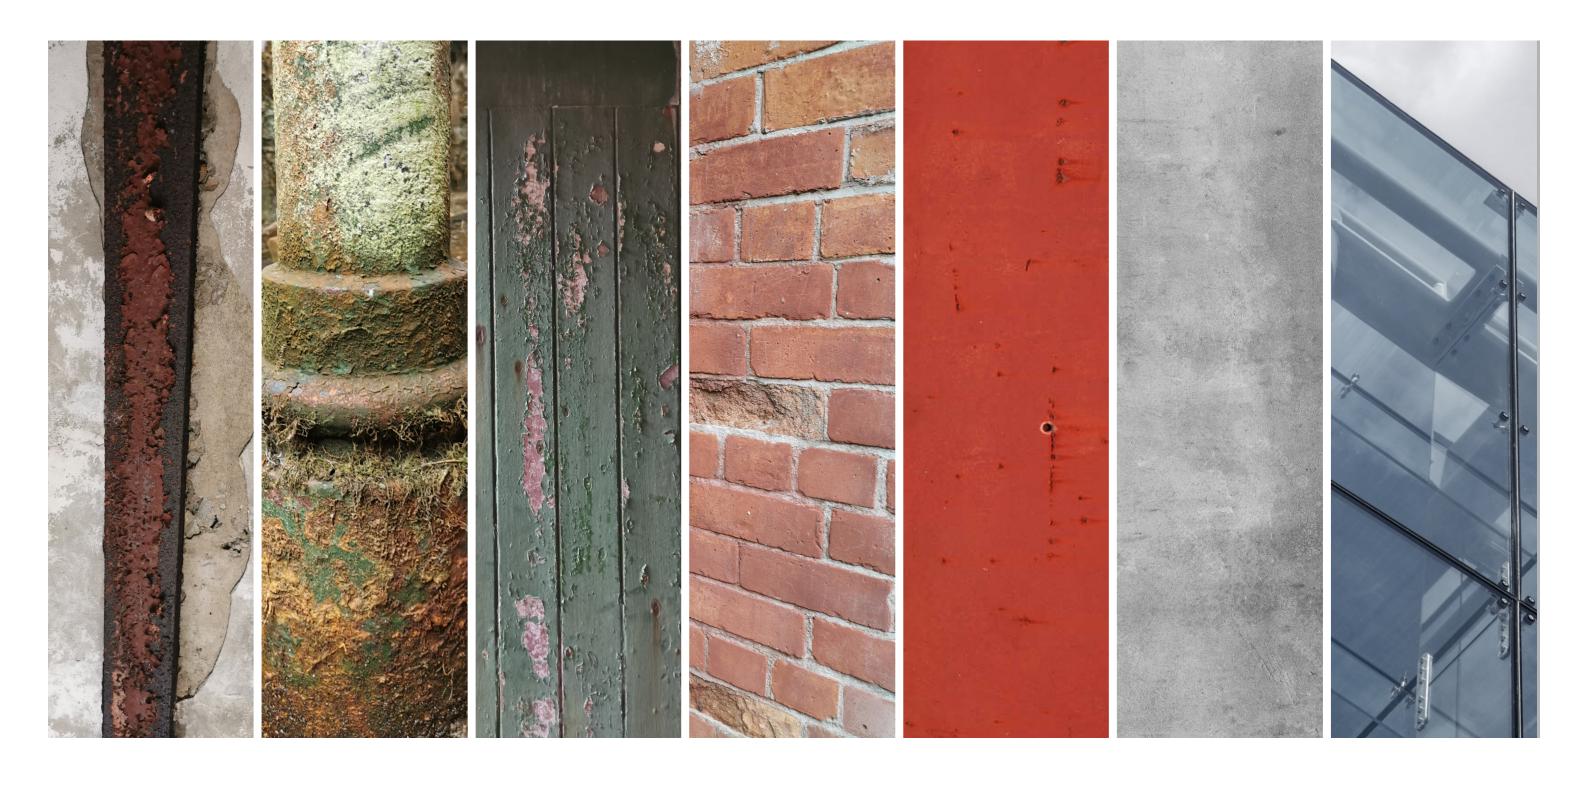
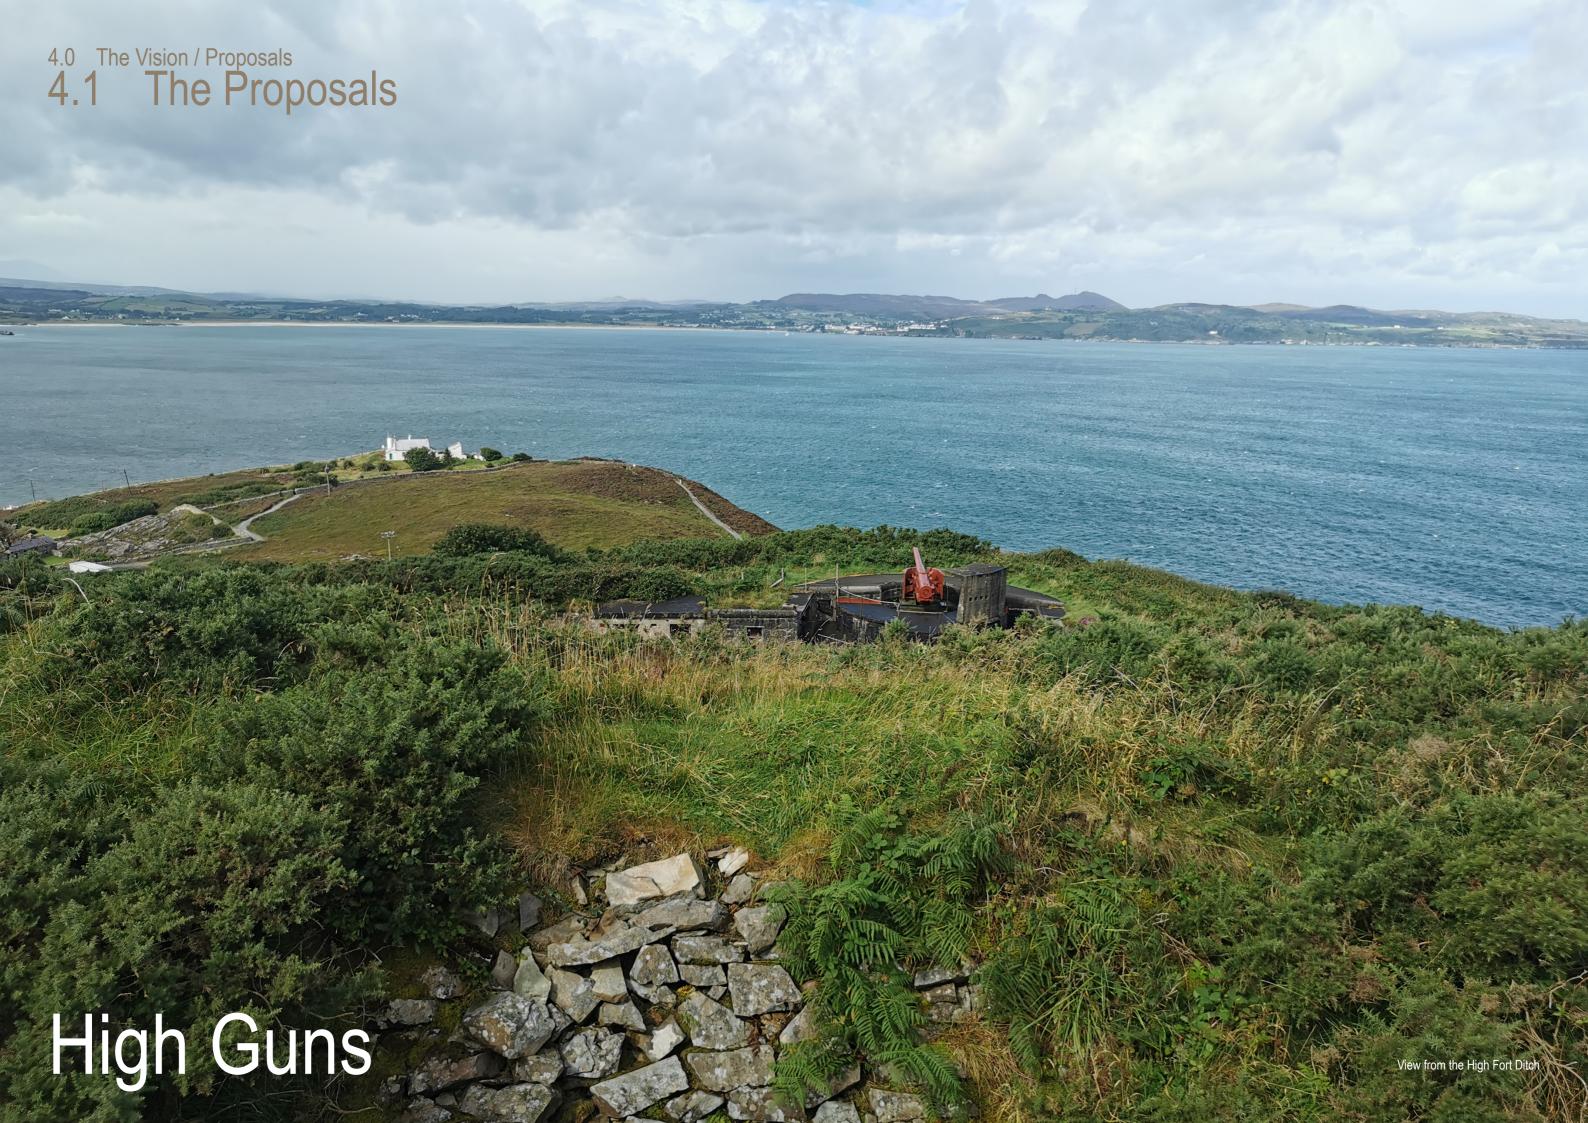
Design Material | Materiality

The existing materials consist mainly of steel, brick, cast concrete and timber and the proposed materials are mainly steel, concrete and glass. Whilst the proposals do not deviate greatly from the existing the finishes will, ensuring the new contrasts with the old while also complementing each other.

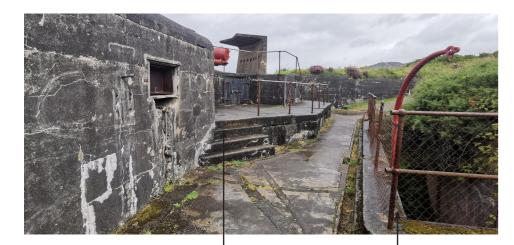
Gun platform (3.12) & Magazine (3.13)

Only light touch refurbishment works and Health and Safety improvement works are proposed. This is focused on one underground ammunition store and one Gun Platform. This will include repairs to the steps, appropriate handrails, guarding around Gun Platform 1, light internal repairs and the installation of lighting and electricity for interpretation.

Handrails to existing stairs to be installed. To resemble the existing form

Existing railings to be securely fixed along with the existing mesh guarding to

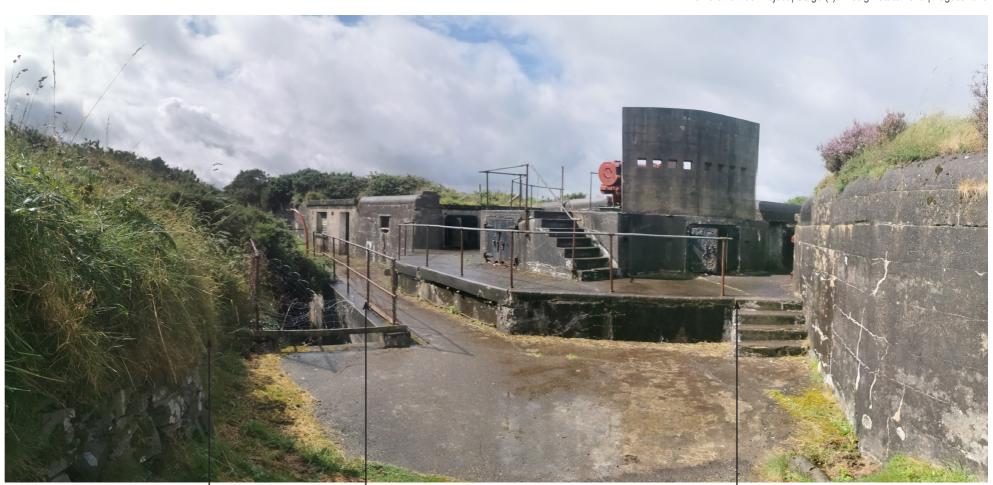
Overgrown vegetation to be cut back and maintained

Existing railings to be securely fixed along with the existing mesh guarding to prevent falls.

Handrails to existing stairs to be installed. To resemble the existing form

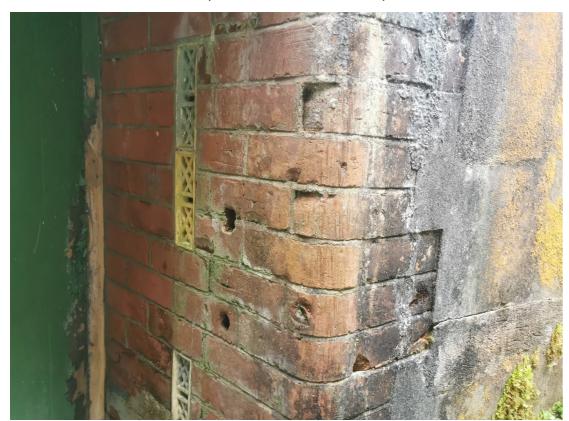
Sensitive colour matched repairs to the existing brickwork only where necessary. Holes created during original use to be retained.

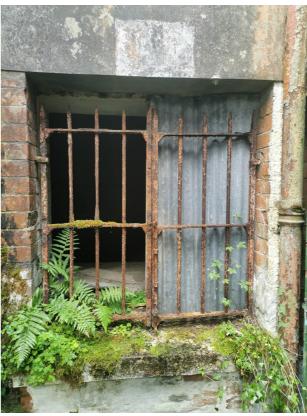
Installation of basic lighting is necessary to open up to the public. Surface mounted fixings and ducting to be used as per the existing.

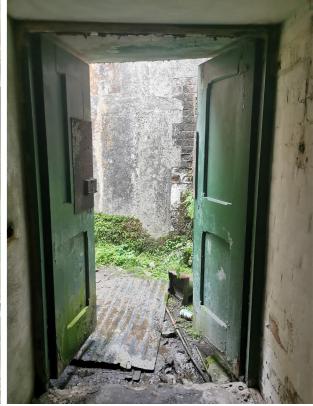
Repair to the existing metalwork. All vegetation to be carefully removed and Repair to the existing timber-work the affected area to be made good

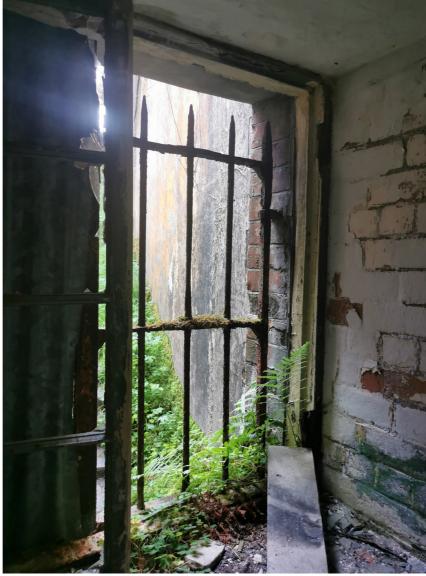
Design Team to seek advice from an expect on the practicality of reinstating or restoring and protecting the existing ammunition lift

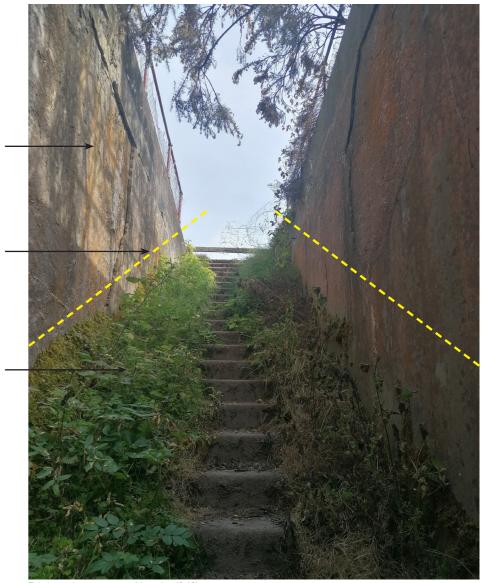
As it is not possible to alter the existing stairs or form an alternative route to greatly improve accessibility, an interpretative virtual tour is proposed.

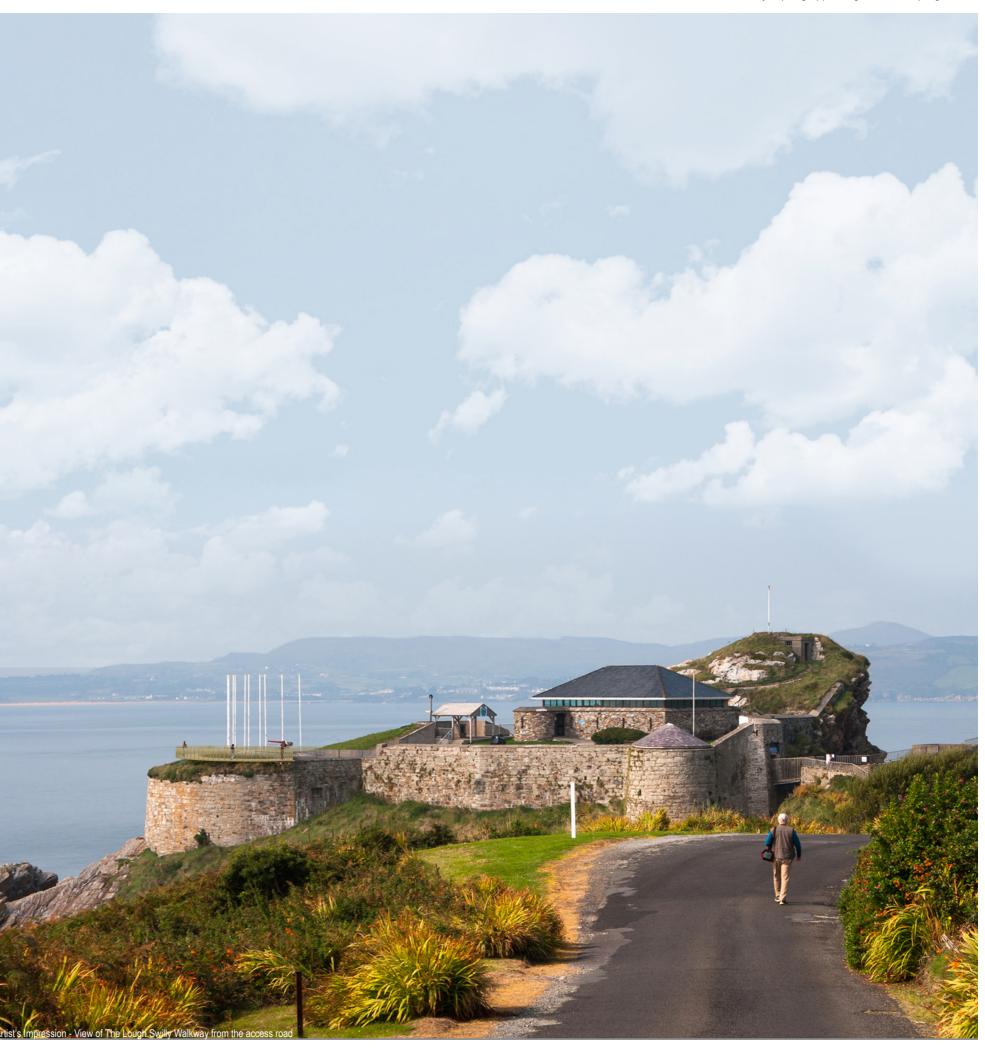
- 2. The existing accessibility is poor in the Lower Fort. An accessible route from the drawbridge to the installation is proposed.
- 3. Expansive views and visitor experience stepping on the glass floor looking to the cliffs and Swilly below.

As access to the walkway is an existing route on an existing site, full accessibility is not necessarily required . However, due to the level of funding and the experience proposed the Client has expressed that it must me fully accessible. To achieve this, the existing drawbridge must be replaced along with the removal of the existing concrete path to install a ramped access to the current regulations. Where practical and feasible this ramp has been kept to a maximum of 1:21 to negate the need for handrails and therefore a negative conservation impact.

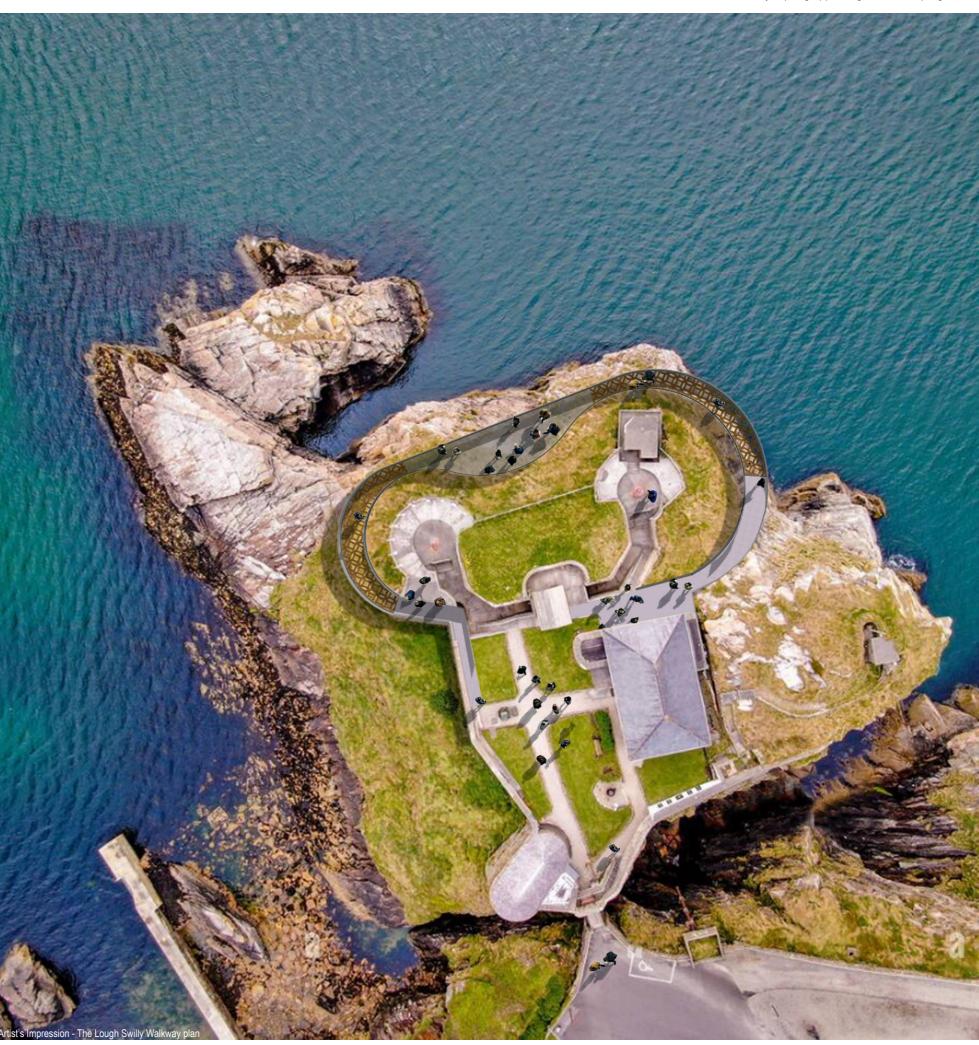
As indicated by the Figure below, the Lower Fort Structure can be broadly broken into 4 key forms from a structural perspective as follows:

Central Cantilever – as per 75006-31-ZZ-ZZZ-DR-KXM-ARPL102, the central cantilever section is proposed to comprise of a cantilevered tapered I-beam fixed back to a reinforced concrete pad foundation structure, suitably sized to prevent overturning of the structure.

Blockhouse Cantilever – similarly to the central section, the proposed walkway is proposed to cantilever beyond the cliff edge in this area. However, due to the proximity of the existing blockhouse and conservation concerns, a steelwork grillage secured back to the existing rock face via grouted rock anchors (micropiles) are proposed, in lieu of a reinforced concrete pad foundation structure.

Northern Stepped Access – similar to the south approach, it is anticipated that the top landing of the Northern Stepped Access will be formed via in-situ reinforced concrete ground bearing slab.

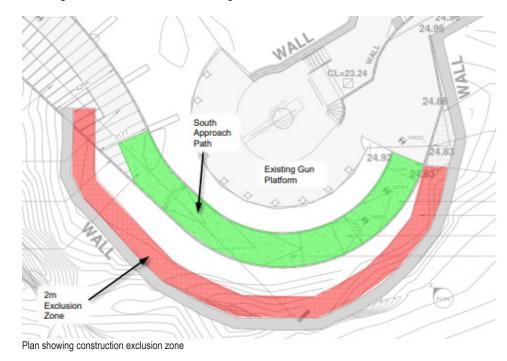
With respect to the protection of the Lower Fort Wall & Gun Platform to the southern walkway approach, it is proposed that a minimum 2m exclusion zone is maintained from the face of the Lower Fort Wall and 1.0m from the railings of the gun platform (see image above). It is important to note however that the vast majority of the approach path achieves an exclusion zone in excess of 4m to the Lower Fort Wall. In addition, the approach path is proposed to tie into existing levels as far as reasonably practical to ensure that any increase in loading adjacent to the existing structures is minimised.

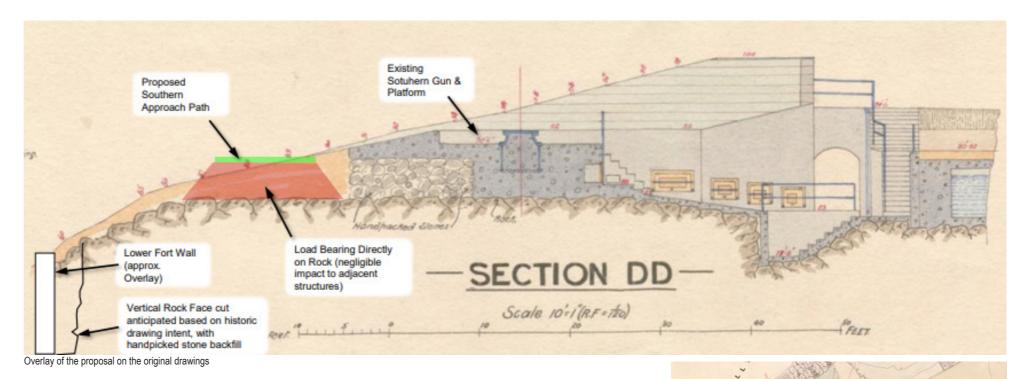
From the historic drawings, it is anticipated that the Lower Fort Wall is in the region of 1-1.5m thick. Considering this and the fact that rock is highly likely to be present at shallow depth, it is unlikely that any direct loading would be imparted on the adjacent structures. This assumption is validated by the extract taken from Section C-C of Historic Drawing WO78_4912_008, which clearly illustrates rock at shallow depth. It also depicts the intent that vertical rock cuts would be formed for the structures, and backfilled with hand picked stone. As such, if the proposed structures bare on competent rock, no loading would be imparted on the adjacent structures

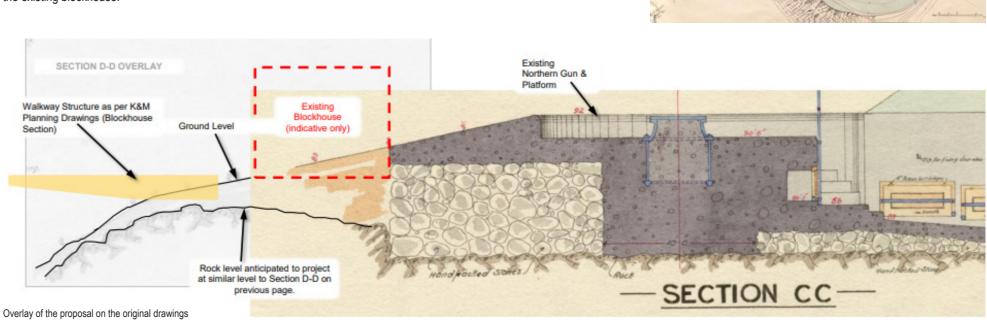
The foundation for the blockhouse is unknown and given the sensitive nature of the existing structure, intrusive ground investigation Pre-Planning was not deemed suitable. However, it is a reasonable assumption that the blockhouse is founded on a shallow foundation, bearing directly onto hand-picked stones on existing bedrock. This assumption is validated to reasonable degree by Section C-C of Historic Drawing WO 78_4912_008, which clearly illustrates the proposed construction of the Northern Gun. For the purposes of communicating the relationship between proposed and existing, further detail has been added to Section C-C below. Based on the rationale above, the likelihood of any walkway works undermining the blockhouse foundation is deemed low. Cautiously however, an alternative foundation design solution has been proposed, as illustrated below to negate the need to carry out any significant excavation works adjacent to the existing blockhouse.

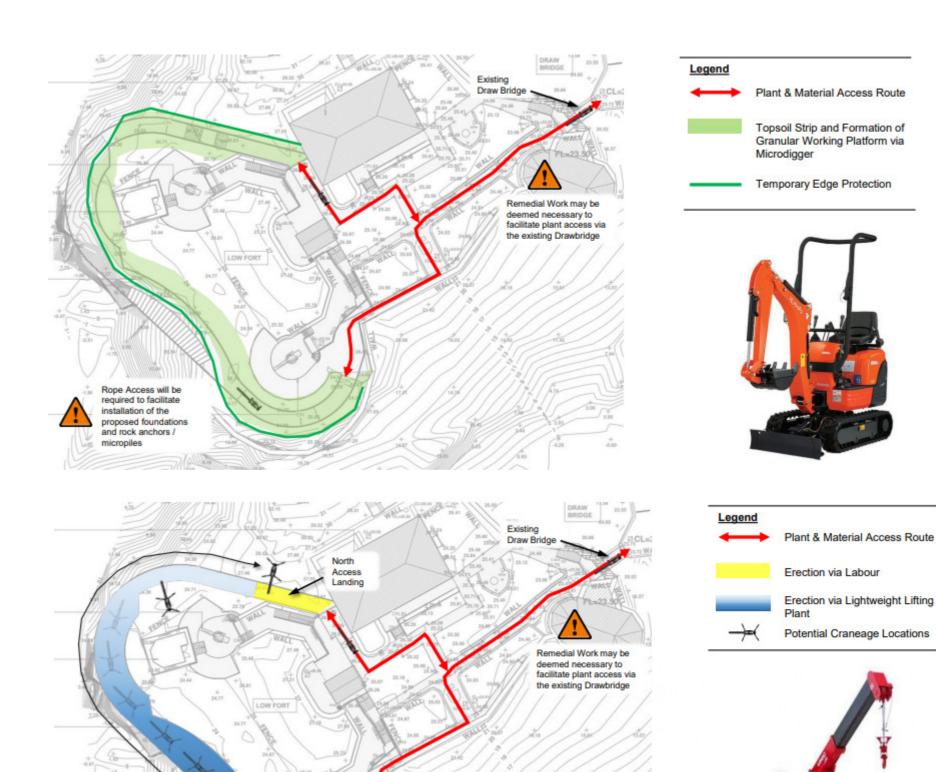
1. Enabling Works: This will involve the removal of top soil in the area local to each foundation structure and shallow depth excavation to identify rock level / suitable bearing stratum. On the basis of the historic sections presented previously, it is anticipated that rock level will be identified typically 0.5-1m below existing ground level. Following this, the ground would then be prepared with granular working platforms, to facilitate tracked plant access. In addition, a Temporary Edge Protection System would be installed adjacent to the cliff face.

- 2. Foundation Construction: Following the enabling works, foundation construction would then commence. The exact extent of walkway for which a concrete or a steelwork grillage foundation type is utilised will be subject to Detailed Design and Costing, as described previously. Due to the access constraints posed at the Fort, it is likely that any pad foundations would need to be cast in-situ, with concrete supplied to the works area via a concrete pump positioned outside the Fort. Any rock anchors / micropiles deemed necessary would be installed via a suitably sized, tracked micropile rig refer to figure right for context. It is important to note however that either foundation construction will require some degree of rope access and fall arrest equipment to facilitate safe construction.

- 3. Superstructure Erection: On completion of the substructure (foundations), the next stage in the construction process will be the erection of the superstructure. Given site access constraints, the walkway superstructure will be pre-fabricated off-site and suitably detailed such that all steelwork elements are easily manually handled, or erected using Mini Spider Cranes (1-2T Gross Weight) or similar light-weight lifting plant. Such plant could be tracked across the existing drawbridge subject to confirmation of suitable structural capacity. Alternatively, the plant could be readily lifted over the top of the Lower Fort Walls via one-off cranage and tracked to their proposed works area. The intent of this method is that it will allow the walkway to be constructed from within the walkway itself, helping to mitigate any risk of plant collision and/or collapse on to the existing heritage structures. To facilitate this method, the walkway would be designed in support of the proposed plant. The likely travel path of the proposed cranage is as indicated in the figure on the right. Alternative sequencing is also possible, and the sequence shown is for information purposes only.

- 4. Approach Landings: The final stage in the construction process will be the casting of the approach landing to the North and Approach Path to the South. The feasibility of proposing pre-cast concrete solutions for both elements will be explored further at Detailed Design Stage.

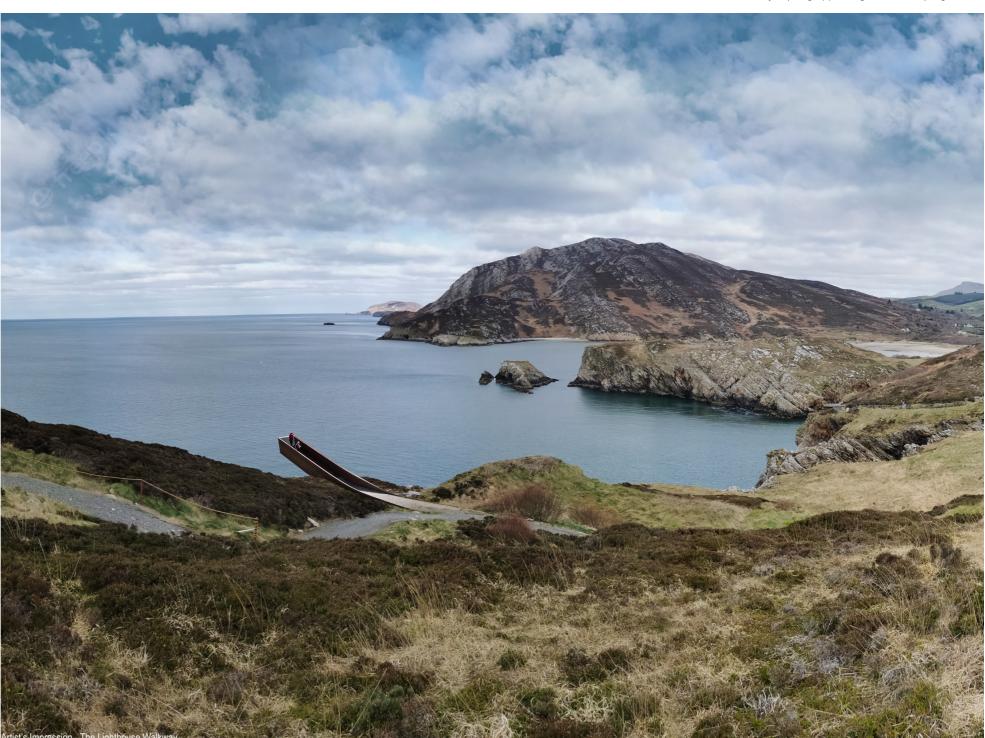
It is proposed that The Lighthouse Walkway and the Lough Swilly Walkway work hand in hand in terms of materiality. Similarly, the main material chosen will be a GRAEPEL perforated metal balustrade and flooring or equivalent.

Following discussions at the PSGM on 18th July 2023 a gate to restrict access is to be included.

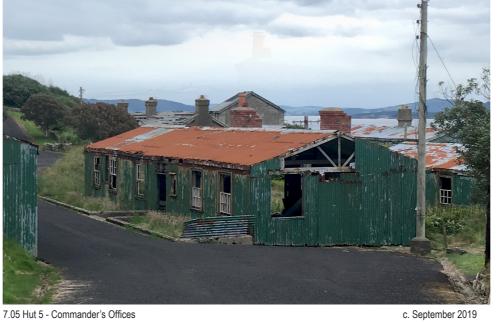
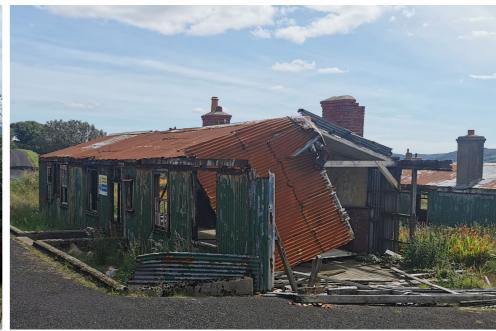
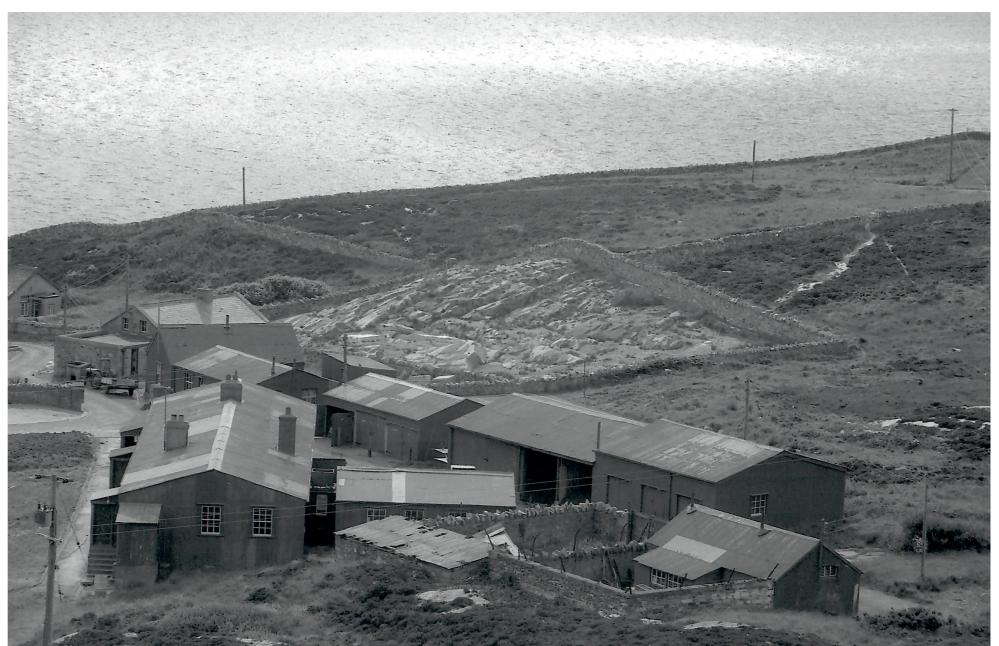
The photographs to the right and below highlight the damage caused over a three year period from September 2019 to August 2022. The bottom right photograph was taken in 1983: All of the corrugated-metal buildings in this picture are now gone. These photographs illustrate the importance of the proposed works.

The strategy is to restore the worst affected buildings and stabilise the rest. For example Hut 7.05 (right), it is quickly deteriorating and at a high risk of full collapse. Hut 7.05 is located in the centre of 'the village,' directly on the access road so its importance is elevated. The proposal looks at fully restoring this structure along with Hut 7.01 directly opposite.

7.05 Hut 5 - Commander's Offices c. August 2022

1983 photo of the village buildings now gone from the site

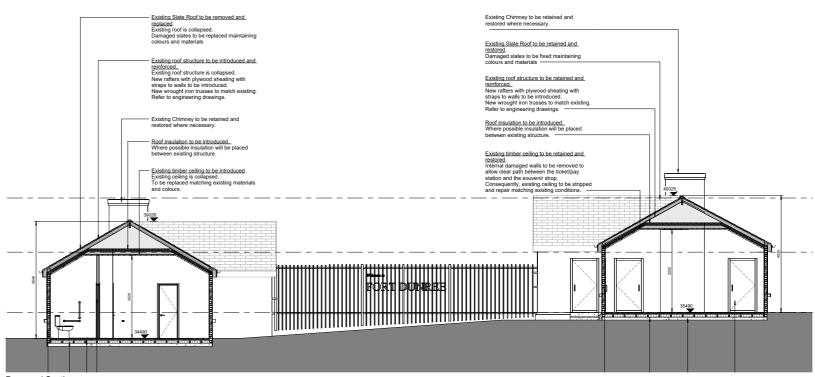
Proposed Section

The two welcome buildings act as a bookend to the entry and exit of the site. The necessary facilities to operate a tourism site such as a ticket desk, retail shop and WC's are located within these.

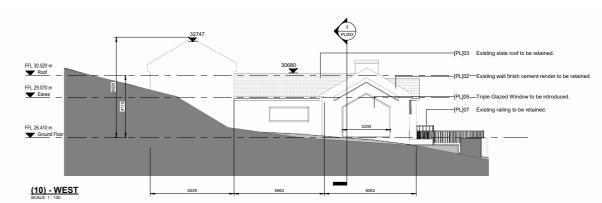
Side Elevation

The rear store is inaccessible to the public. It is currently being used to stores bins associated with the cafe. The roof is in very poor condition causing considerable water damage

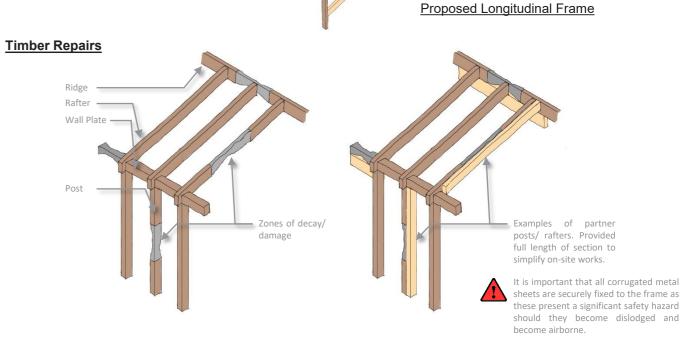
Transverse Frame Strengthening Hanger Principal Rafter Tie Beam Elbow Haunch New diagonal struts and tie beam to provide additional lateral rigidity. Existing Transverse Frame at Truss Proposed Transverse Frame at Truss Longitudinal Frame Strengthening

Typical Existing Timber Frame

Typical Proposed (Partnered) Timber Frame

Structure Overview: The typical hutment structures consist of a timber frame clad in corrugated iron. The ground floor is of timber joist construction, suspended between brickwork piers The roof structure consists of timber rafters spanning onto a ridge beam which in turns spans onto timber trusses at regular spacings. Typically the trusses have elbow haunches which provide some rigidity to the frame. Some of the hutments have brickwork chimney breasts which provide some nominal stability to the frame subject to presence of the corrugated iron diaphragm

Structural instability - The structures are very lightweight and therefore susceptible to damage under the action of high winds Some of the structure have collapsed in the past with the ruins evident, as is the case of the gymnasium shown above This collapse is due to a lack of lateral stability in the frames, both inherently and also as a result of the degradation of the timber and loss of the corrugated sheets acting as stability diaphragms The diagrams above show how the current framing system could lead to collapse

Timber decay - Many of the timber section will be subject to rot decay due to moisture migrating through gaps in the corrugated iron sheeting This will be particularly the case for those unoccupied structures which have lacked basic maintenance for decades The timber decay will have caused a loss of strength of the sections Some timbers have been subject to fire damage Proposed Solution: Initially a timber survey will be carried out to determine the extent of rot decay or infestation The proposed solution involves partnering timbers as shown opposite. The existing fabric will remain in place (subject to surveyors advice) and new timbers will simply be partnered to the side of existing. Again this means maximum retention of original fabric, as well as a reversible and cost effective solution

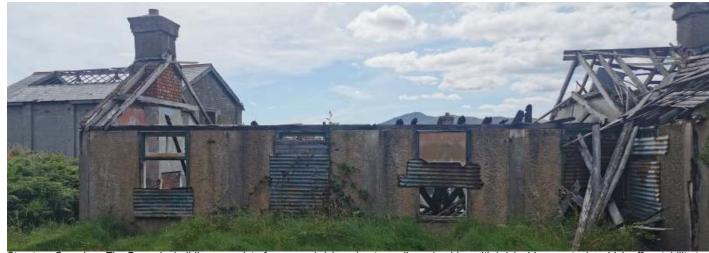
Barracks Restoration

Structure Overview: The Barracks buildings consist of masonry brick perimeter walls and gables with brick chimney stacks which offer stability to the building. The roof consists of collar tie rafters and steel (possibly wrought iron) trusses. The trusses are supported on columns embedded in the external masonry walls. The ground floor consists of suspended timber construction bearing on brick piers or tassle walls.

Defect Description: The existing roof has collapsed in many locations and is judged to be beyond repair. The ground floor structure is not fully visible but likely subject to significant rot decay. Proposed Solution: It is proposed that a new roof is installed to match existing. The roof should have tion of the existing fabric and also to ensure plywood sarking glued & screwed, and straps between rafters & walls as per Building Regs. The columns are left in place and the new columns ground floor structure will have to be replaced to match existing where required. New piers are required with pad-stones where new columns are being supported.

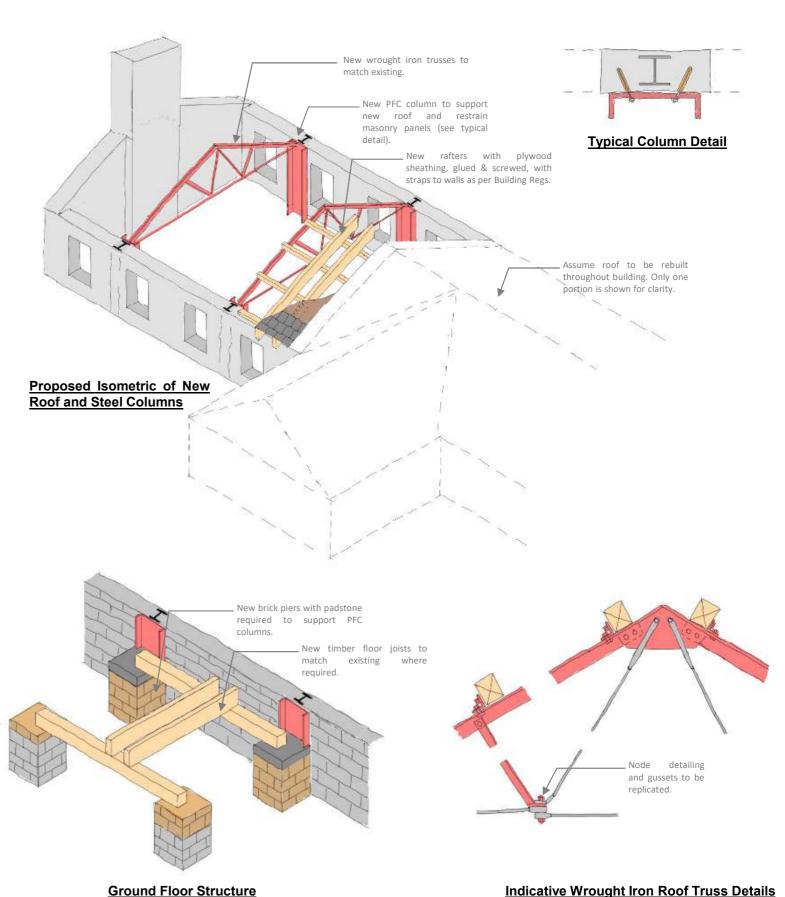
4.0 The Vision / Proposals

4.1 The Proposals

The drawing below demonstrates the level of repair proposed depending on the structure type, and

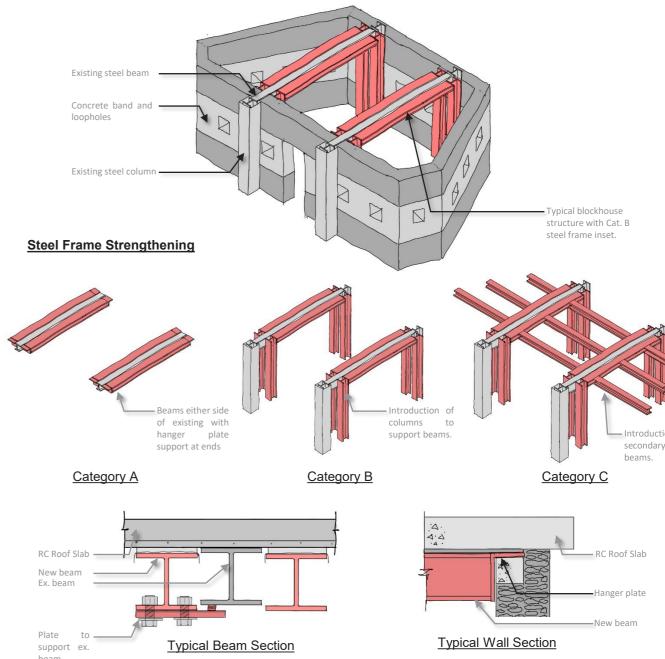
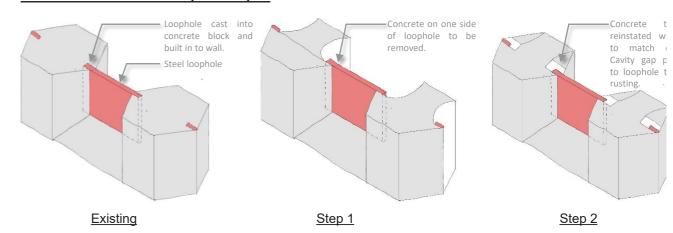
Concrete Band & Steel Loophole Repair

The steel loopholes are heavily corroded and rust jacking has caused severe cracking in the concrete surround. This has caused bowing in some walls, and if allowed to continue will jeopardise the stability of the walls.

Install beams along the side walls as per Cat A repair to relieve the load of the roof slab. Remove the concrete from one face of the band to allow the steel plate to rust and expand freely. The concrete outer leaf could be recast allowing a permanent cavity and enabling the steel loophole to continue to rust/expand uninhibited (refer Steps 1-3).

Alternatively the loophole could be completely exposed on both sides and coated in an anti-corrosion primer, however this would mean an increased loss of fabric.

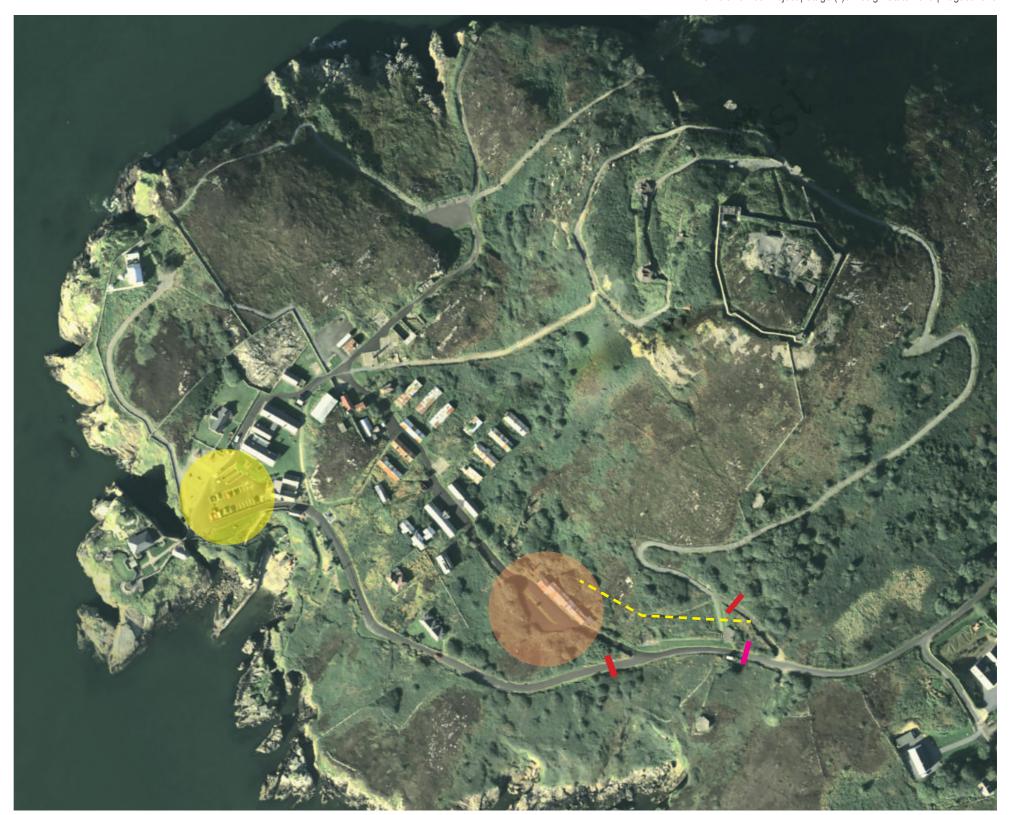
Following extensive traffic survey analysis and 10 year projections, it was determined that a minimum of 110 spaces should be provided. The developed design achieves the requirement. The general layout includes the main car park and an overflow car park which will be utilised during peak season. The car park capacity is as follows;

- 110 car parking spaces including 11 accessible spaces and 5 EV charging spaces,
- 5 minibus /camper-van spaces
- 5 coach spaces, one of which is an accessible drop off point
