Fort Dunree Project

Design Statement

August 2023

By
Keys and Monaghan Archiect
and
Taylor McCarney Architects

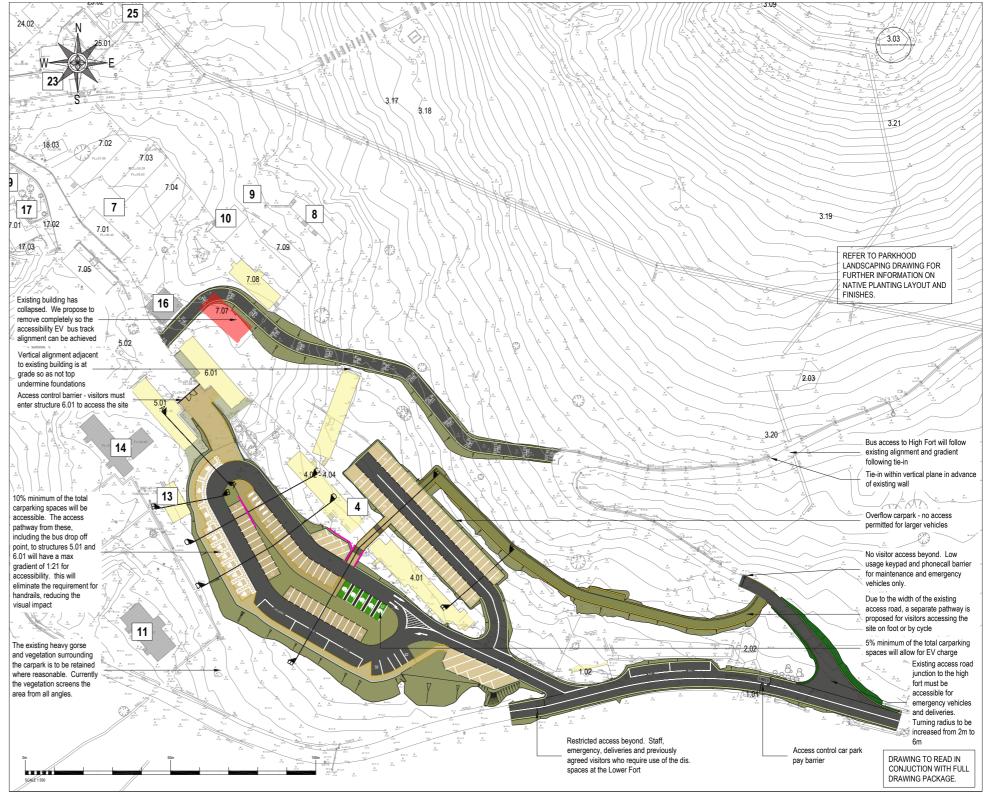
Proposed New Car Park Layout

Existing Structure Remains In The Proposed Car Park To Be Retained. Proposed car park location, already partially of tarmac construction

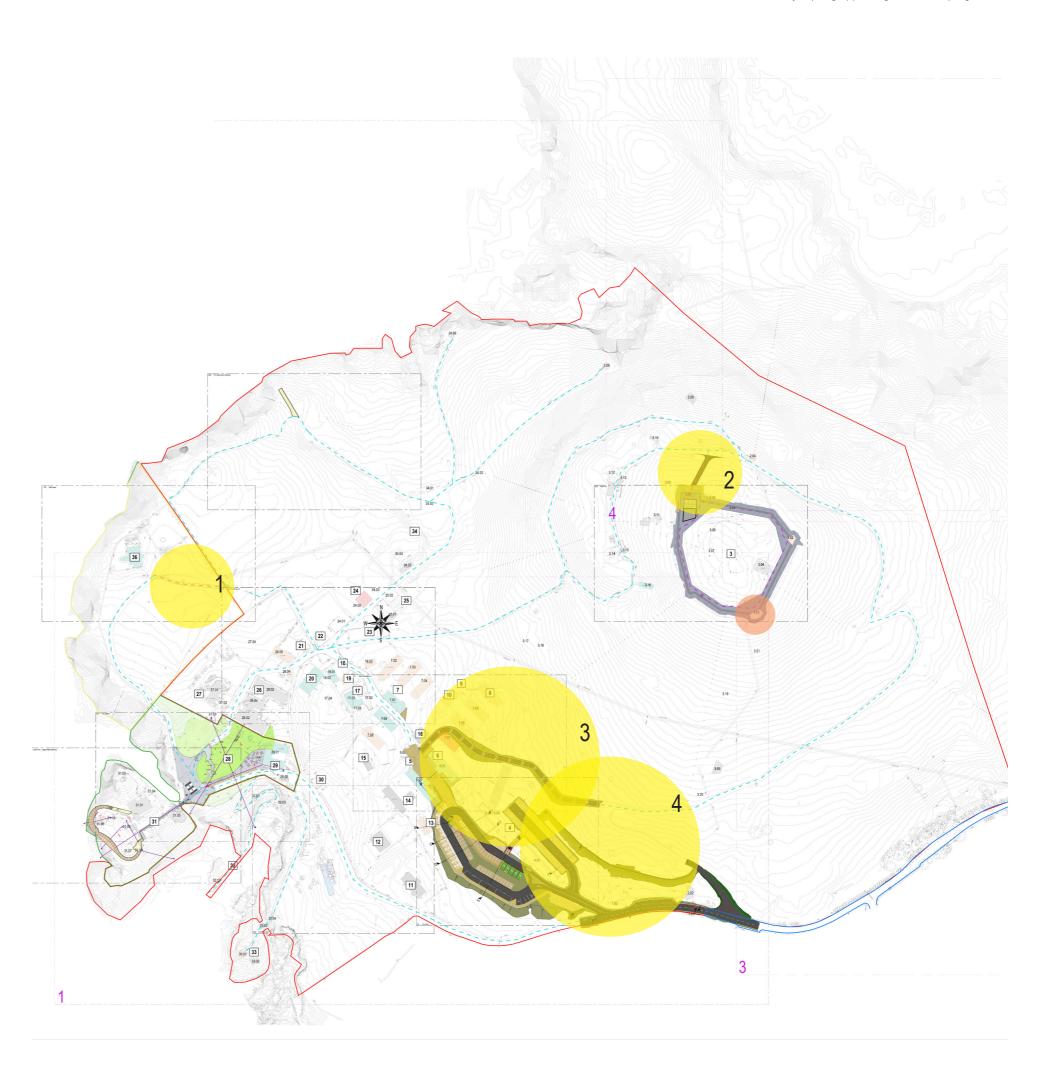
Walkways

New connecting pathways and the provision of repairs to the existing pathways is also proposed. The new connecting pathways atr highlighted and illustrated on the map below.

- 1. New pathway to form a looped walk from the lighthouse
- 2. Reinstate pathway up to the High Fort (See 'Access for All to the High Fort' for further details)
- 3. New pathway connecting the Welcoming building and the existing High Fort Acess Road (See 'Access for All to the High Fort' for further details)
- 4. Pathway for visitors arriving to site on foot or by cycle (See 'Car Park' for further details). The proposed Buncrana to Carndonagh Greenway Project will run past the Fort Dunree site This pathway will future proof the site whilst also promote and encourage sustainable transport.

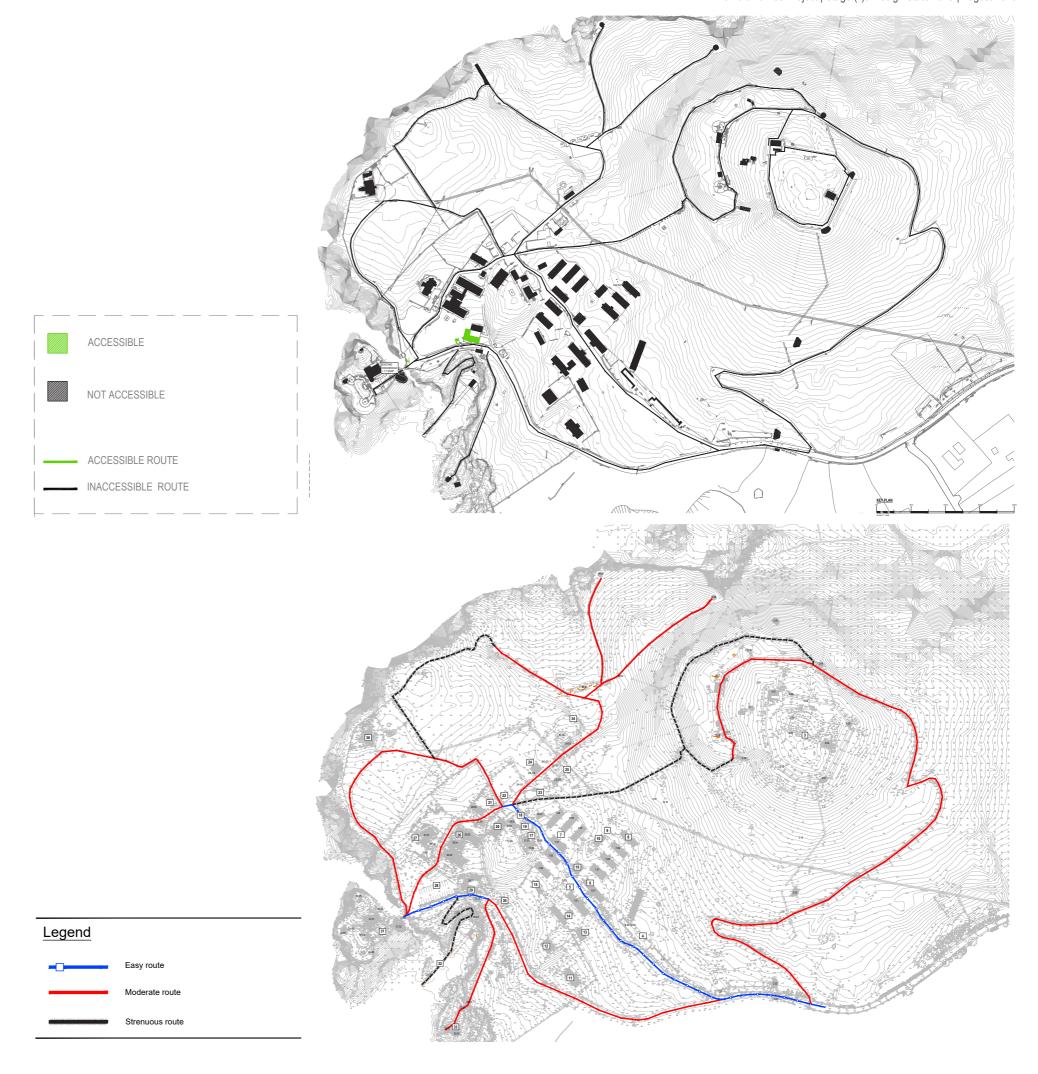
This existing accessibility of Fort Dunree according to Part M of the Technical Guidance Regulations is extremely poor. As shown on the map to the right, only the cafe is wheelchair accessible due to the adjacent accessible car park space.

The accessibility of the site and external trails has been assessed using the Sport Ireland Classification. This is recognised throughout Ireland to communicate the difficulty of access along outdoor trails. The blue trail intends to be accessible for all however some, help from a carer may be necessary on parts of the path, and the trail may have surfaces that may require more strength from wheelchair users. The existing accessible trails can be viewed on the site map below.

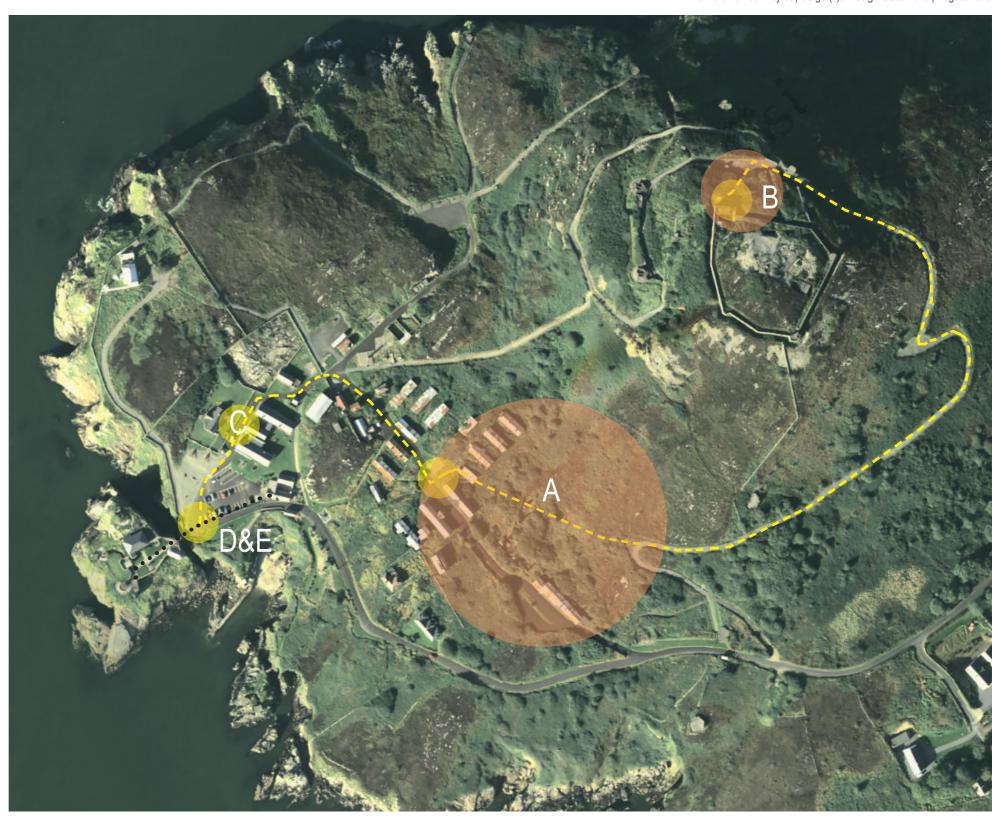
Access for All to the High Fort

The High Fort is currently inaccessible to visitors of limited mobility due to the existing topography. At Platforms for growth stage and Stage 1 an inclined elevator was proposed, however, through increased capacity requirements from a 14 person lift to a 25 person lift and current inflation, the cost of the installation was not sustainable for the project. Eliminating this element reduces the potential environmental and visual impact on the landscape. It is now proposed that an EV mobility bus will transport visitors from the Welcome buildings to the High Fort and Low Fort, stopping at the Saldanha Suite along the way.

- 'A': A new road section is required from the Welcome buildings to the existing High Fort access road.
- 'B': The existing path to the High Fort will require widening, on the existing Kew maps this path is currently 3.2m wide. It is proposed that this will be increased by 400mm to allow a separation zone between pedestrians and the bus (see analysis on next page). The existing path is purposely not maintained and overgrown to restrict public access to an unsafe area.

- 'E': An accessible route from the lower Fort Drop off point to the Lough Swilly Walkway must be implemented (See 'The Lough Swilly Walkway' proposals for further details). The includes the necessity of a new drawbridge as the existing incline is 1.7 over c. 3.3m.

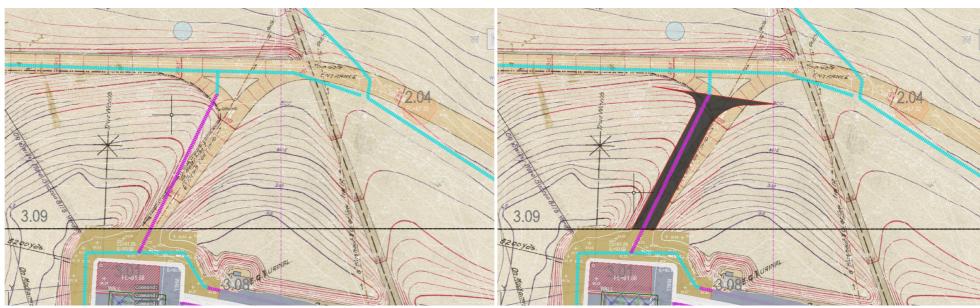
Access road to the High Fort as shown on Kew Drawing WO 78_4911_017

The proposed pathway to the High Fort. As shown from the alignment of the proposed pathway, the contours from the topographical survey deviates from the existing drawings. The alignment will be confirmed during detailed design stage by clearing the existing vegetation and resurveying the area.

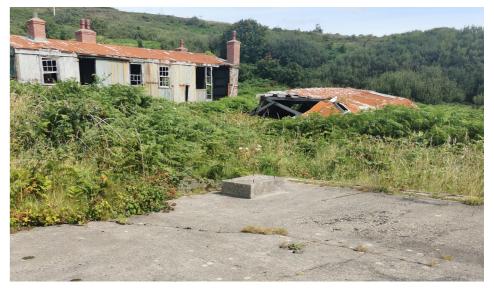
Structure 7.07 collapsed - to be removed and the new road section installed

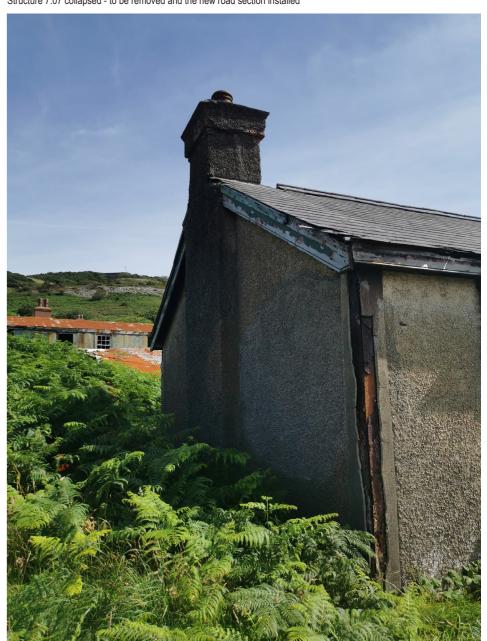
New road section to arrive north west of structure 6.01

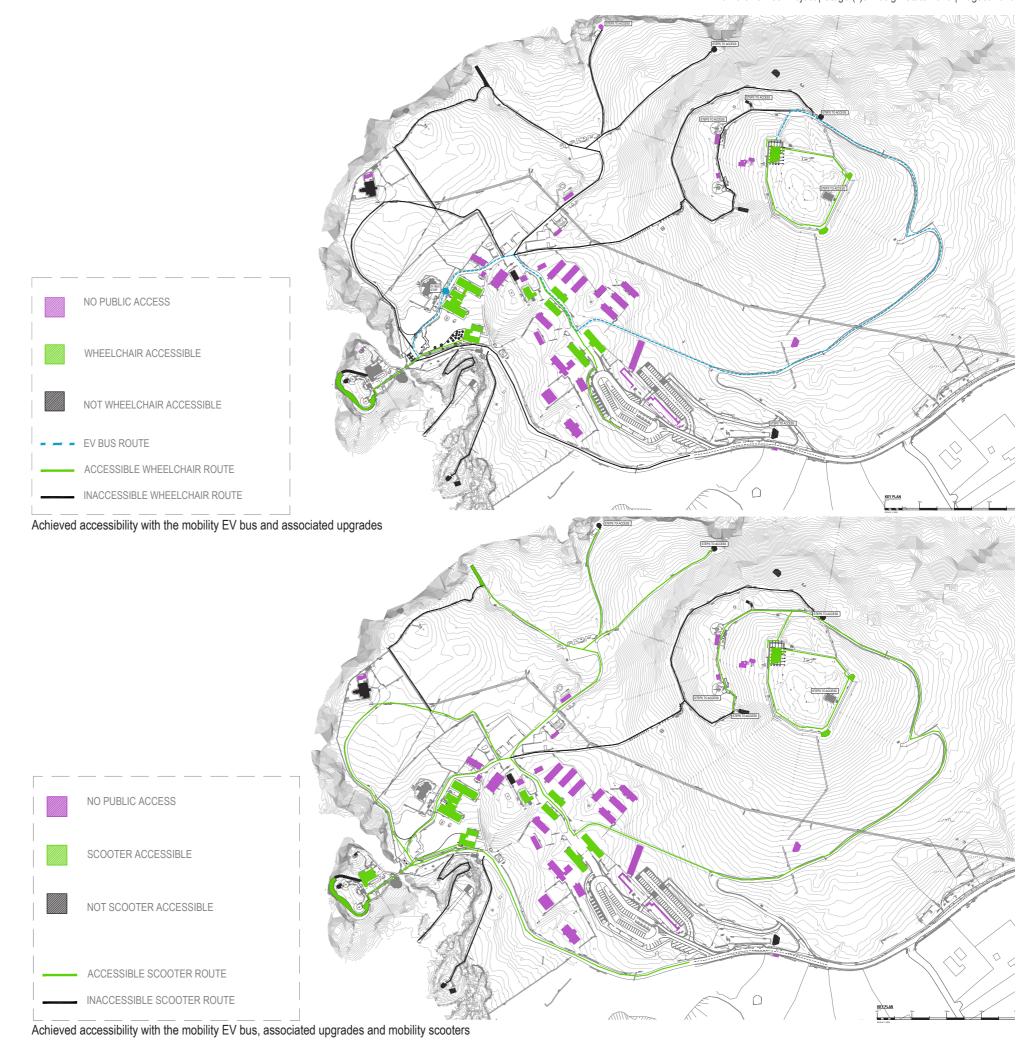
The map to the right demonstrates the accessibility achieved throughout the site along with the structures that can be accessed through the use of the EV mobility bus.

In addition to this, it is proposed to implement mobility scooters for even further exploration of the site as shown on the map bottom right.

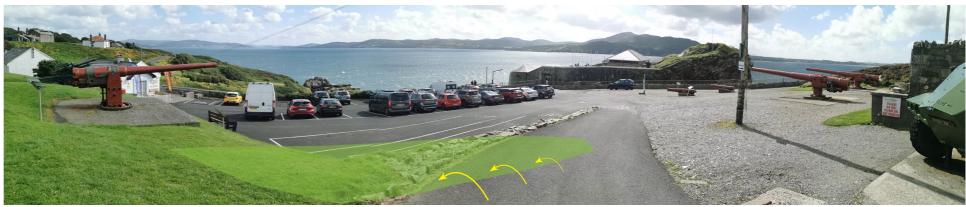
Indicative soft landscaping proposed. Note the risk of fall is eliminated with this proposal.

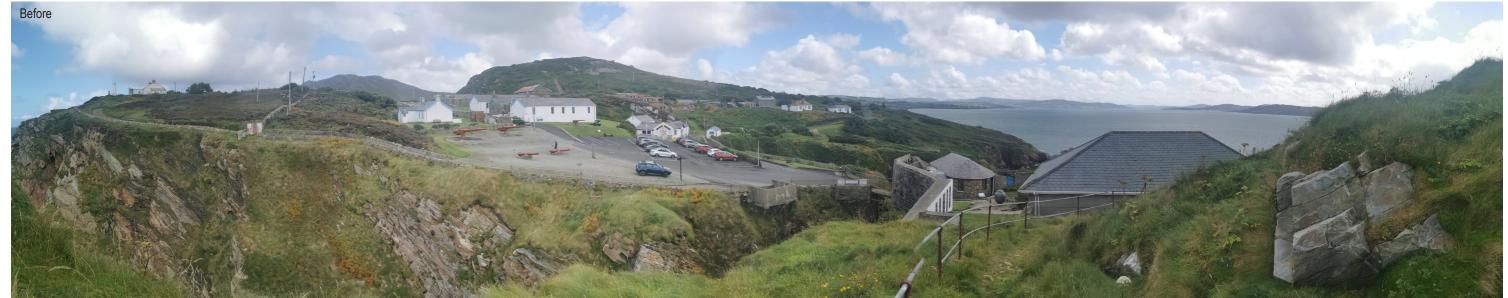
View from the Lower Fort: The visual impact of the hard surfacing is high and it detracts from the existing heritage site and structures. Soft landscaping will be more appropriate.

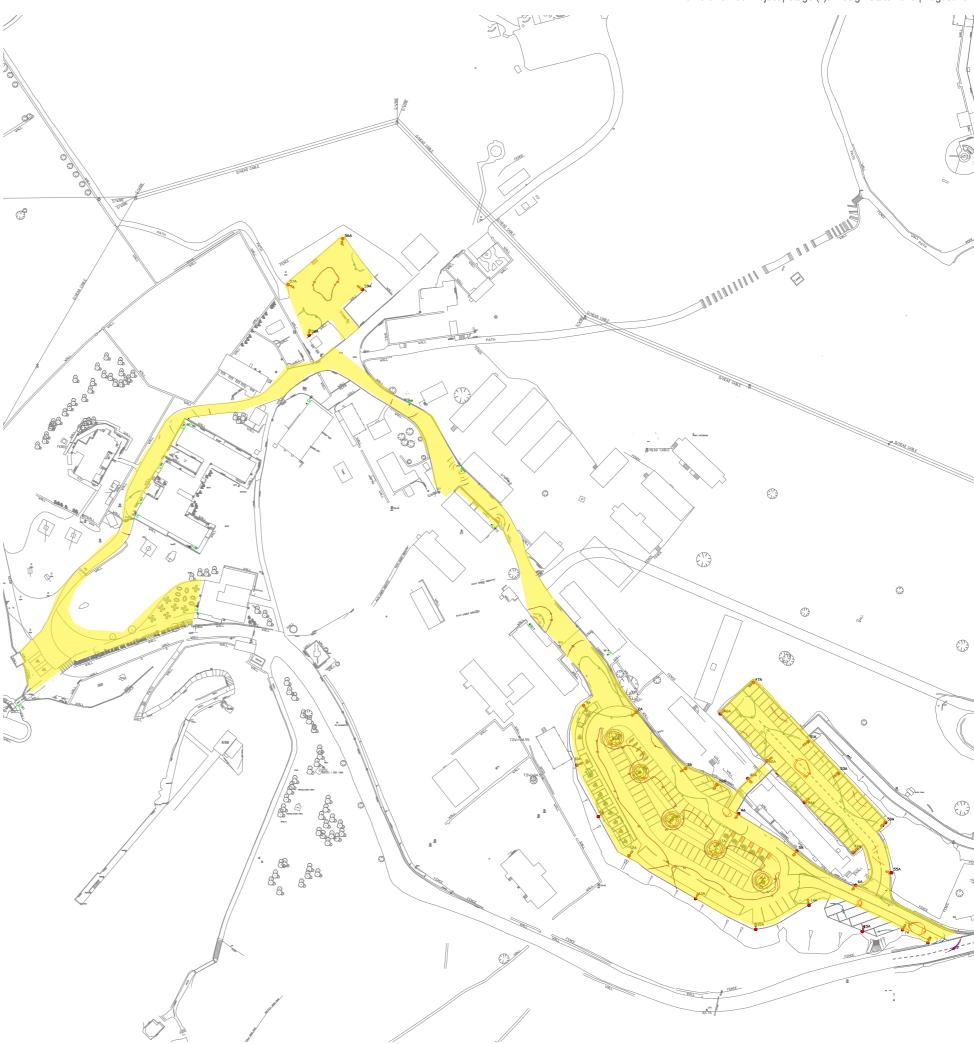
General Infrastructure | Electric

The existing electricity supply is derived from the ESB overhead network. A three pole mounted transformer was installed by ESB at the rear of the Site Office (27). This transformer serves the Light House, the Office, and the Lower Fort. These supply cables run underground to the switchroom in the Lower Fort and to the Site Office (27).

Due to an increase in capacity a new electricity supply is required from ESB to serve the site. Overhead services were the original method used to supply, however, the entire site is prone to lightning strikes which has caused outages to electricity, data, telephones etc. This would cause ongoing maintenance costs along with a loss of services and experience for visitors, and potential revenue. To reduce the likelyhood of this, all services will be contained underground where possible.

- Proposed Underground Services
- Existing Underground Services (Condition Survey To Be Carried Out)
- Supply To Be Retained
 Supply To Be Retained
 - Existing Three Pole Mounted Transformer
 - Proposed Comms Cabinet Location
 - Distribution Pillar
 - Existing Single Phase Lv Supply Point (Ps2)
 - Proposed New Esbn Lv Supply Point
 - Proposed Treatment Plant (Power Supply Required)
 - Existing And Proposed Structure To Have A Power Supply

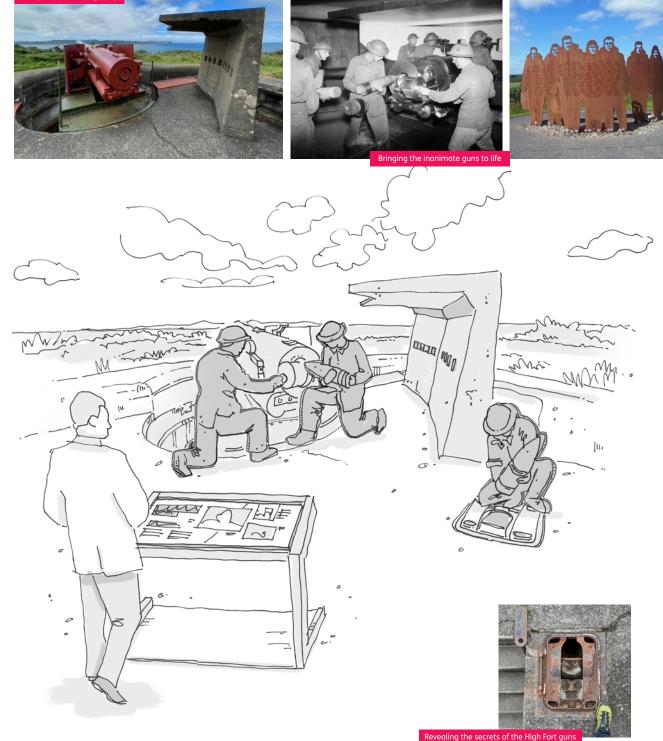
Interpretation & Interventions High Fort: Magazine

The underground magazine, now restored, will provide opportunities to interpret how the guns worked. Putting the 'people' back into the magazine will aid visitors' understanding of the Fort's function.
