CROFTER LIFE ON THE
WEST DONEGAL
SEABOARD

PATRICK O'NEILL

1940

Volume 2.

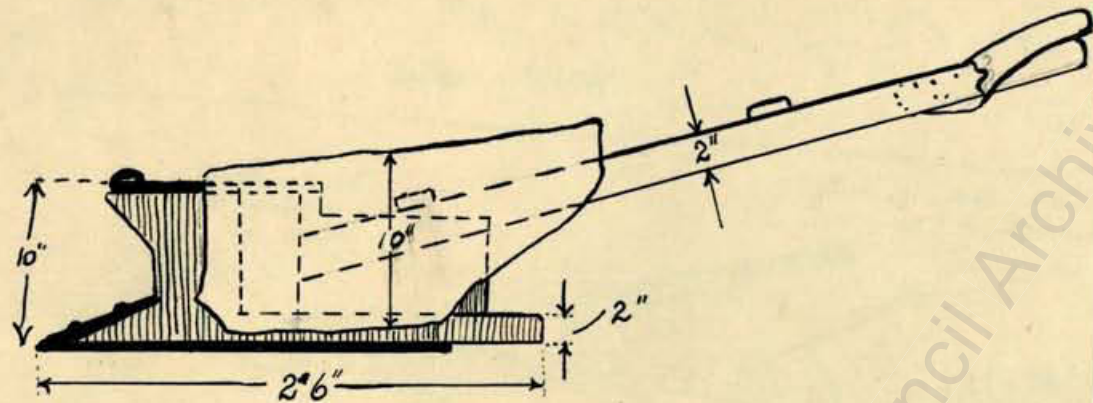
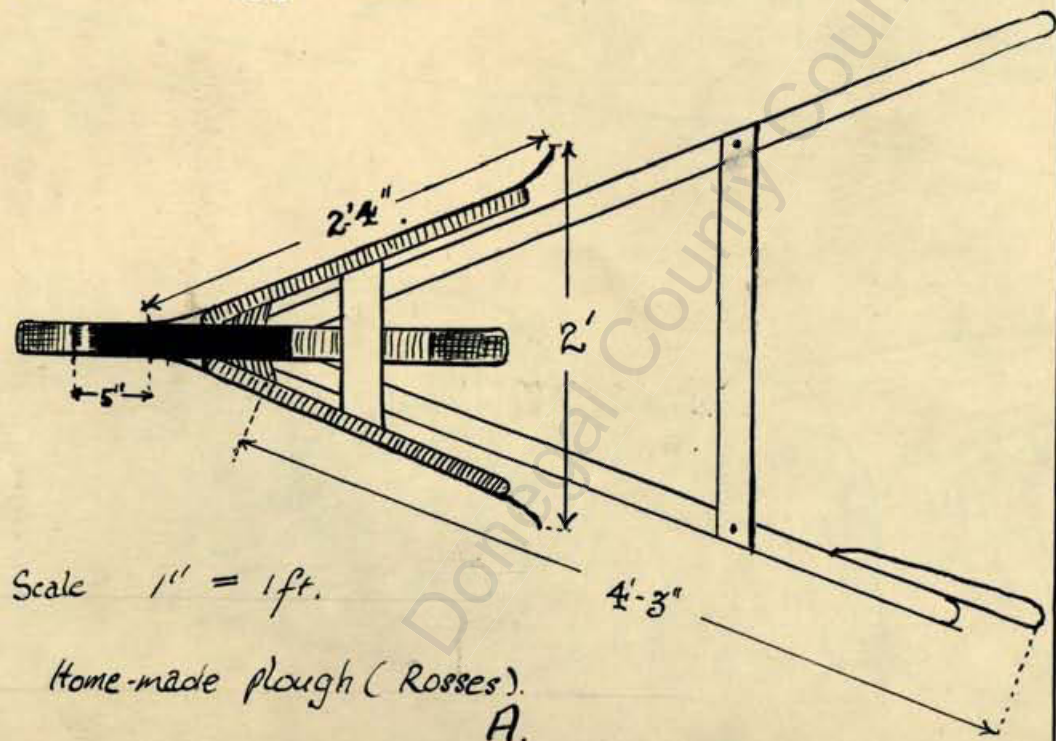
FIG. 9.

Scale 1" = 1ft.

Home-made plough (Rosses).

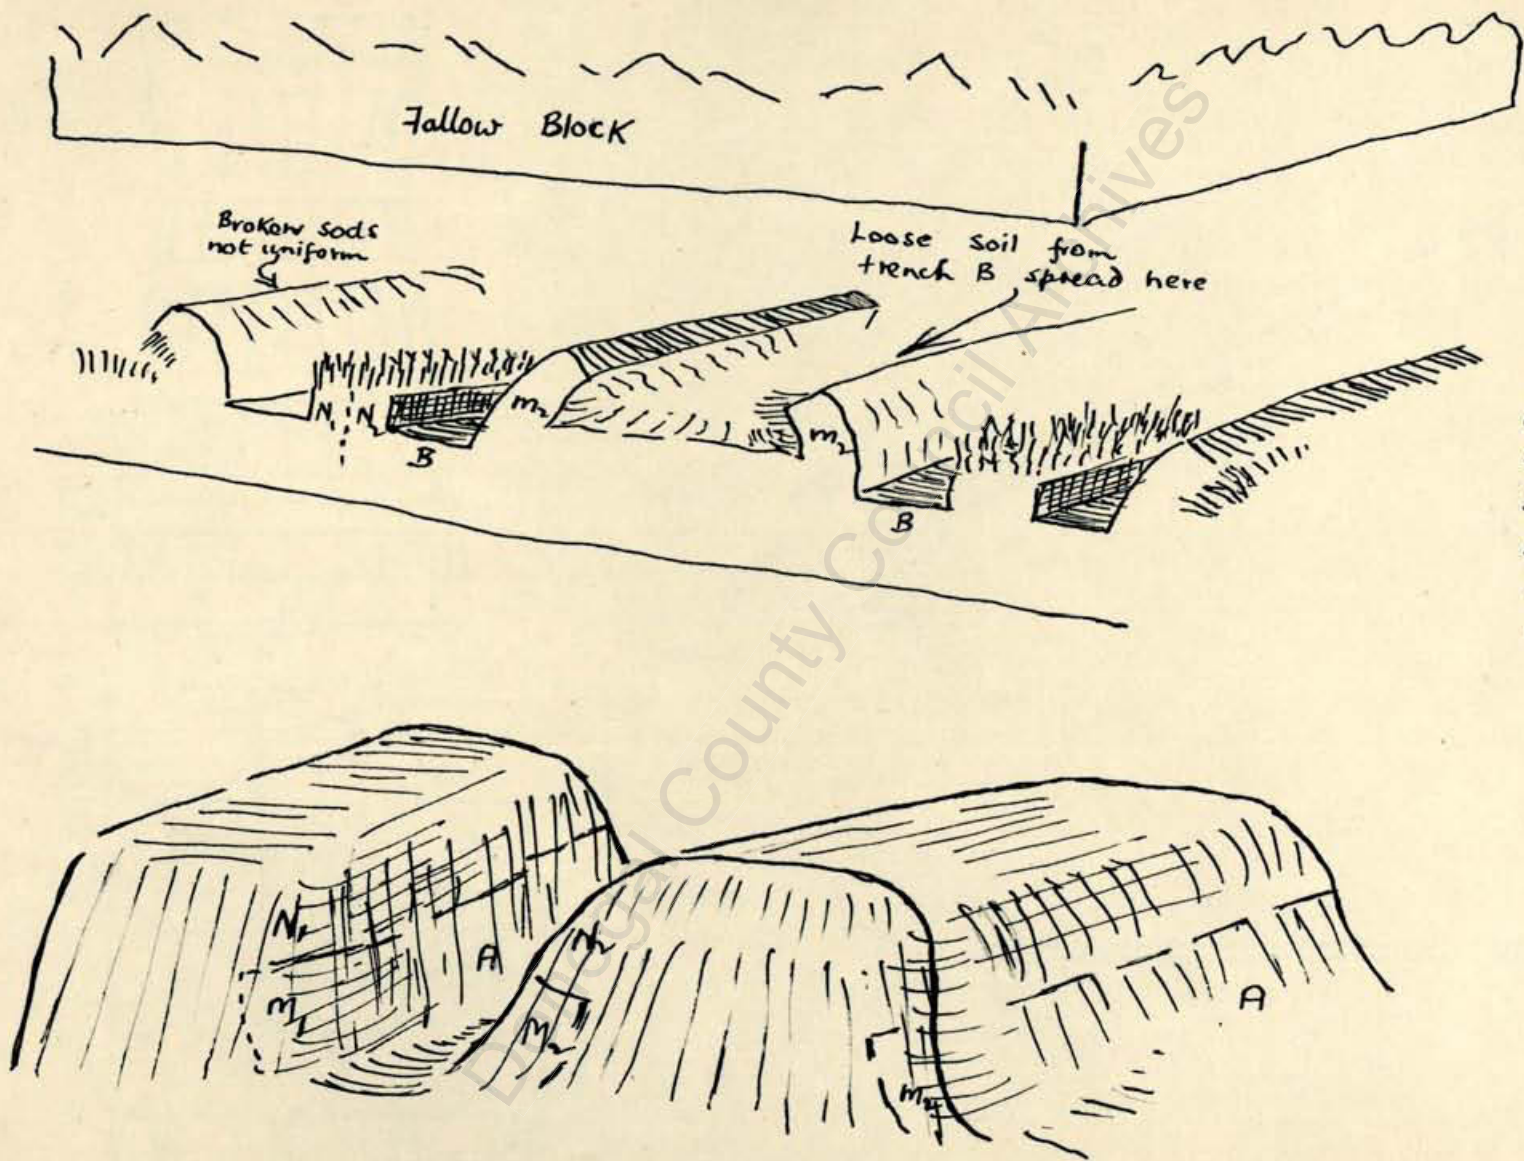
FIG. 10.

First series of sods M₂ dug from B to form first wall of new rig. Soil from B then spread on grass between M₂, M₂. When N₂ has been added trench A is deepened by using its soil to build up rig.

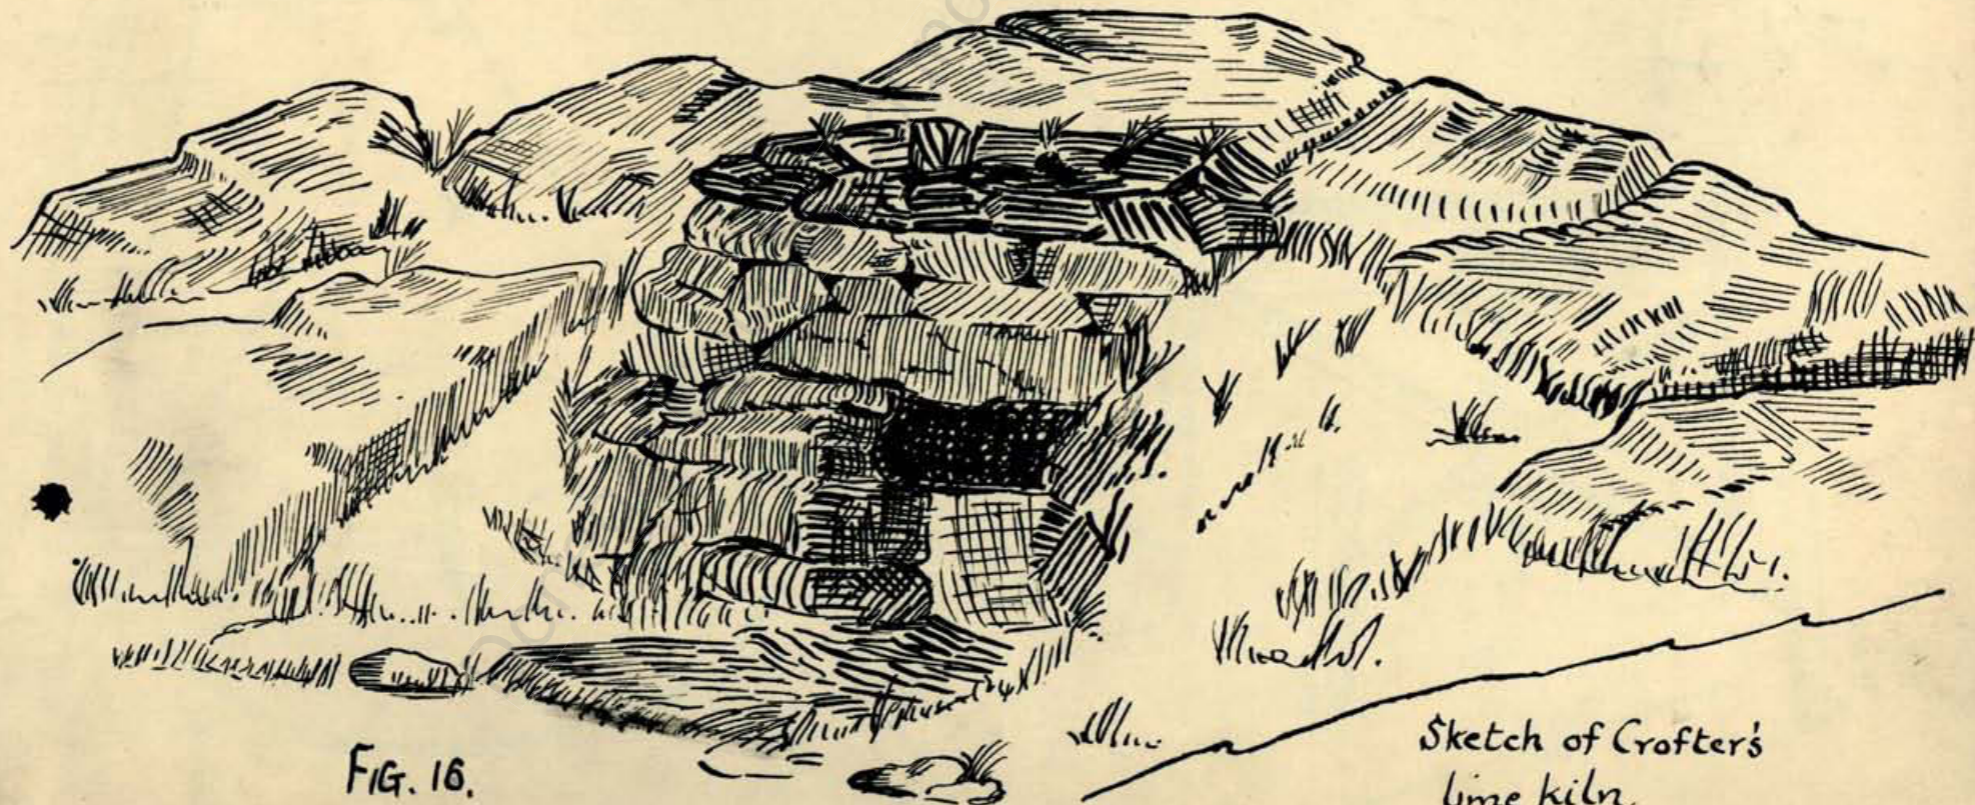
FIG. 16.

Sketch of Crofter's
lime kiln.

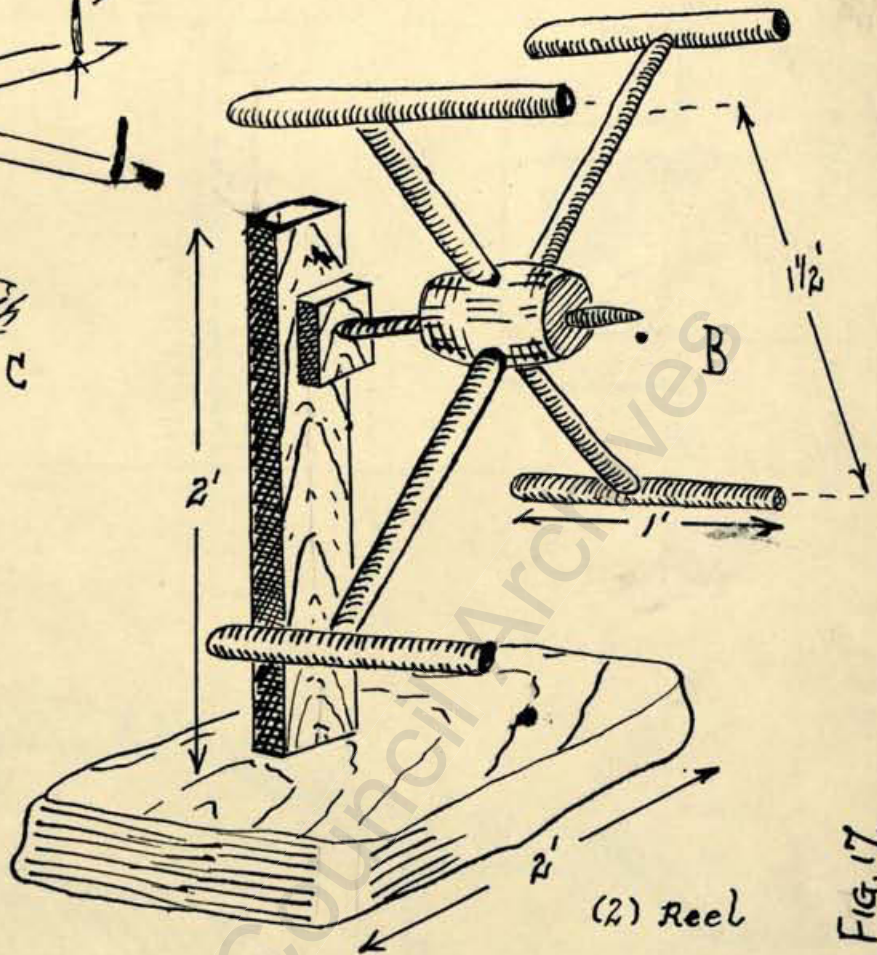
FIG. 17.

Common spool into which
a metal bobbin holder
is fixed

Pot for holding
yarn

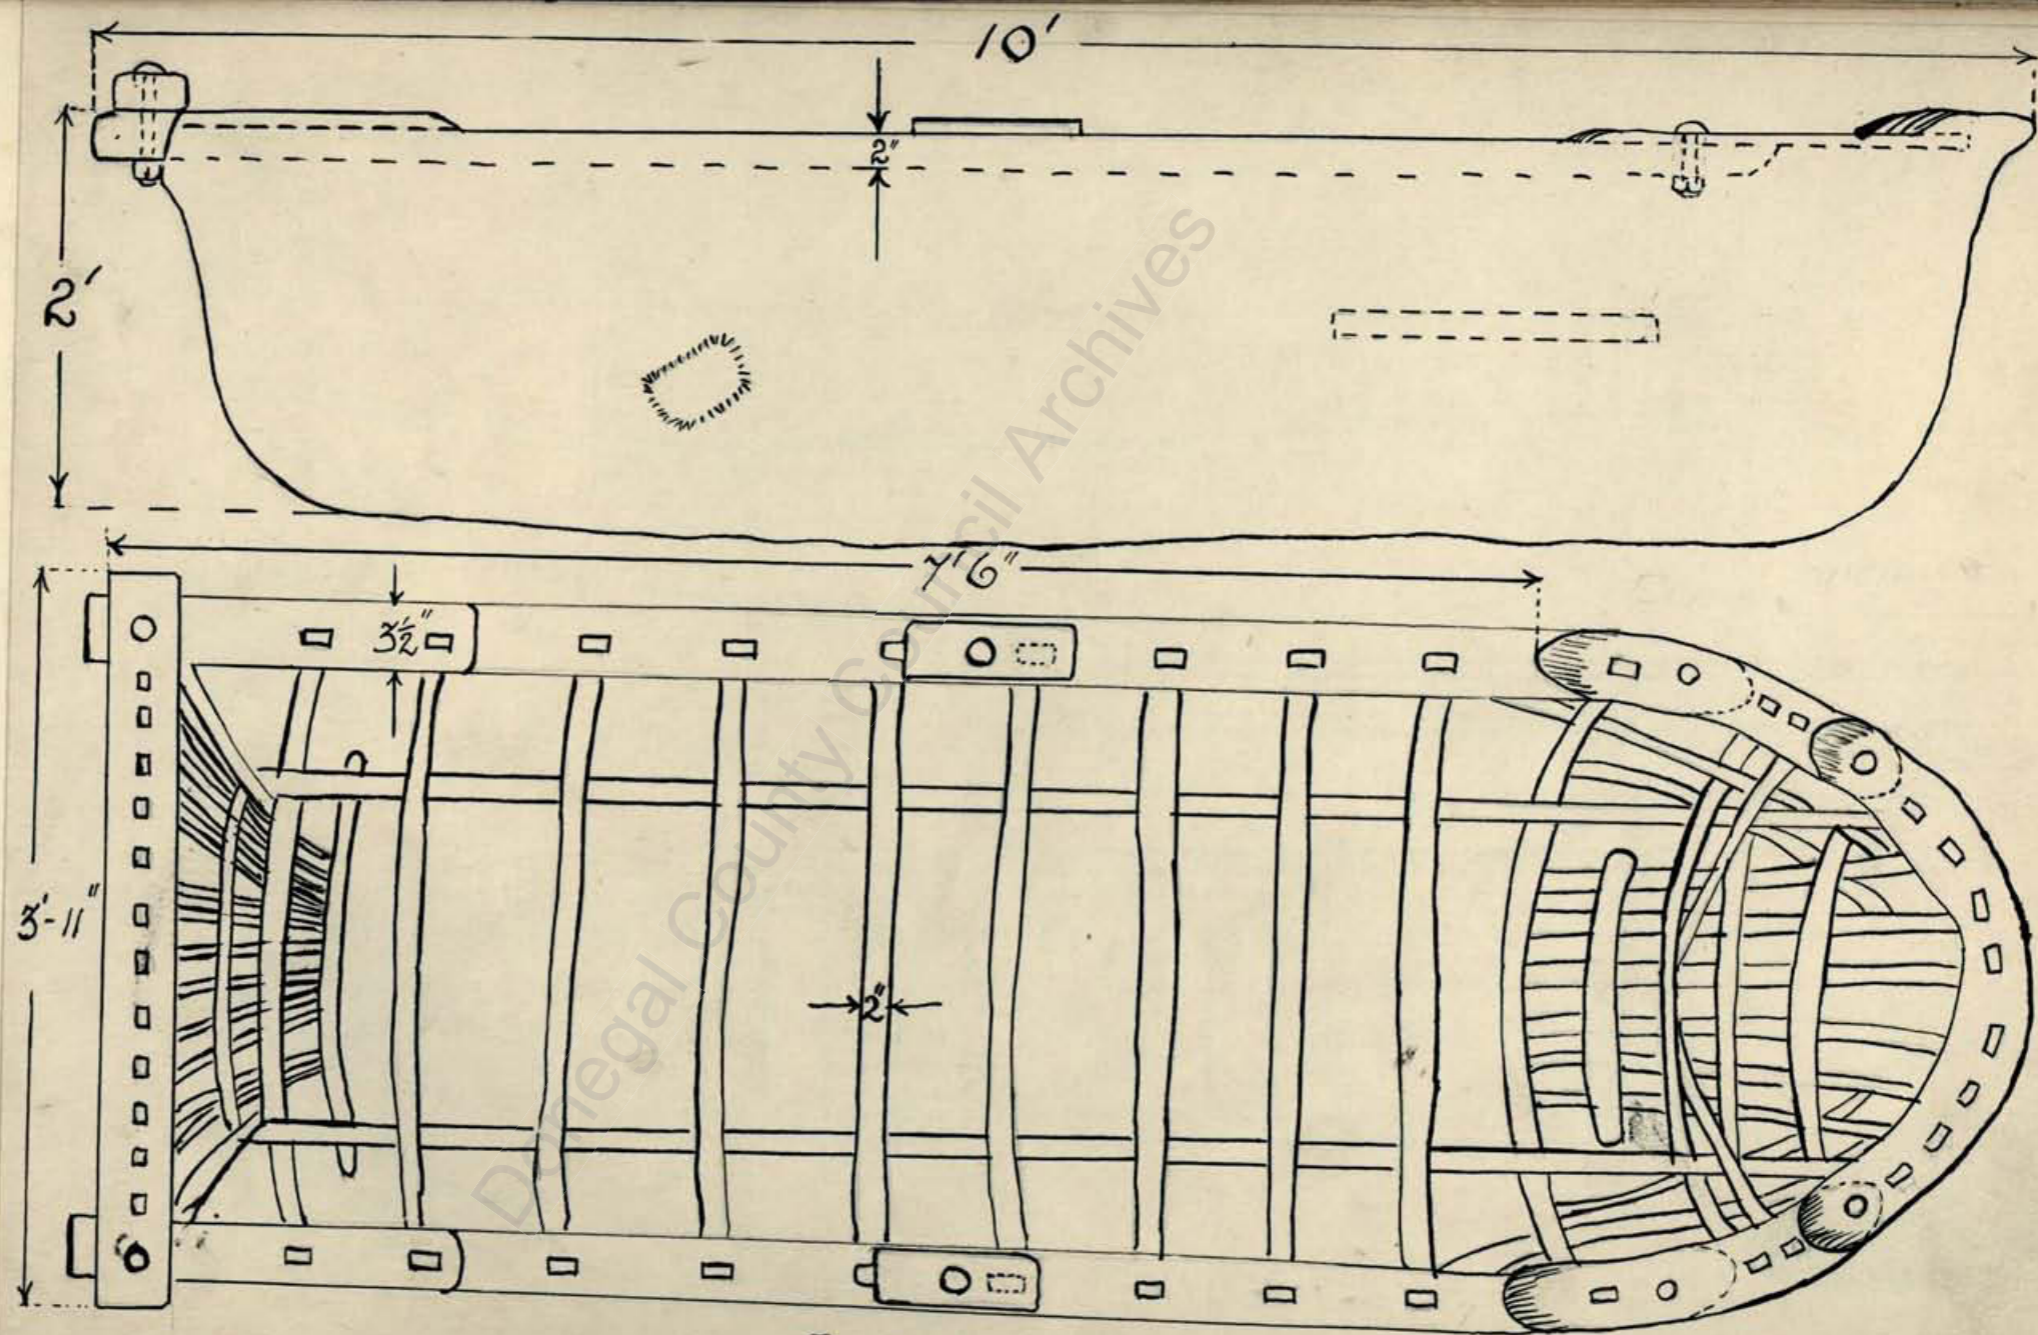
FIG. 19.

Scale 1" = 1ft.

Fig 1. A Bunbeg Curragh.

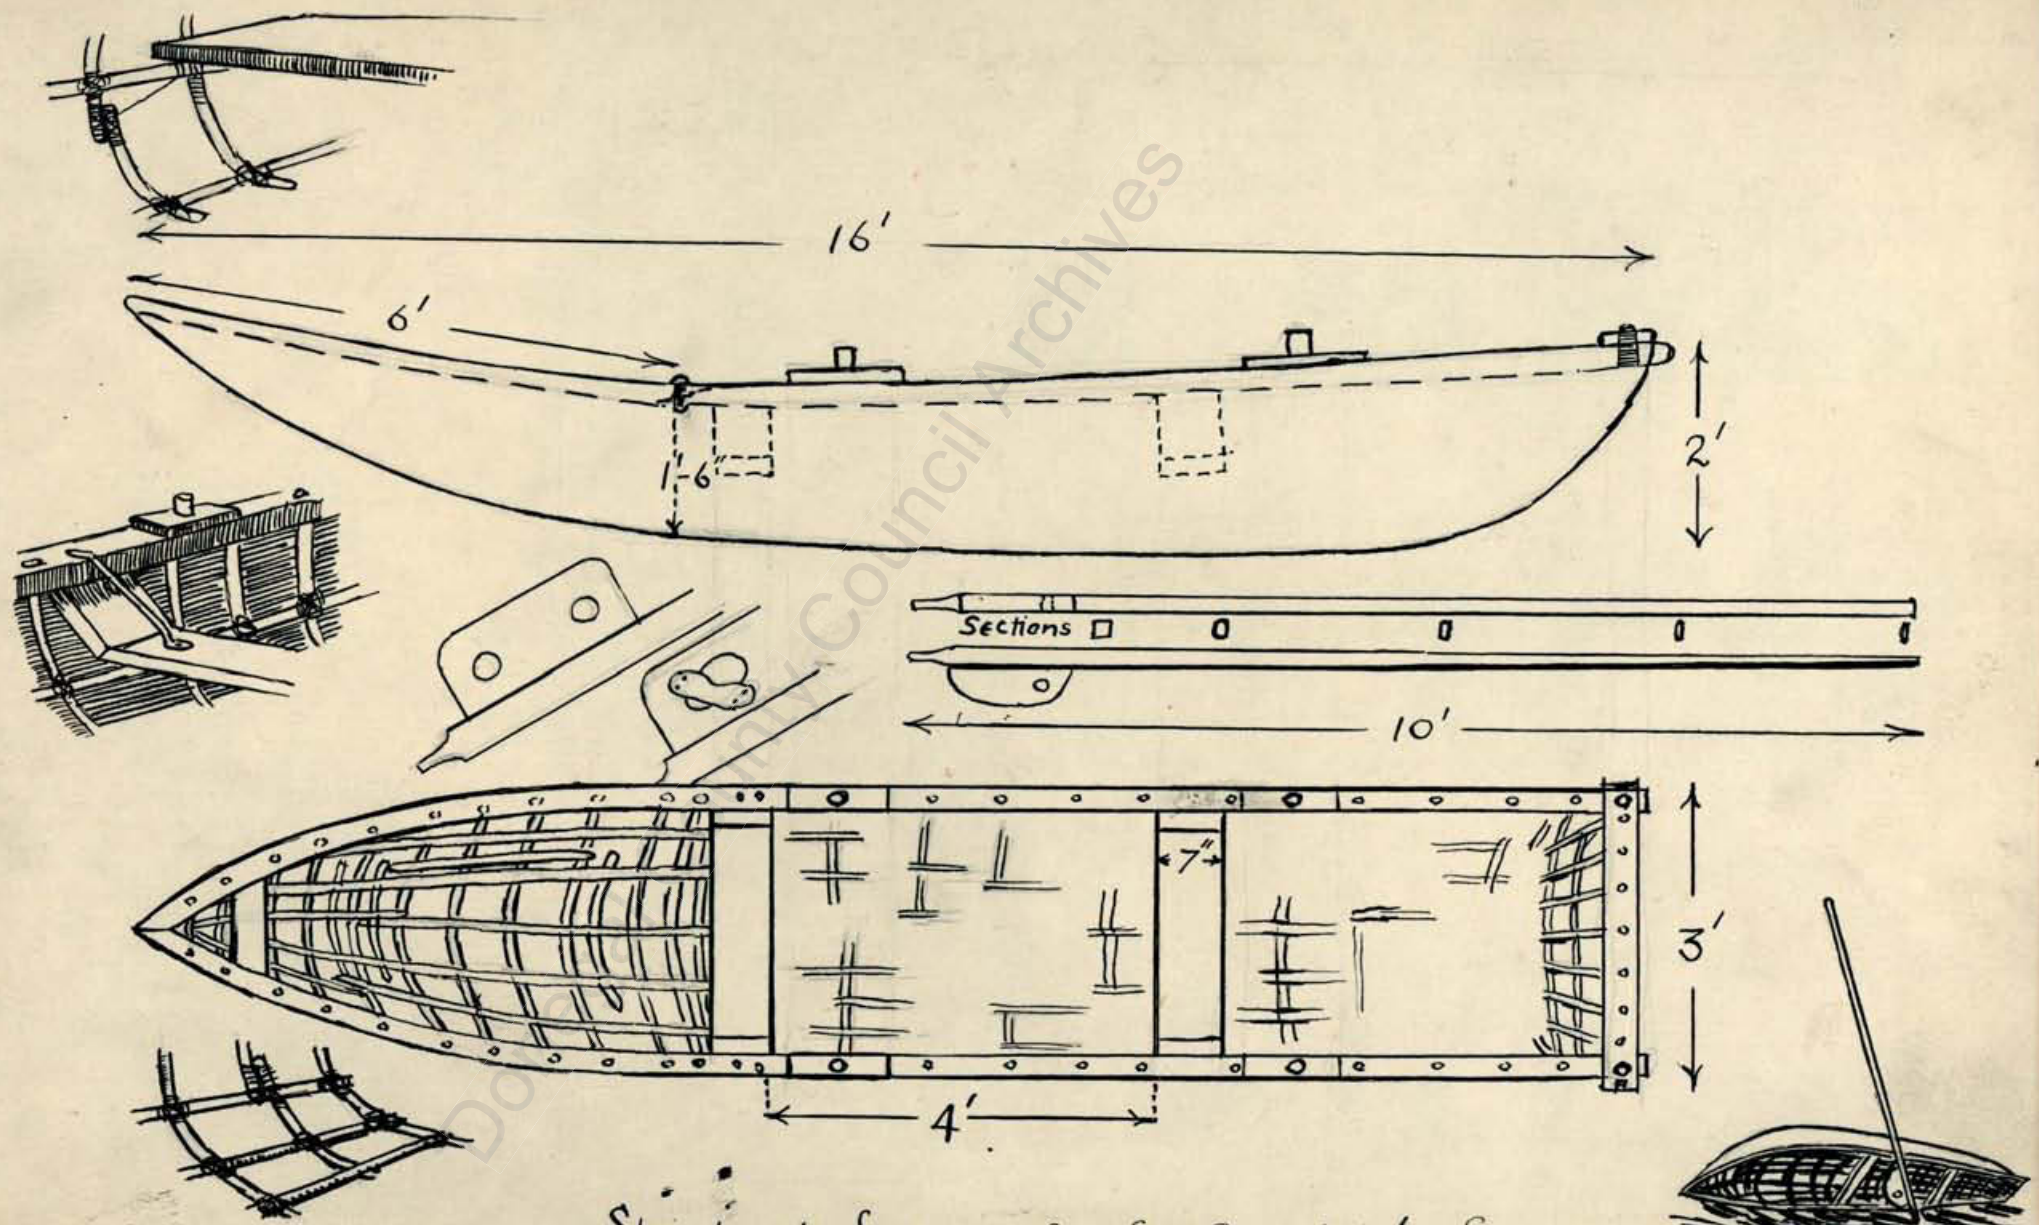
Structural features of a Sea Curragh (16) Scale 1" = 2 ft.
 FIG. 20.

Fig 2.

A Sheephaven Curragh

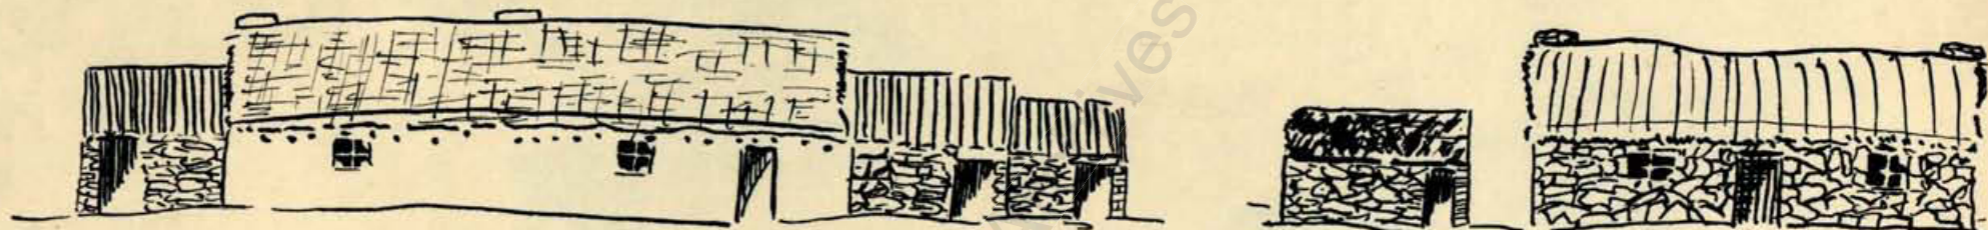
HOUSE TYPES LOCATED ALONG WESTERN SEABOARD AND SHOWING.
ESPECIALLY DEVELOPED BY ACCRETION. FIG. 22.

REAR VIEW SHOWING CAILLEACH.

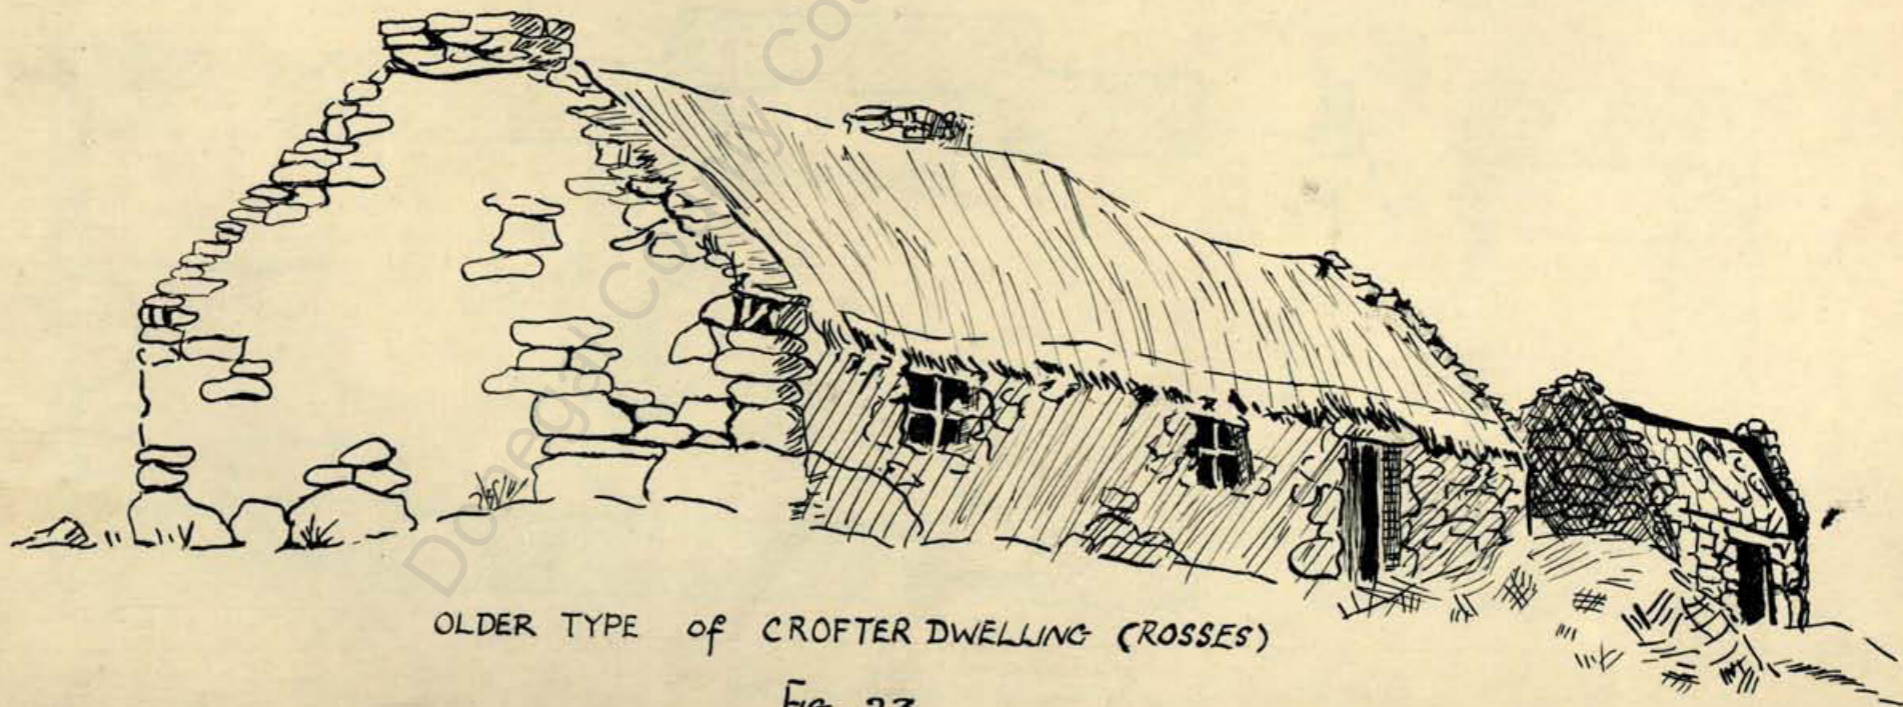
FIG. 23.

OLDER TYPE OF CROFTER DWELLING (ROSSES)

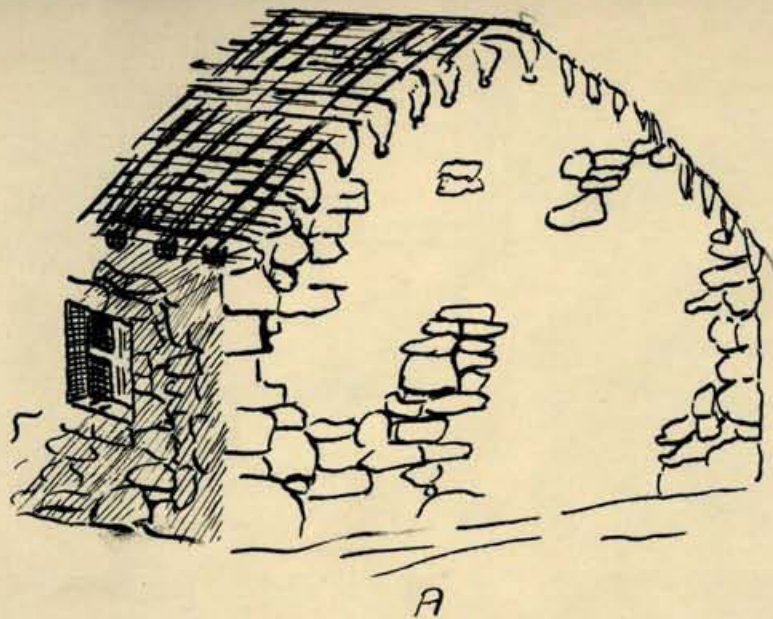
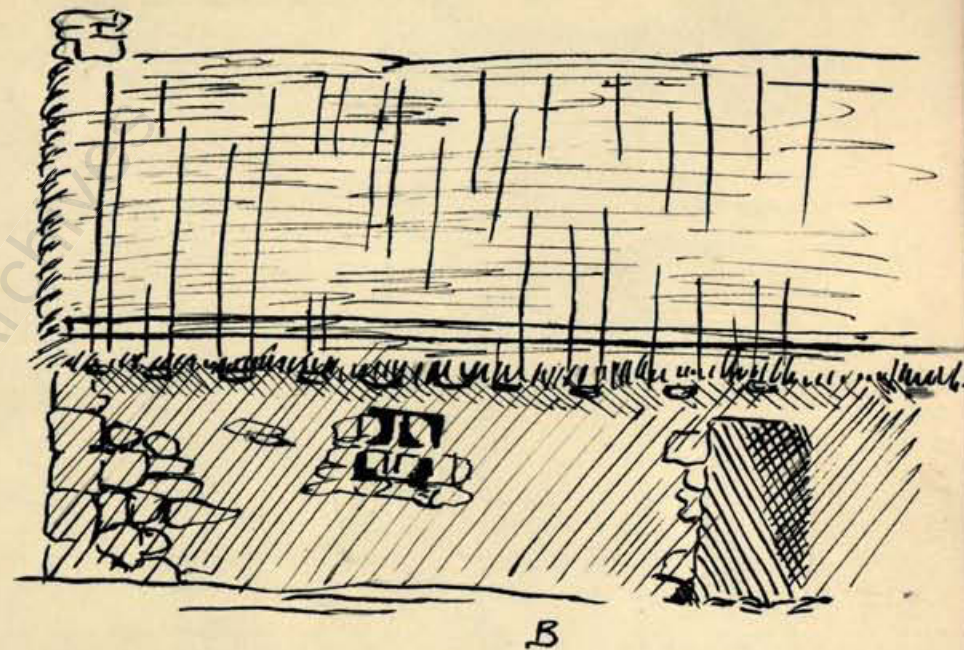
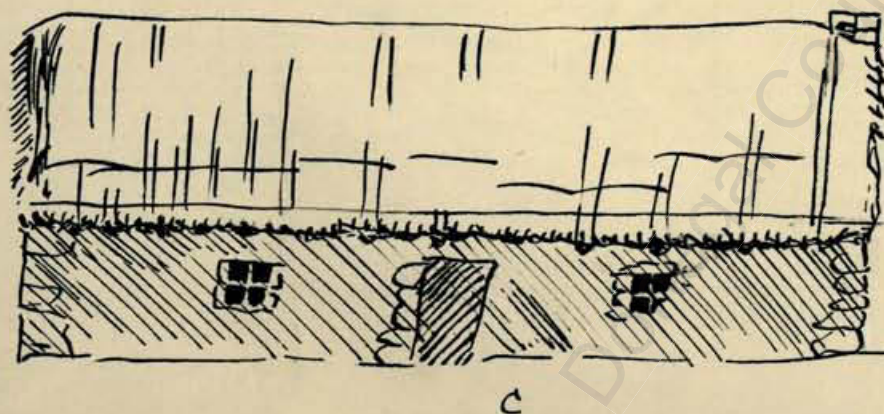
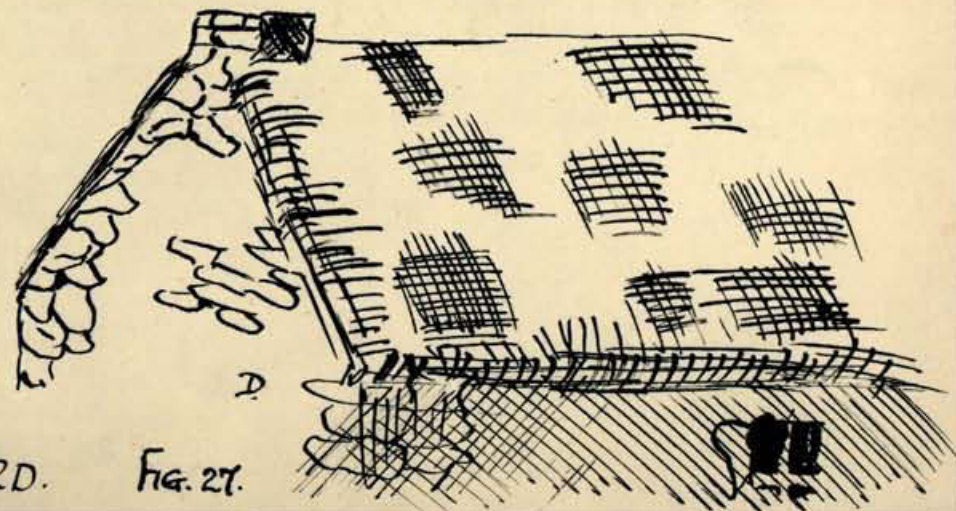
ROOF TYPES ON W. SEABOARD. FIG. 27.

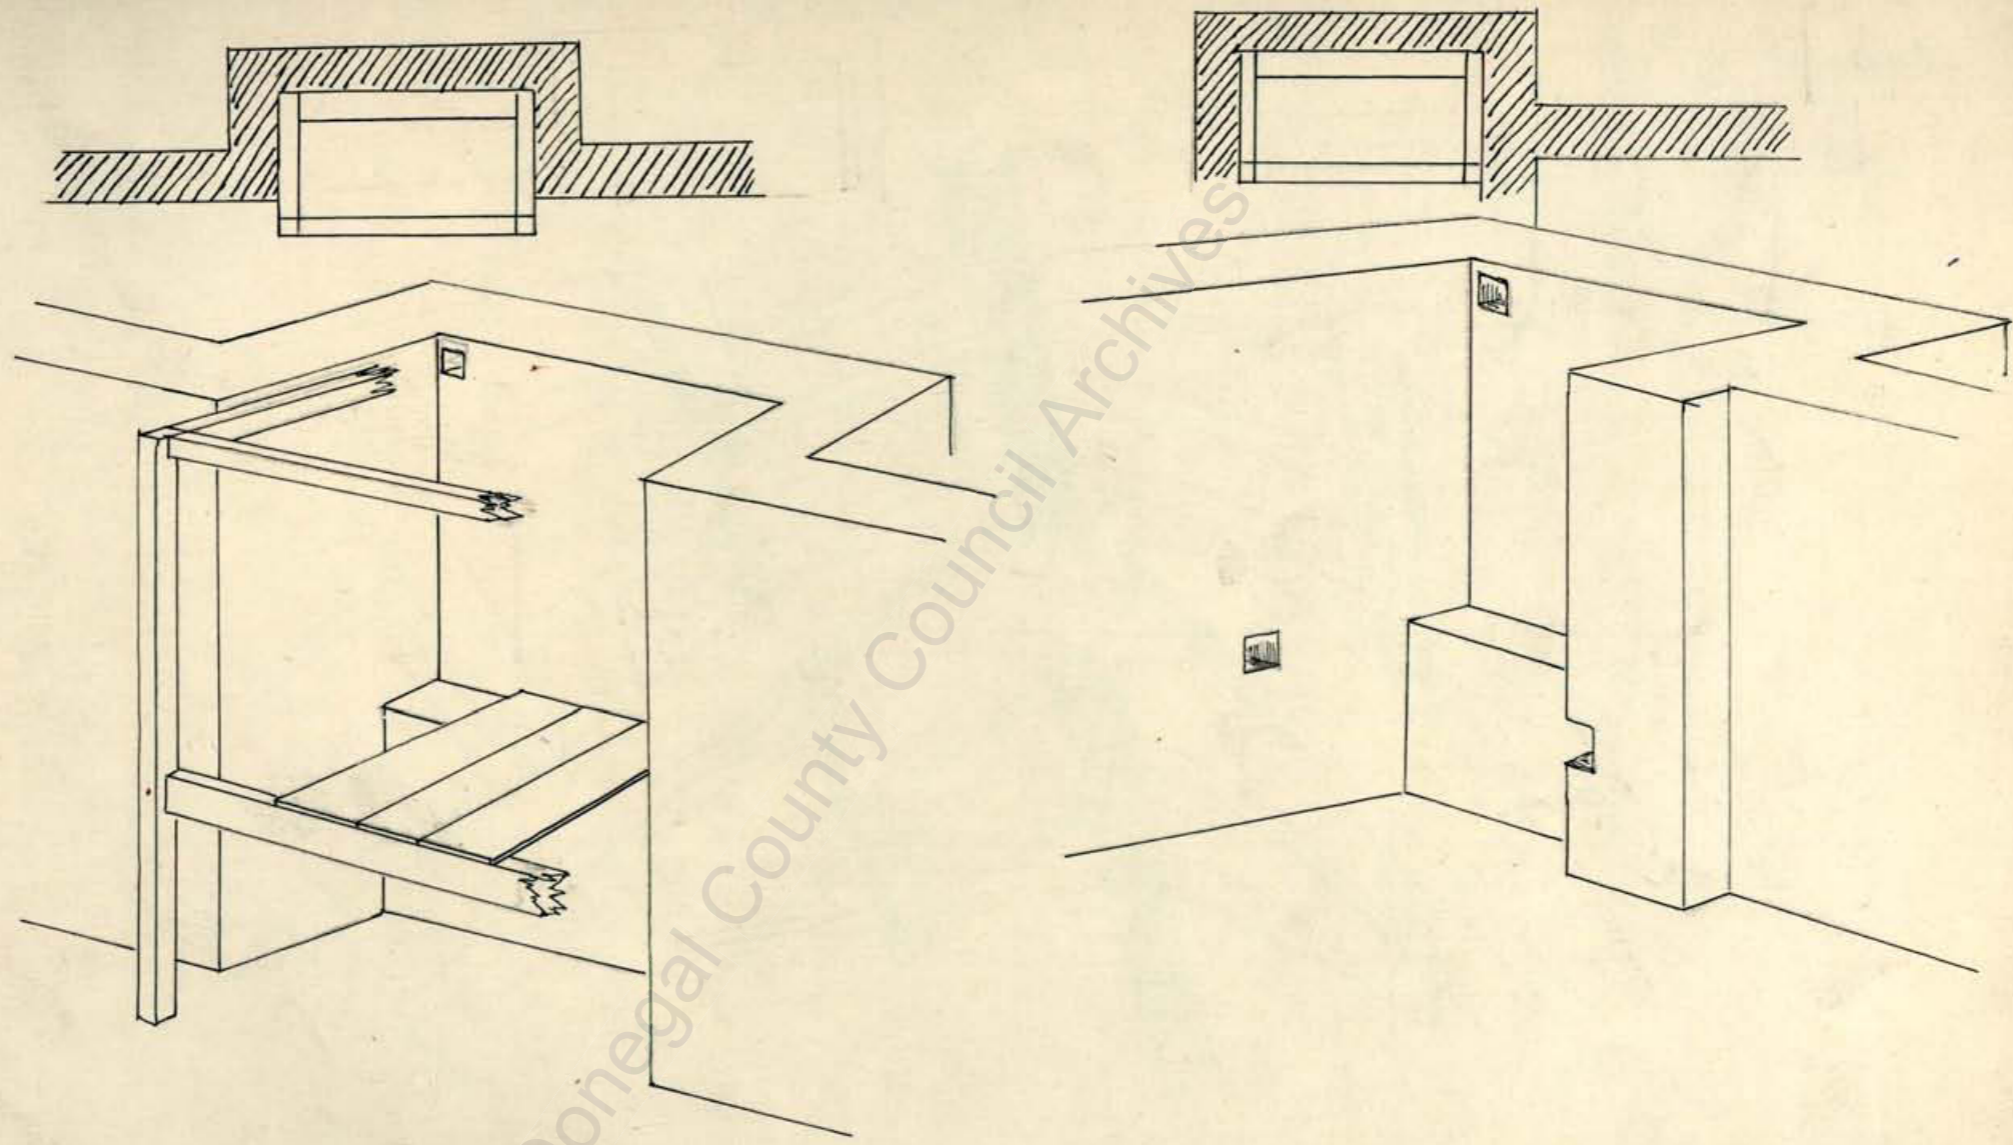
FIG. 28

Wall-bed.

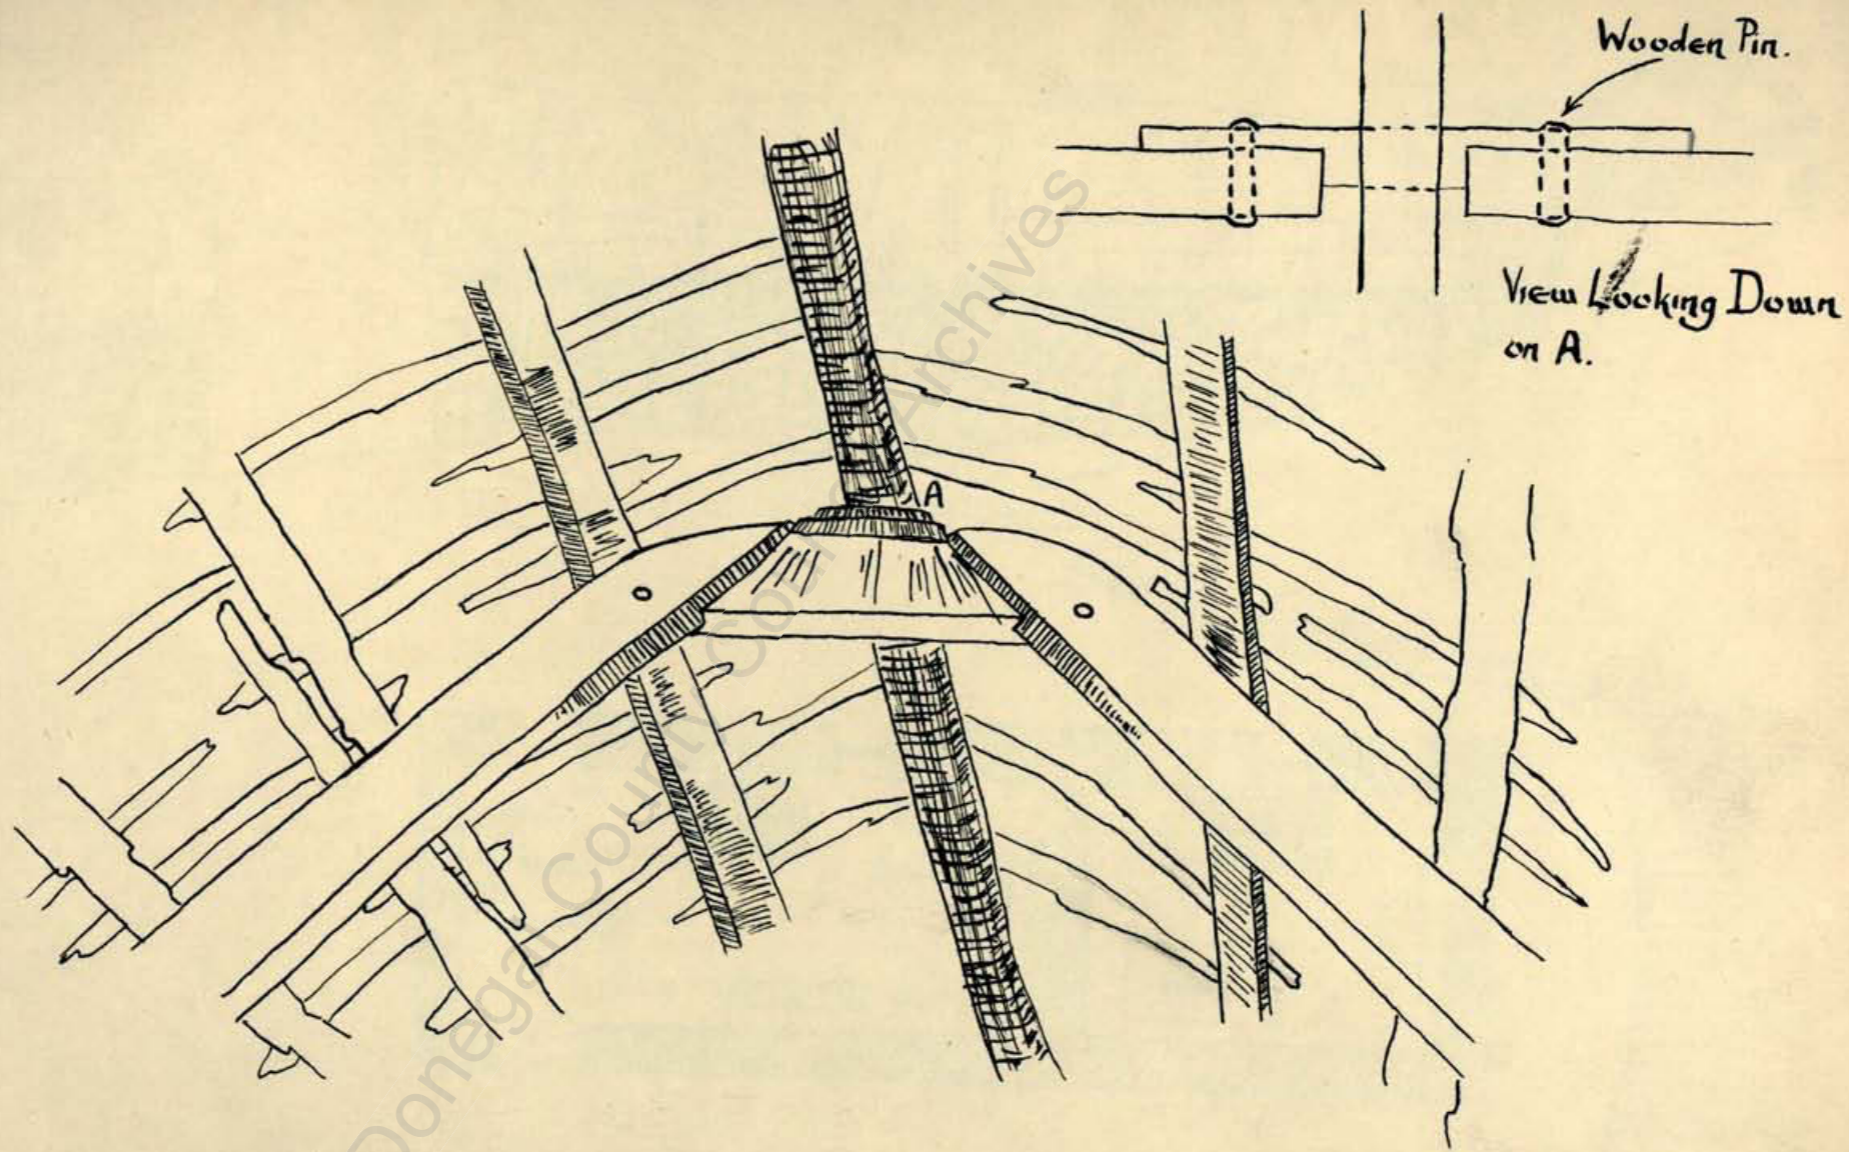
Fig. 29.

Structural features of roof

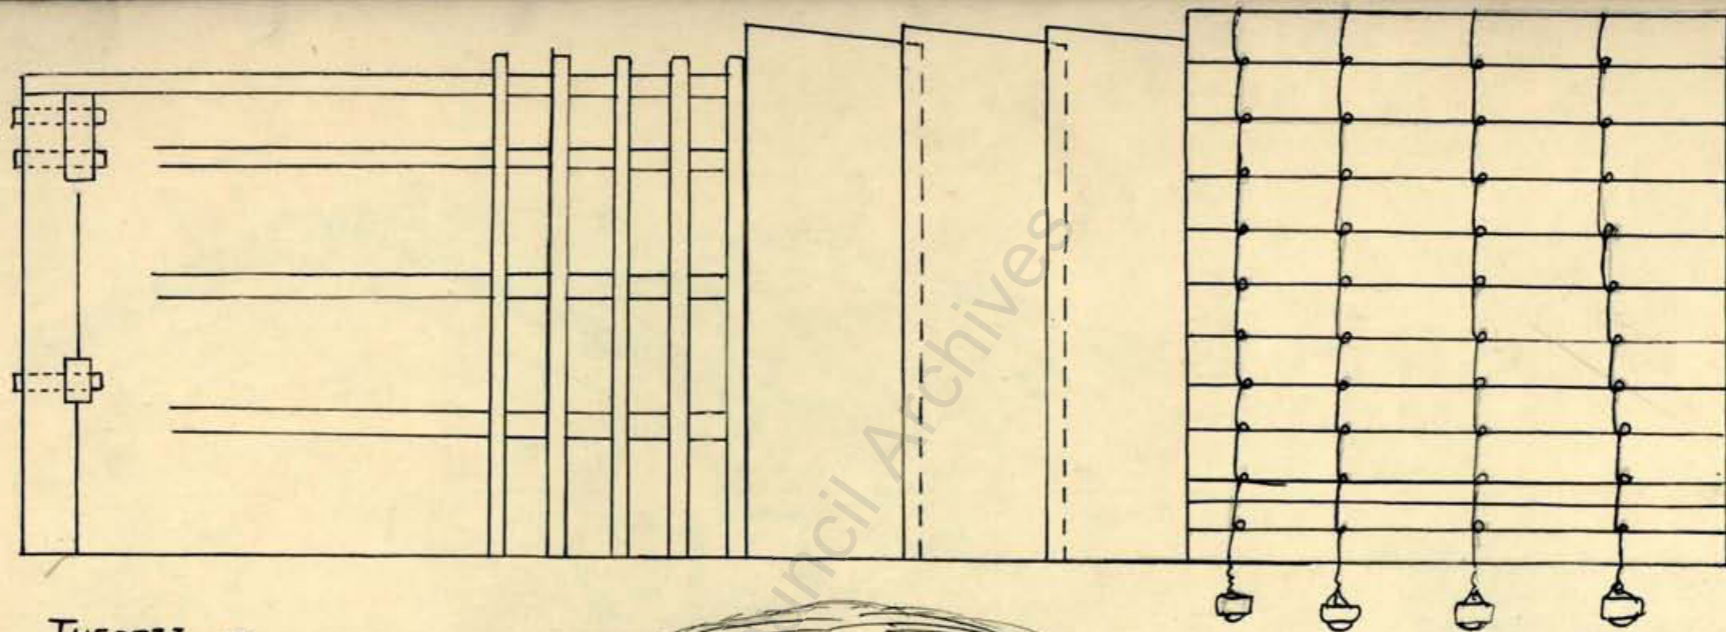
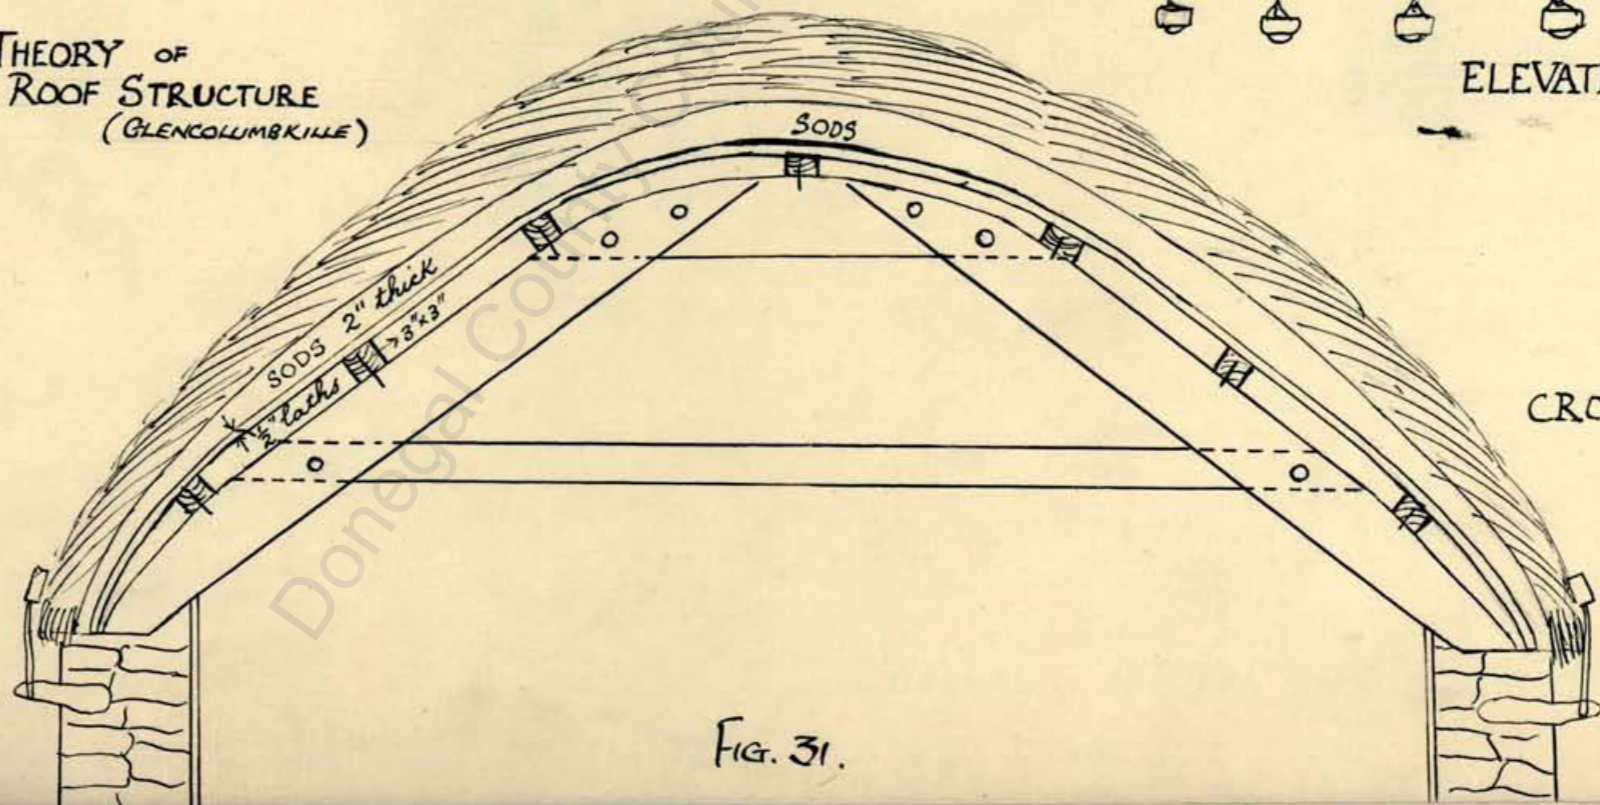
FIG. 31.

ELEVATION

THEORY OF
ROOF STRUCTURE
(GLENOLUMBKILLE)

CROSS-SECTION

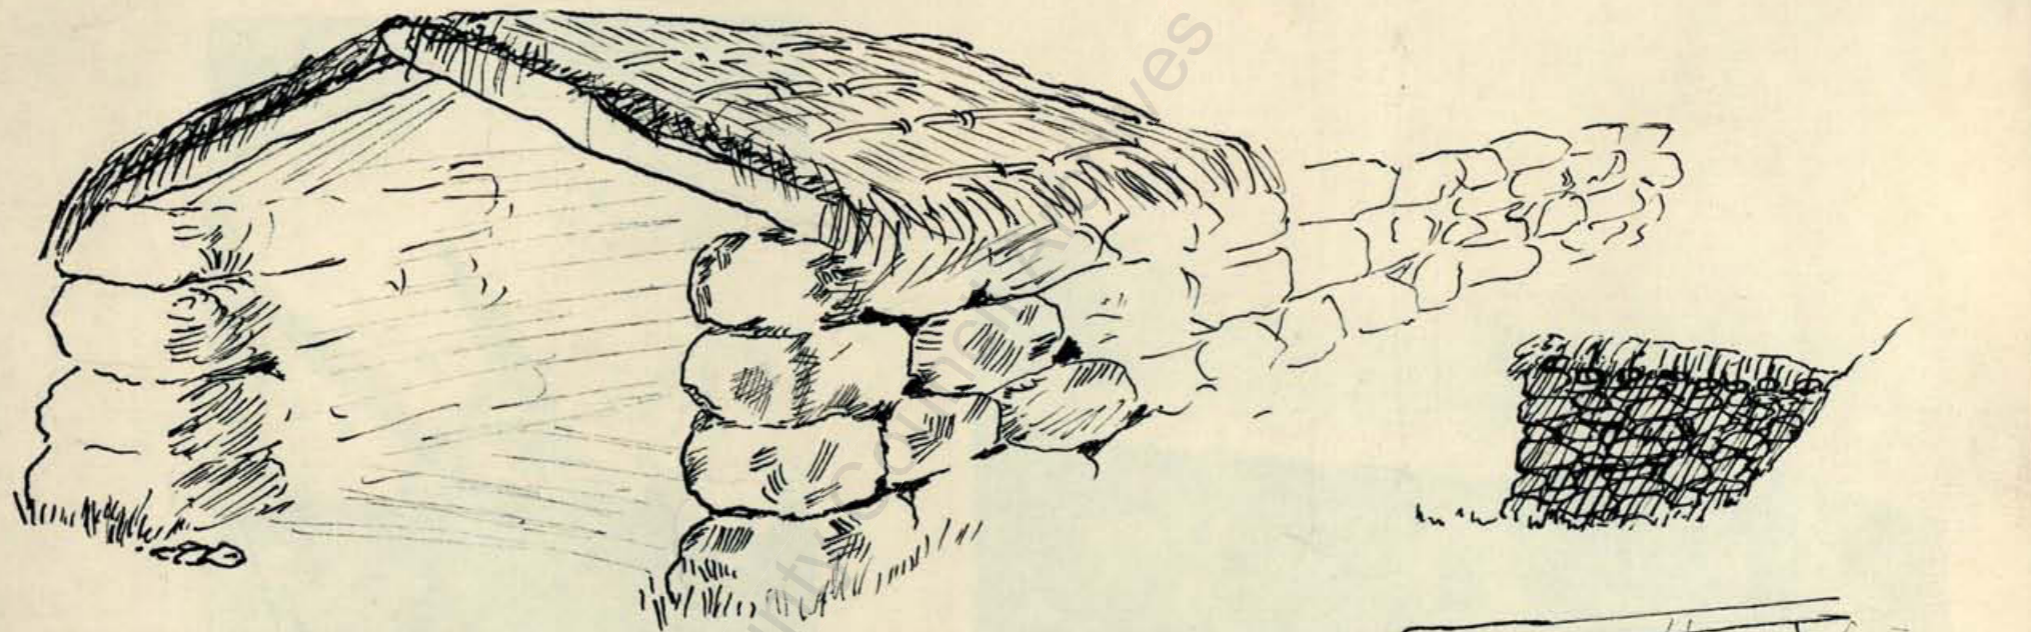
FIG. 32.

Roof-trees

Sods laid on
crossed
branches.—then
thatch

Utilisation of ditch wall. (Golly, Donegal).

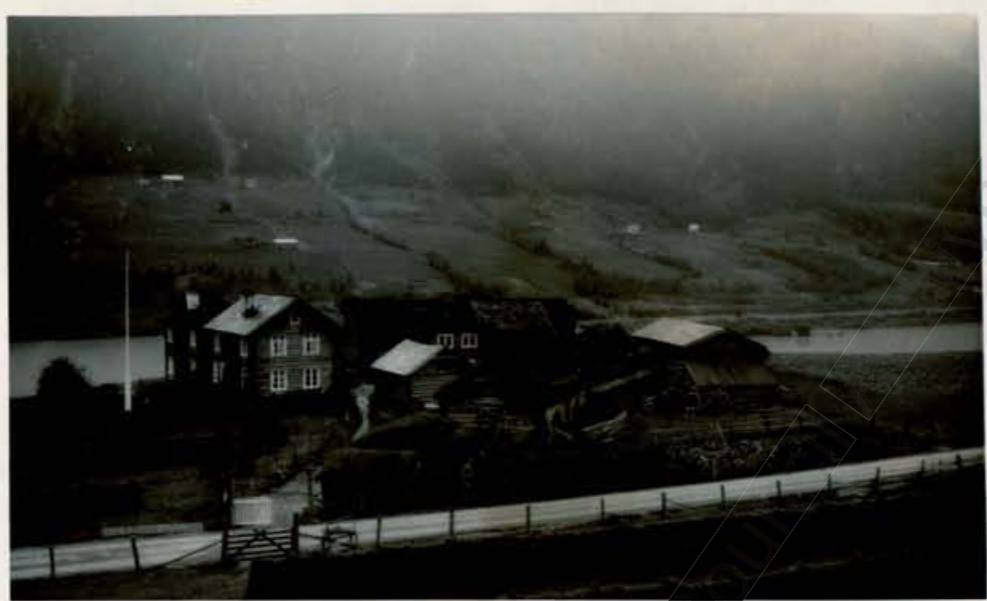
22

Influence of local material
on house structure

1. Schistose slab roof
2. Timber walls.
- 3 Lake boulders as base.
(Sogndal - Sogne Fjord).
