**Comhairle Contae
Dhún na nGall**
Donegal County Council

SECTION 4a) CARNDONAGH ADDITIONS

**made at the Carndonagh Municipal District Meeting on
21st June 2017**

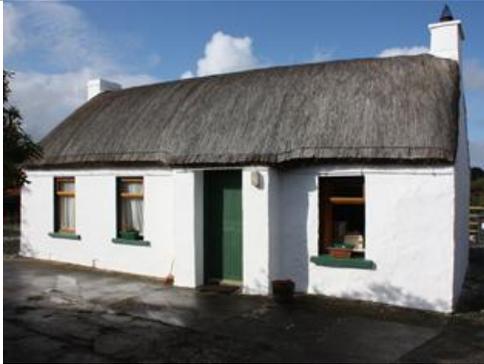
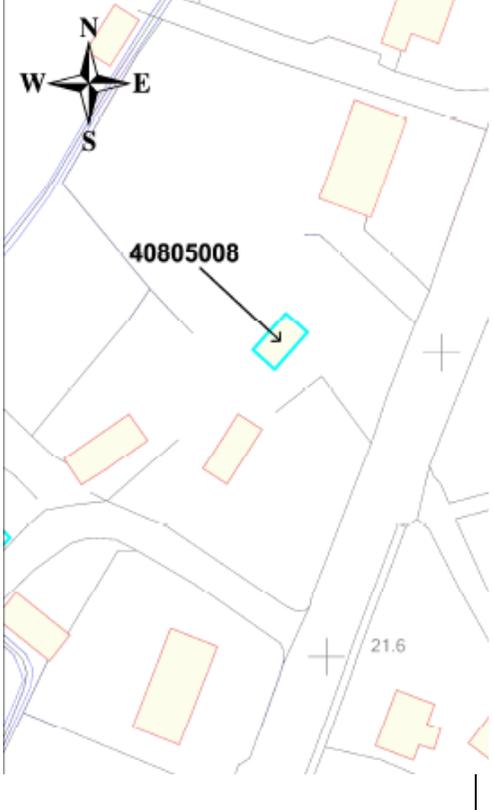
No Name	Malin Road, Churchland Quarter, Carndonagh, Co. Donegal	Detached four-bay single-storey vernacular house, built c. 1860, having projecting entrance porch offset to the north-east side of the main elevation (south-east). Possibly containing earlier fabric. Pitched thatched roof with rounded ridge, rendered chimneystacks to the gable ends, and with ropes over secured on metal pegs and wrought-iron bar below eaves level. Whitewashed rubble walls. Square-headed window openings with replacement casement windows and surviving stone sills. Square-headed door opening to windbreak porch having replacement battened timber half-door. Set back from road in own grounds to the north of the centre of Carndonagh. Rendered boundary walls and rendered gate piers to the east of site.	This well-maintained thatched vernacular house retains much of its early form and character, and is an appealing feature in the landscape to the north of Carndonagh. It probably originally dates to the second half of the nineteenth century, and appears to have formed the northern half of a pair of semi-detached dwellings c. 1900 (Ordnance Survey twenty-five inch map); a long terrace of buildings is indicated on this site c. 1837 (Ordnance Survey first edition six-inch map) so it is possible that this building contains earlier fabric. The loss of the original fabric to the openings fails to detract substantially from its appeal and integrity. Modest in scale, it exhibits the simple and functional form of vernacular building in Ireland. Of particular interest in the survival of the thatch roof, which is now sadly becoming increasingly rare in Donegal. The rounded roof is a typical feature of thatched houses located close to the sea in exposed areas in the north-west of Ireland, while the metal pegs to the eaves were used to tie ropes (and sometimes nets) over the roof to secure it against the prevailing winds, as is the case in this particular example. The windbreak porch is a typical	ARCHITECTURAL TECHNICAL	Regional

<p>feature of vernacular dwellings in the area. The form of this building and location of the chimneystacks suggests that this building is of the 'direct entry' type that is characteristic of the vernacular tradition in north-west Ireland. The arrangement of outbuildings\former dwellings and a further vernacular house with thatched roof in the immediate vicinity to the south-west (see 40805007) suggests that it formed part of a small nucleating settlement or clachan. This house and represents a fine surviving example of a once ubiquitous building type in the rural Irish countryside, and is an element of the extensive vernacular heritage of County Donegal.</p>

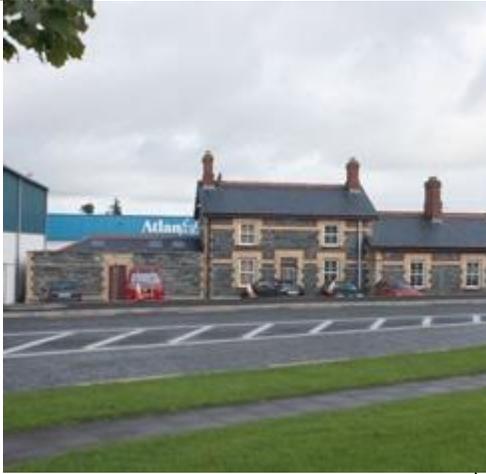
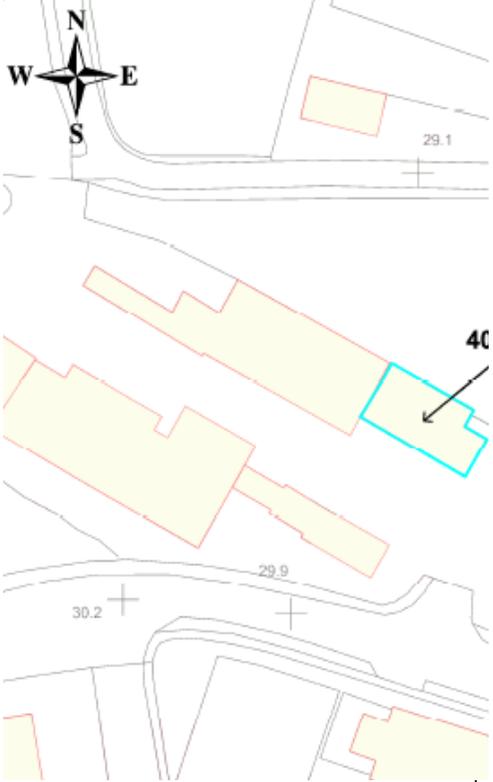
Former Carndonagh Railway Station	Atlanfish Limited (Limited Liability Company), Churchland Quarters, Carndonagh	Detached multiple-bay former railway station and station master's house, built c. 1900-1, comprising central three-bay two-storey block with attached four-bay single-storey block to east and single-bay single-storey block to west. Originally the terminus of the former Buncrana to Carndonagh section of the Londonderry & Lough Swilly Railway line. Line closed in 1935 and later in use as a house, building now in use as commercial offices. Pitched slate roofs with pierced terracotta ridge cresting, and red brick chimneystacks having stepped coping over. Overhanging eaves with timber bargeboards to gables. Replacement and surviving sections of cast-iron rainwater goods. Snecked squared rock-faced stone walls (basalt?) with yellow brick block-and-start quoins to corners, flush yellow brick bands surmounted by moulded brick stringcourse, projecting snecked rock-faced stone plinth with chamfered yellow brick coping over. Segmental-headed window openings having chamfered yellow brick reveals with chamfer-stop, yellow brick block-and-start surrounds,	This well-detailed former railway station, built in the characteristic style of the Londonderry and Lough Swilly Railway Company, retains its original character and form despite some recent alterations to accommodate new uses. It has been sensitively restored in recent years, and modern replacements are in keeping with the original structure, and fail to detract from its appeal. The main elevations of this attractive building are enhanced by the contrast between the dark grey rock-faced stone walls and the yellow brick detailing and rendered detailing, which creates interesting textural and tonal variation. The rock-faced masonry used in its construction is a feature of Victorian and Edwardian railway architecture in Ireland. This is a feature of many of the railway stations on Inishowen. This railway station was built as the terminus of the Tooban Junction & Carndonagh section of the Londonderry to Lough Swilly Railway line, which opened on the 1st of July 1901 and closed in December 1935. It was originally built by the Londonderry & Lough Swilly Railway Company who had built the earlier section of the line between Derry and Buncrana in 1864. This line was originally a	ARCHITECTURAL SOCIAL	Regional

<p>standard 5ft 3-inch gauge but was regauged to the 3ft narrow gauge in March 1885; the later line was also of this narrow gauge. This former railway station now acts as an interesting historical reminder of the formerly extensive railway network in County Donegal, and is an integral element of the built heritage of the local area and of the wider transport heritage of the county. The simple but well-built rubble stone former railway goods sheds and/or former engine house to the north of site survive in relatively good condition, despite some alterations and modern additions, and add significantly to the historic context and setting of the site.</p>

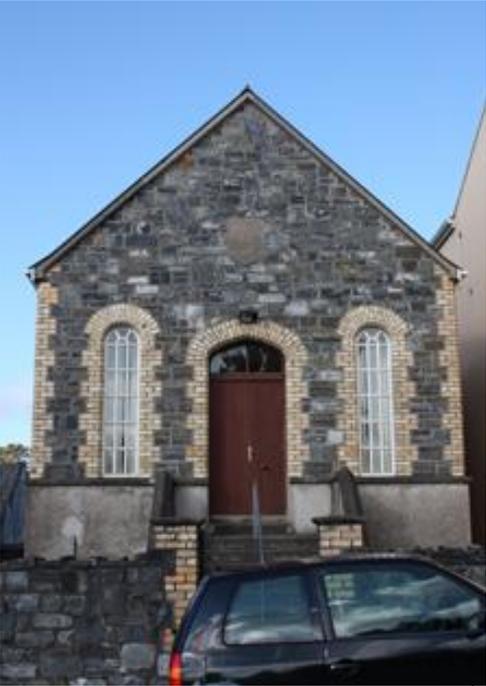
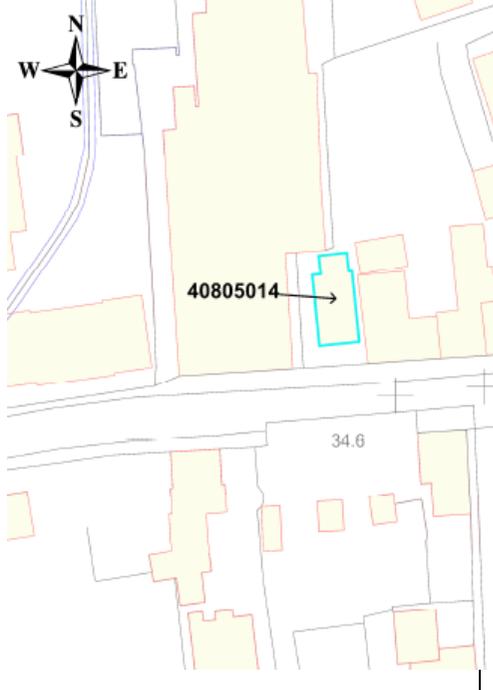
Wesleyan Chapel	Churchland Quarters, Carndonagh, Co. Donegal.	Detached three-bay single-storey over raised basement gable-fronted Wesleyan Chapel, dated 1867, having two-storey extension to rear (north) elevation. Pitched natural and artificial slate roof with slightly overhanging eaves. Replacement rainwater goods. Squared snecked rubble stone walls with flush yellow brick block-and-start quoins and rendered sill course to ground floor. Date plaque to gable incised '1867'. Roughcast rendered walls to basement up to sill course. Round-headed window openings at ground floor level having flush yellow brick block-and-start surrounds, and with multiple-pane timber windows. Square-headed window openings at basement level having four-over-four pane horned timber sliding sash windows. Central Tudor-arched door opening to front (south) having replacement double-doors and glazed overlight. Doorway approached by flight of steps from street level flanked to either side by rendered boundary walls. Set slightly back from street to the west of the centre of Carndonagh with limestone rubble wall to road-frontage to south.	This plain but appealing Wesleyan Chapel, dated 1867, retains its early form and character despite some modern alterations. It is given a sense of presence in the streetscape by the raising of the hall above a raised basement, while the contrast between the grey dimension stone and the yellow brick block-and-start quoins and surrounds to the openings add tone and texture to the façade. The gable-fronted form is typical of many mid-to-late nineteenth century chapels and meeting houses built by Wesleyans, Presbyterians and Methodists, while the round-headed window openings lend it a muted classical character. It was built to designs by the local Carndonagh architect Thomas Brady to accommodate two hundred at a cost of £400. The contractors involved were a Hutchison & Colhoun, of nearby Derry. This building is testament to the religious diversity that existed, and still exists, in this part of County Donegal at the time of construction. A Revd. Kilpatrick was the rector here in 1881, and a Revd. J.S. McDade and a Revd. John Johnston worked here in 1894 (both Slater's Directory). Sited along the main approach road into Carndonagh from the west, this	ARCHITECTURAL SOCIAL	Regional

<p>building is an important element of the built heritage of the local area and it makes a positive contribution to the streetscape of the town. The simple boundary walls and gateway complete the setting of this composition.</p>

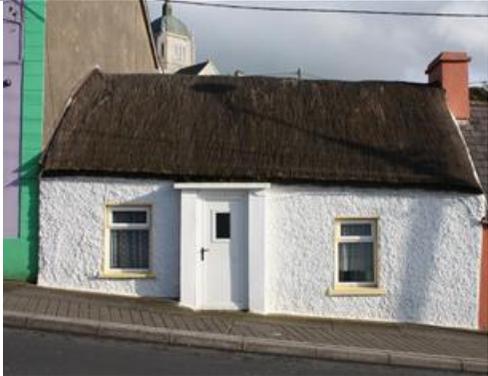
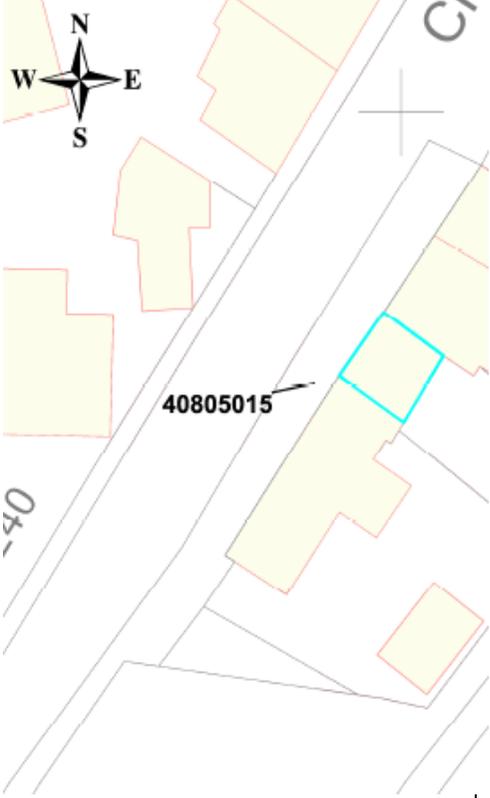
No Name	Chapel Street, Churchland Quarters, Carndonagh, Co. Donegal.	Attached three-bay single-storey vernacular house, built c. 1820, having projecting single-bay flat-roofed entrance porch to central bay to the front elevation (west), and with central single-bay lean-to porch addition to the rear (east) having corrugated-metal roof over. Pitched thatched roof having ropes and wire mesh over secured on metal pegs and wrought-iron bar below eaves level. Roughcast rendered walls to front elevation, smooth rendered walls to porch. Square-headed window openings stone with sills and replacement window fittings. Square-headed door opening to front porch having replacement door. Fronts directly onto Chapel Street to the south-west of the centre of Carndonagh. Built on a sloping site. Single-storey outbuildings to rear.	This charming and well-maintained thatched vernacular house, probably dating to the first half of the nineteenth-century, retains its early form and character, and is an appealing feature in the streetscape to the south-west of the centre of Carndonagh. The differing window levels, reflecting the slope of the street, add to its character. Modest in scale, it exhibits the simple and functional form of vernacular building in Ireland. Of particular interest in the survival of the thatch roof, although recently renewed, which is now sadly becoming increasingly rare in Donegal. The rounded roof is a typical feature of thatched houses located close to the sea in exposed areas in the north-west of Ireland, while the pegs and wrought-iron bar to the eaves were used to tie ropes (and sometimes nets or wire meshing) over the roof to secure it against the prevailing winds, as is the case at this particular example. The loss of the salient fabric to the openings fails to detract from its visual appeal. This building is probably of the 'direct entry' type that is characteristic of the vernacular tradition in north-west Ireland. While vernacular thatched houses are becoming increasingly rare, those surviving	ARCHITECTURAL TECHNICAL	Regional

<p>in an urban context are even more exceptional survivals, making this house of more significance.</p>

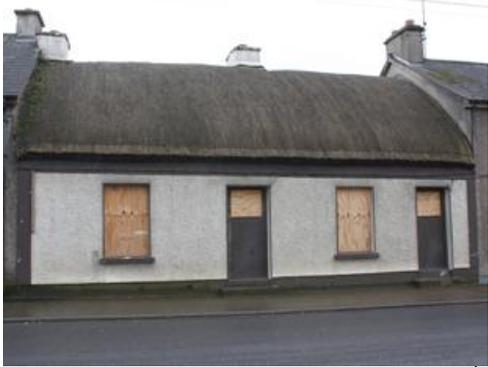
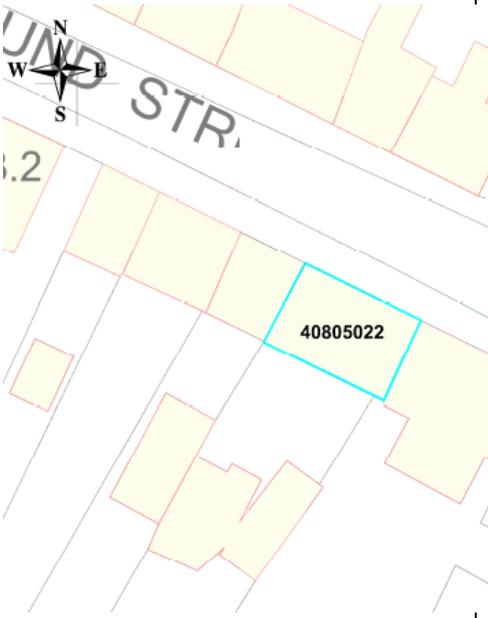
No name	Pound Street, Churchland Quarters, Carndonagh, Co. Donegal.	Attached four-bay single-storey vernacular house, built c. 1820. Now out of use. Pitched thatched roof having ropes and wire mesh over secured wrought-iron bar below eaves level, and with smooth rendered chimneystacks to the east gable end and to the centre. Smooth rendered eaves course. Roughcast rendered walls to front elevation with smooth rendered plinth course and margins. Square-headed window openings with stone sills, smooth rendered reveals, and with openings now boarded\blocked. Square-headed door openings having smooth rendered reveals, and with replacement battened timber doors with glazed upper panels (now boarded). Road-fronted to the east of the centre of Carndonagh.	Although now sadly out of use, this charming thatched vernacular house survives in relatively good condition, and is an appealing feature on the streetscape to the east of the centre of Carndonagh. It probably originally dates to the first half of the nineteenth century, and probably was formerly one of a number of thatched dwellings located along Pound Street based on the form of other altered buildings in the streetscape. Modest in scale, it exhibits the simple and functional form of vernacular building in Ireland. Of particular interest in the survival of the thatch roof, although recently renewed, which is now sadly becoming increasingly rare in Donegal. The rounded roof is a typical feature of thatched houses located close to the sea in exposed areas in the north-west of Ireland, while the wrought-iron bar to the eaves were used to tie ropes (and sometimes nets or wire meshing) over the roof to secure it against the prevailing winds, as is the case at this particular example along Pound Street. Although the openings are now blocked, the basic structure and form of this building survives intact. While vernacular thatched houses are becoming increasingly rare, those surviving in an urban context are even more exceptional survivals,	ARCHITECTURAL TECHNICAL	Regional

Reference Number	Type of Structure	Photo	Name	Location	Description	Appraisal	Special Interest	Rating
						making this house of more significance. Sensitively restored, this building would make a strongly positive contribution to the streetscape of Carndonagh, and is an integral element of the built heritage of the town.

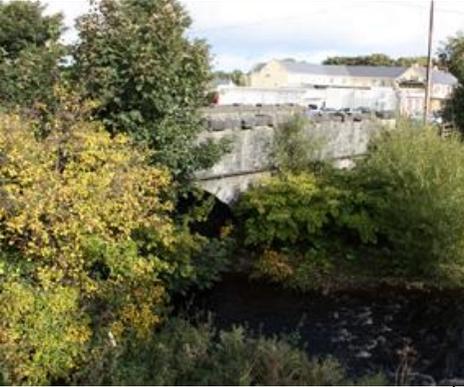
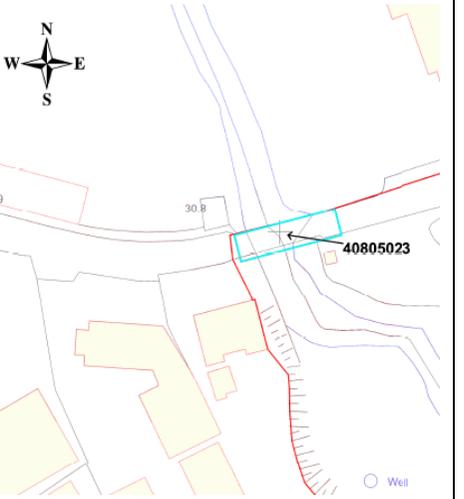
Glenngannon Bridge	Churchland Quarters, Carndonagh, Co. Donegal.	Triple-arch bridge carrying road over the Glenngannon River, built c. 1800. Central and arch to east currently dry-arches. Segmental-headed arches having dressed ashlar voussoirs; squared and coursed rubble stone masonry to arch barrels with cut stone stringcourse at arch springing points. Squared and coursed rubble stone construction to piers, abutments, spandrels and parapets; squared crenellated rubble stone coping to parapets. Water pipe fixed to south side of south parapet. Tarmacadam deck with grass verges. Located in the rural countryside to the east of Carndonagh.	This appealing triple-arch bridge retains its early character and form, despite some modifications, and is an appealing feature in the scenic rural landscape to the east of Carndonagh. It is robustly-constructed in local rubble stone masonry, and its continued survival and use stands as testament to the quality of its original construction, and of the skill of the masons involved. This bridge is notable for the high-quality squared rubble stone masonry used in its construction with ashlar voussoirs to the arches and the cut stone stringcourse at the arch springing points. The use of large coping stones over the parapets is a common vernacular detail on bridges in Donegal. This bridge probably dates to the end of the eighteenth century or the first decades of the nineteenth century, a period that saw a great deal of road and bridge-building in Ireland, particularly by the Grand Juries (the forerunners of the County Councils). This appealing bridge is an integral element of the built heritage and transport heritage of the local area, and makes a positive contribution to the landscape.	ARCHITECTURAL TECHNICAL	Regional

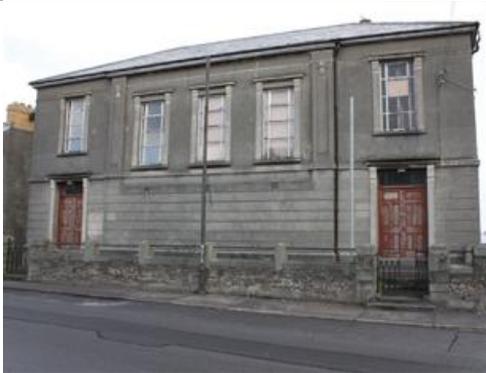
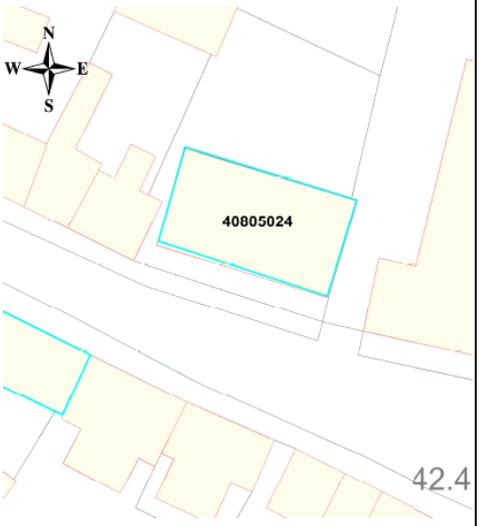
Carndonagh Courthouse	Carndonagh, Co. Donegal	<p>Detached five-bay two-storey over basement former courthouse, built 1873 and 'reconstructed' in 1925, having central shallow three-bay breakfront . Formerly with library to ground floor. Shallow hipped natural slate roof with grey clayware ridge tiles, projecting eaves course, and with yellow brick chimneystack to the south pitch having stepped brick coping over. Replacement rainwater goods. Smooth rendered ruled-and-lined walls at first floor level and channelled smooth rendered walls at ground floor level separated by smooth rendered stringcourse; projecting smooth rendered plinth; smooth rendered pilasters to either end of breakfront having recessed rectangular panels and with capital detailing over; smooth rendered stringcourse over first floor openings. Roughcast rendered walls to rear and side elevations. Square-headed window openings having timber casement windows with margin glazing bars, and with rendered surrounds comprising pilasters with consoles over supporting render entablatures. Square-headed window openings to the rear having timber casement windows with margin glazing bars, and two-over-two and four-</p>	<p>This fine if rather austere mid-to-late nineteenth-century classical-style courthouse retains its early form and character. The subdued classical detailing, including entablatures to the window openings and the channelled walls at ground floor level, helps to give this building a strong presence in the streetscape of Carndonagh and air of authority that befits an important civic building such as a courthouse. It follows a standard courthouse pattern of a three-bay central block with single-bays to either side providing separate entrances for the judge etc. and the public. There was also formerly a library here until recent times. The interior retains some interesting timber joinery, including a timber reredos to the judge's chair which may be later additions (see below). Its plan and form are similar to a number of courthouses built in some of the smaller regional towns in Ireland during the mid-to late nineteenth century, including those at nearby Bunrana (see 40815039) and at Glenties in Donegal (which was probably built to designs by William Caldbeck in 1842), at Listowel in Kerry, Newcastle West in Limerick, and at Youghal in Cork. This courthouse was built to designs by William Harte (c.</p>	ARCHITECTURAL SOCIAL	Regional

Reference Number	Type of Structure	Photo	Name	Location	Description	Appraisal	Special Interest	Rating
					<p>over-four pane timber sliding sash windows. Square headed door openings to end bays of front elevation having timber panelled double-doors, plain overlights, and with render surrounds comprising pilasters with consoles over supporting render entablatures. Flight of steps to entrances. Set slightly back from road to the east of the centre of Carndonagh. Bounded on road-frontage to the south by low rubble stone boundary wall (added 1878) having chamfered cut stone coping over with wrought-iron railings over, and with cut stone piers at interval along length. Pedestrian gateways to site, serving each doorway, comprising a pair of tooled ashlar limestone gate piers (on square-plan) having chamfered capstones over, and with cast-iron fates with fleur-de-lys finials. Yard to rear having random rubble stone walls to north and west boundaries and high smooth rendered wall to the east boundary. Double-height courtroom having fixed bench seating, gallery with cast-iron supports, plaster ceiling cornice, reredos to judge's bench, cast-iron fireplaces, and timber stairs with turned balusters and newel posts.</p>	<p>1825-95), County Surveyor for Donegal at the time of construction. The contractor involved was Robert Colhoun of Derry. The boundary walls with railings and the gates were added in 1878. This courthouse replaced an earlier courtroom in Carndonagh, which was located to the upper floor of the market house in the centre of the Diamond (extant 1837, now demolished). Slater's Directory (1881 and 1894) records that petty sessions were held here every fourth Wednesday, monthly, at these times. The courthouse was later damaged during the War of Independence or the Civil War, a fate suffered by many buildings of its type throughout Ireland between 1919 and 1923, and was later 'reconstructed' in 1925 by William James Doherty (1887-1951), an architect from Derry City who worked extensively in County Donegal from the 1920s. Doherty also 'reconstructed' the courthouse in Bunrana at the same time. Occupying a prominent site in the streetscape to the east of Bunrana, this building is a notable and imposing feature in the streetscape of the town, and an integral element of the built heritage of the local area. The</p>

Reference Number	Type of Structure	Photo	Name	Location	Description	Appraisal	Special Interest	Rating
						<p>simple but appealing boundary wall with chamfered cut stone coping, cut stone piers, and iron railings, and the simple gateways to site, add considerably to the context and complete this composition. As an important public building within the town, this courthouse is a structure of merit, not simply for its restrained classicism, but because it represents historical and social significance to the local area.</p>

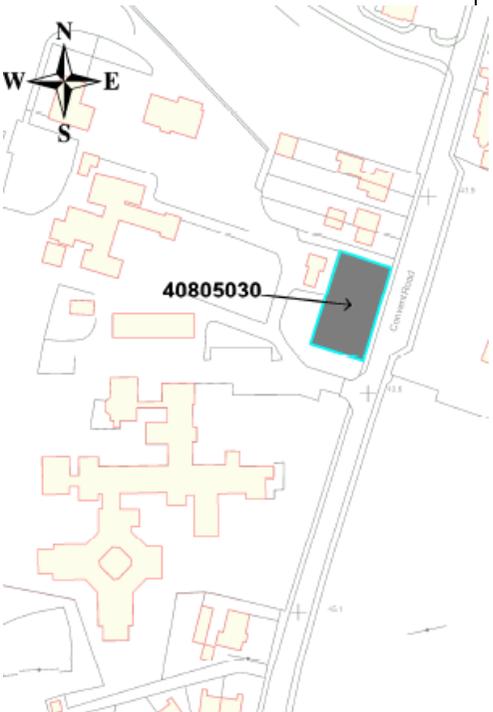
Carndonagh District Hospital	Carndonagh	Former union workhouse graveyard on rectangular-plan, in use c. 1845 - 51, containing unmarked graves of victims of the Great Famine. Now out of use. Surrounded enclosed by whitewashed rubble stone boundary walls wall with upright rubble stones to coping. Garden to enclosure. Gateway to the south comprising a pair of roughcast rendered rubble stone gate piers (on square-plan) having pyramidal coping over surmounted by painted cross finial, and with modern gate. Signage to east pier reads 'IN MEMORY OF THOSE WHO DIED OF HUNGER'. Located on to the north-east of the site of Inishowen Union Workhouse complex (built 1843, demolished 1958), and to the east of the former workhouse infirmary (see 40805006). Located adjacent to road to the south-west of the centre of Carndonagh. Modern commemorative stone to the south-west.	This sombre but well-kept former graveyard is associated with the former Inishowen Union Workhouse complex (workhouse demolished, see 40805006 for former fever hospital\infirmary). It largely contains the unmarked graves of victims of the Great Famine (1845 - 49) and acts as a poignant reminder of this traumatic event in Irish history. It is enclosed by simple but well-built rubble stone boundary walls, which are an interesting feature on the streetscape to the south of Carndonagh. Its preservation and maintenance demonstrates the local significance placed on the site, not least in providing a poignant area of reflection.	HISTORICAL SOCIAL	Regional

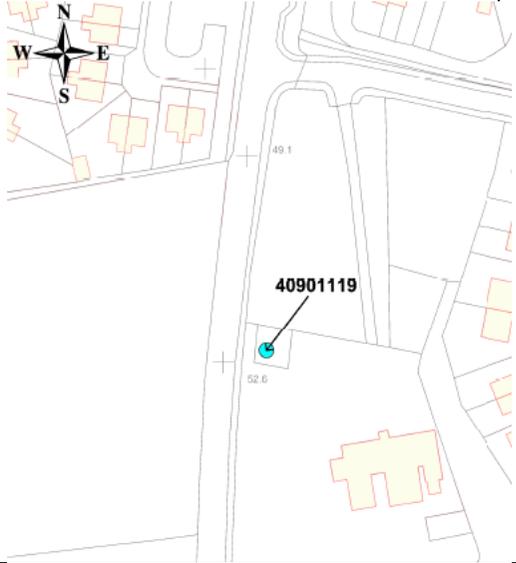
Mount Saint Mary Convent	Churchland Quarters, Carndonagh, Co. Donegal.	Burial ground for the former Sisters of Mercy convent established c. 1880. Entered from east, on square plan, enclosed by roughcast rendered walls with rounded ashlar coping. Cast-iron gate mounted on roughcast rendered piers with ashlar limestone pyramidal coping. Grass surface with range of cast-iron and wrought-iron gravemarker crosses, dating from c. 1880-c. 1960. Set within grounds of former convent.	An interesting and complete example of its type, this convent burial ground is an important part of the social and religious heritage of the area. Its simplicity reflects the vows of poverty, chastity, and obedience taken by the members of the order.	SOCIAL	Regional

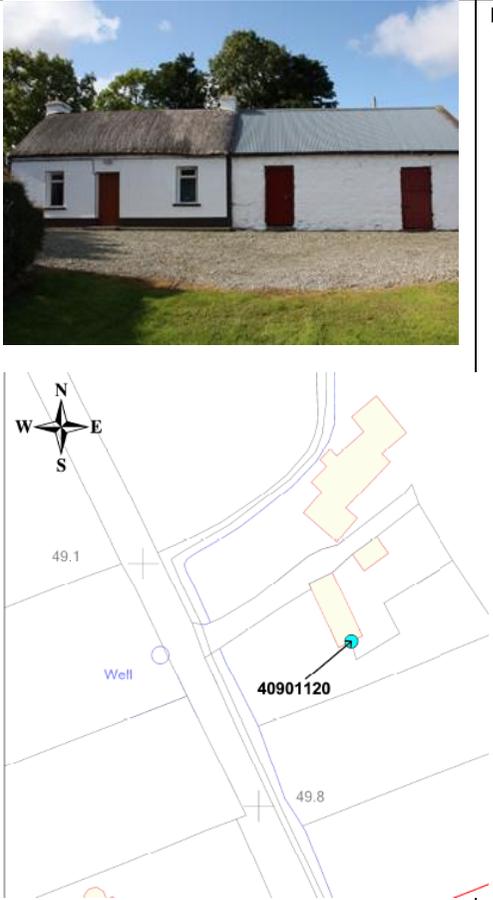
No Name	Churchland Quarters, Carndonagh, Co. Donegal	Detached three-bay single-storey vernacular house, built c. 1820, with two-bay single-storey outbuilding to north. Rounded thatched roof with netting restraint and timber and metal rope stays to eaves, and smooth rendered chimneystacks to gables with stepped cornices and terracotta pots. Pitched corrugated-metal roof with replacement rainwater-goods to outbuilding. Roughcast rendered walls with smooth rendered margins and plinth; whitewashed rubble walls to rear elevations and outbuilding. Square-headed window openings with smooth rendered patent reveals, timber casement windows and painted concrete sills. Square-headed door openings with smooth rendered patent reveals and battened timber doors. Ruinous single-cell outbuilding to south comprising random rubble walls and formerly with pitched slate roof. Single-storey outbuildings to north and north-east of site comprising of random rubble walls; pitched corrugated-metal roofs; square-headed door openings with battened timber doors. Set within own grounds to the south-west of Carndonagh.	A simple, vernacular thatched house, recently renovated and now in fine condition. It is a good example of its type and serves as a valuable addition to the architectural heritage of the area. The rounded pitched roof, designed to minimise the impact of high winds, demonstrates a subtle adaptation of thatch roof construction, to accommodate local climatic conditions in exposed areas such as Inishowen. It is marked on the Ordnance Survey first edition six-inch map of c. 1837 and appears to be associated with a former flax/thrashing mill.	ARCHITECTURAL TECHNICAL	Regional

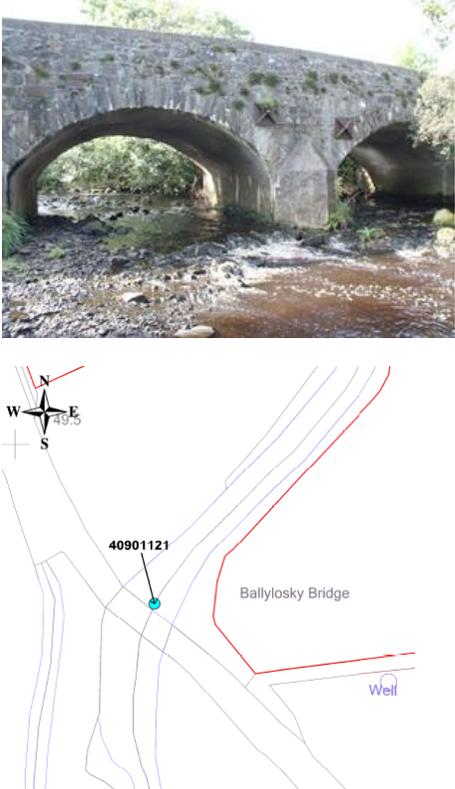
Ballylosky Bridge	Ballylosky, Carndonagh, Co. Donegal	Triple-arch road bridge over Glentogher River, erected c. 1800. Segmental arches with squared-rubble stone voussoirs. Squared rubble to vaults and piers. Random-rubble walls to parapets with rendered coping. Rendered triangular cutwaters to both elevations, with cast-iron bracing through piers. Double carriageway with tarmac to deck. Located to south of Carndonagh.	An attractive, well built bridge, complementary to its rural setting and an integral part of the area's historic environment. It has long-served as an important crossing point over the Glentogher River and its continued use is testament to its solid design and construction.	ARCHITECTURAL TECHNICAL	Regional
