Port Pier Inver

Condition Assessment Report

Donegal County Council

Report No. CM1379-STR-R001

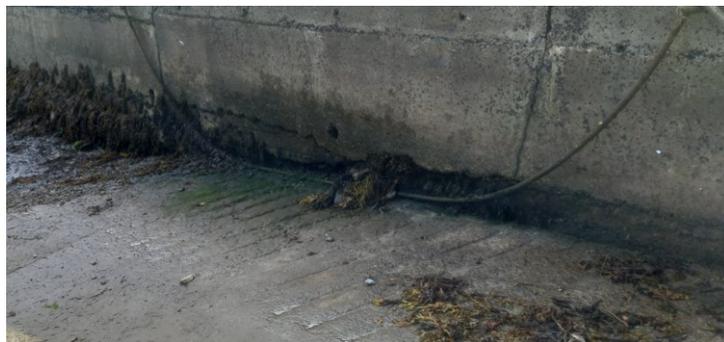
There are however some locations which would require attention to prevent further deterioration such as the undermining of the pier wall near both slipways and the steps.

Figure 2: Undermining of the pier wall near both slipways

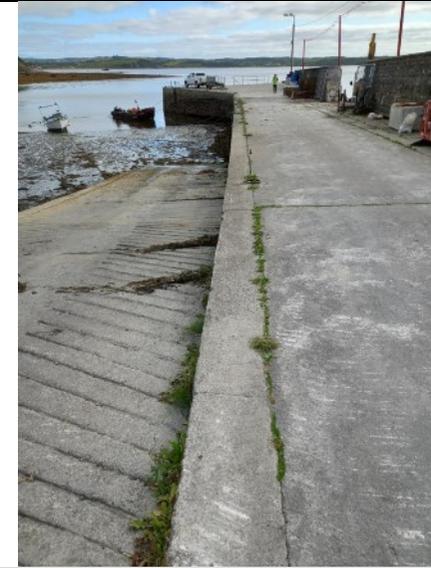
Ref:010 Caption: General condition of concrete deck & cope beam – overview of alignment & vegetation present in joint

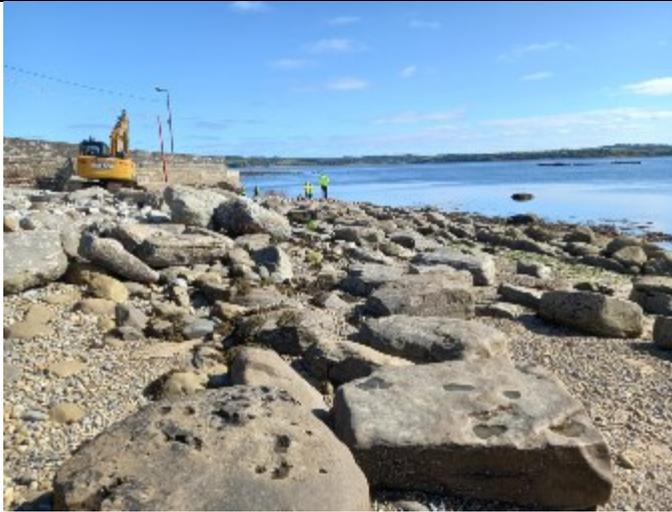
Ref:053 Caption: General overview of masonry sea wall

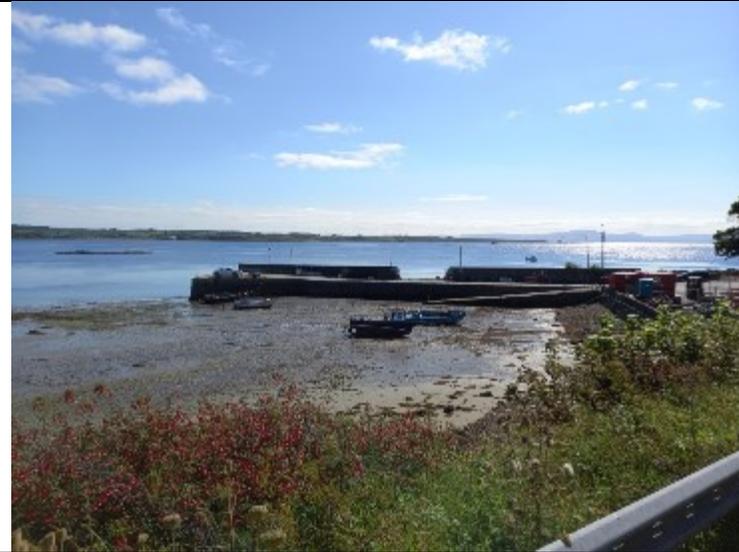
Ref:058 Caption: General overview of Pier- north elevation
